Date: August 20, 2012

Subject: West Dade Regional Library Structural Issues

Subject: *Structural Observations of the Precast Concrete Sun-Control Devices (Precast Concrete Light Shelves)*

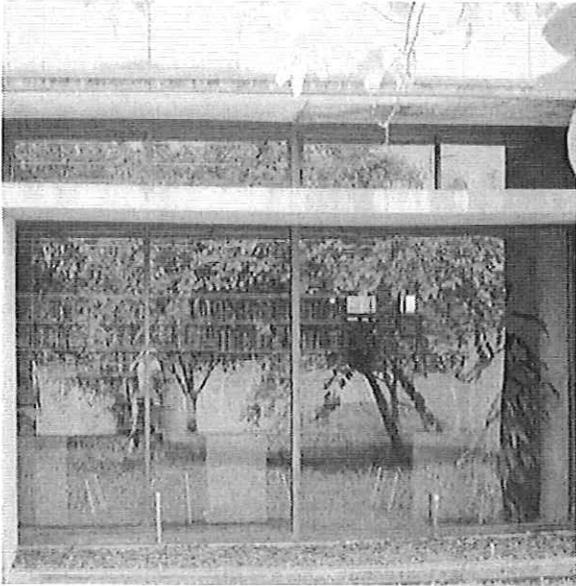
Photograph #1

Observations of the precast concrete light shelves include, but are not limited to, stress cracks at the bottom face of the shelves, general evidence of undesirable deflection, and isolated areas of spalling on some shelves. (See Photographs 1 thru 4) Based on the visual observations performed and the age of the existing shelves, it is our recommendation that a corrective action be taken by the Library Department, with high-level of importance, to shore the existing precast concrete light shelves. Once shored, a remedial plan of action should be created to replace or remove the existing precast concrete light shelves.

Based on the visual observations performed and the age of the existing shelves, ISD is recommending that a corrective action be taken by MDPLS to shore up the existing precast concrete light shelves. Once shored, a remedial plan of action should be created to replace or remove the existing precast concrete light shelves. It is important to note that a review of the existing drawings demonstrates that the library's primary structural elements consist of concrete beams and columns and precast concrete walls; therefore, the precast concrete light shelves are not essential structural elements of the building.
