Subject: Notice of Environmental Contamination in Commission District 13

RE: Hess #09293 (UT-0155/File-6961/DEP Facility ID #13/8504871), located at, near, or in the vicinity of 955 E. 49th Street, Hialeah, Miami-Dade County, Florida (Folio #04-2132-013-1110) for the September 3, 2014 discharge.

NOTICE OF VIOLATION AND
ORDERS FOR CORRECTIVE ACTION

Storage Tank Facility Discharge Site Inspection Report

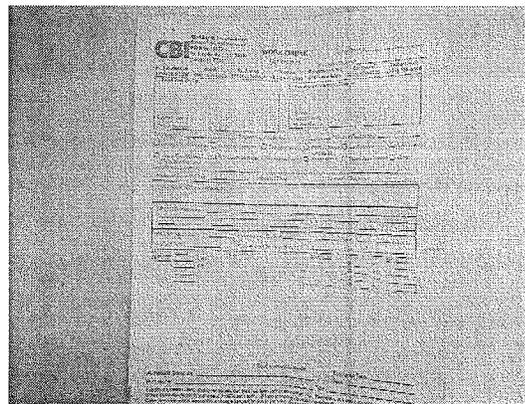
2014-9-3-Storm drain clean out manifest cliff berry inc

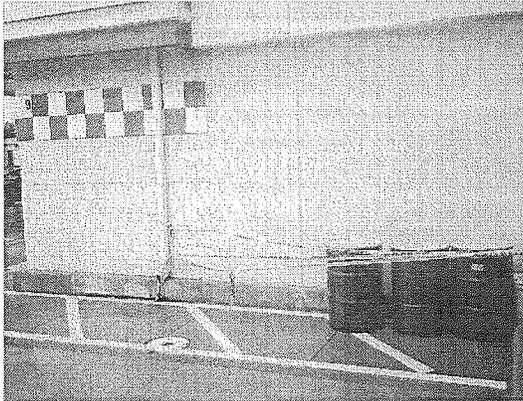
2014-9-3- three 55 gallon drums of pump out water & soil

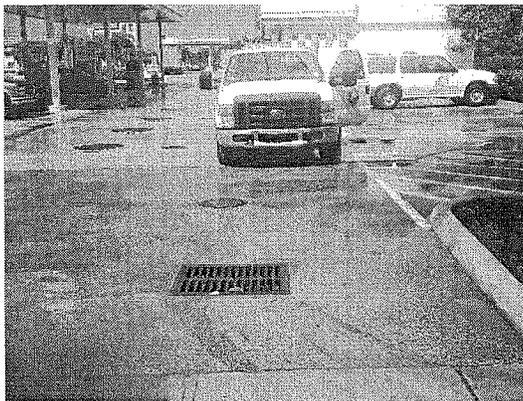
2014-9-3-overview photo of storm drain & tank farm.

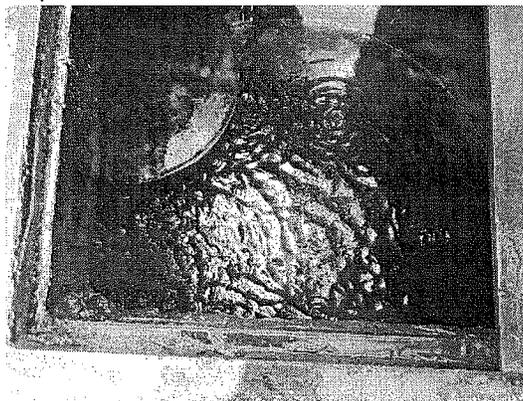
2014-9-3-No product or sheen noted during DRF inspec.

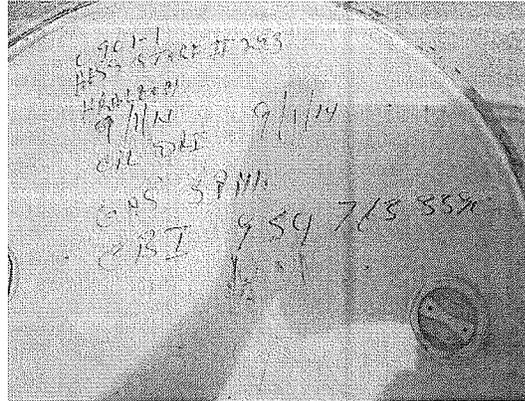
2014-9-3- Drum information for disposal by Cliff Berry.

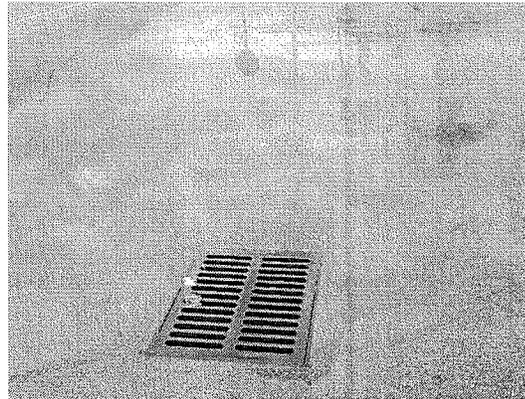
2014-9-3-storm drain and surrounding concrete no sheen.

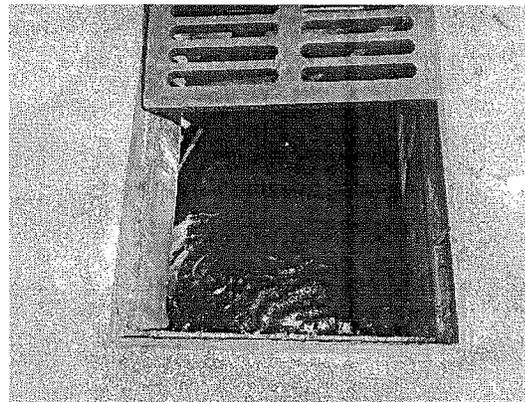
2014-9-3-No product or sheen noted during DRF inspec.

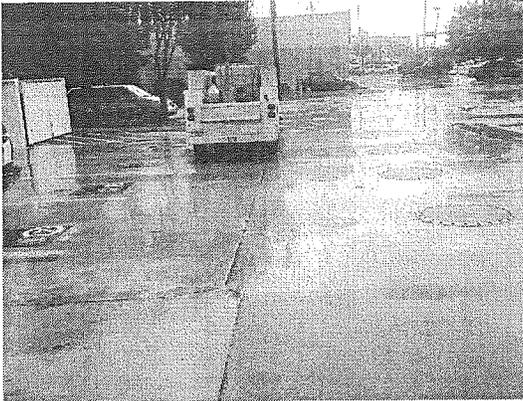
2014-9-3-No product or sheen noted on tank farm surface

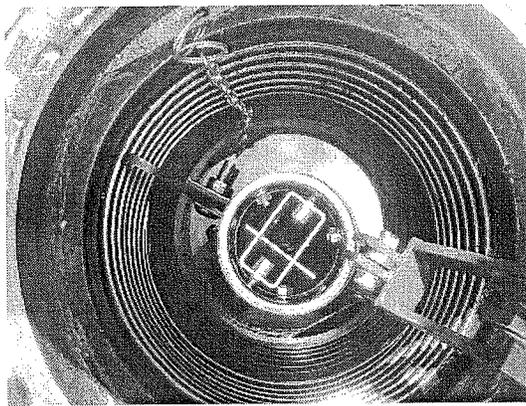
Fill port & vapor recovery lids are properly color-coded.
Fill port & vapor recovery watertight caps contain gasket and have a tight seal.
Fill port & vapor recovery spill containment buckets are free of liquid and release valves are in place.
Great Dane Petroleum Inc. was on site installing an anti-theft cap and locks on diesel fill port.

2014-9-3-Anti-theft cap installed on diesel fillport.

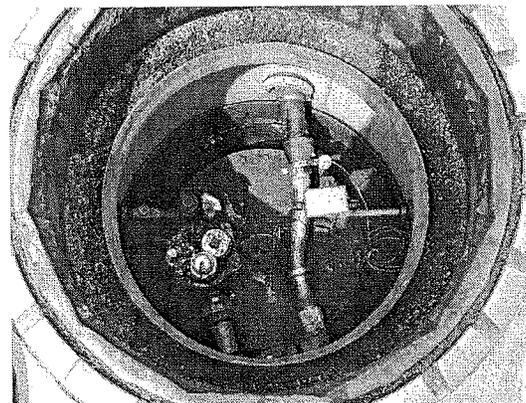
All STP sumps are free of liquid, contain electronic line leak detectors, have boots pulled back for release detection, and sensors are correctly positioned below piping. Piping type is double-walled fiberglass piping. All STP motors and associated metal unions are free of corrosion.

2014-9-3-All STP sumps dry & sensors operational.

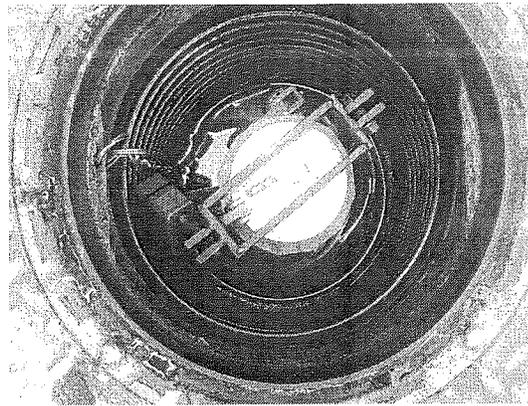
2014-9-3-Anti-theft cap installed on diesel fillport.

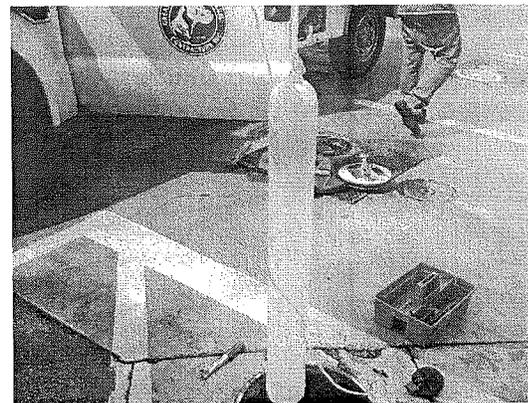
There are a total of 6 compliance monitoring wells on site. Approved Plans dated 12-31-1993 also calls for 6 compliance wells. All compliance monitoring well watertight caps are locked or properly secured and properly color coded. All monitoring well pipes are at least 1 inch above the surface and the containment appears to be properly grouted. No visual evidence of free floating product or sheen observed, as well as no odors was detected during the inspection in all monitoring wells. All monitoring wells Depth to water /Depth to bottom was measured on 11-13-2013. On that date water column levels were determined adequate for release detection meeting the 3 ft requirement.
Site diagram and site photos attached.
A signed copy of today's inspection report and DRF form was printed and left on site with Facility

2014-9-3-no product or sheen noted in all six wells.

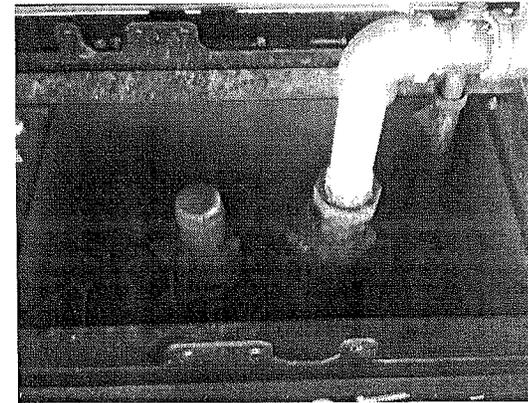
There are a total of 5 dispensers on site. Dispenser liners are free of liquid and shear valves appear to be properly braced or anchored.

2014-9-3-All dispenser liners dry & shear valves braced

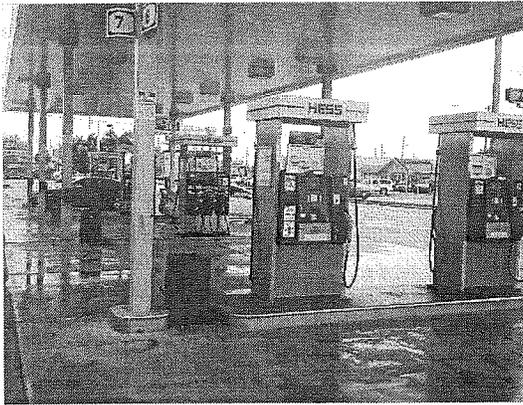
2014-9-3-overview of dispensers.

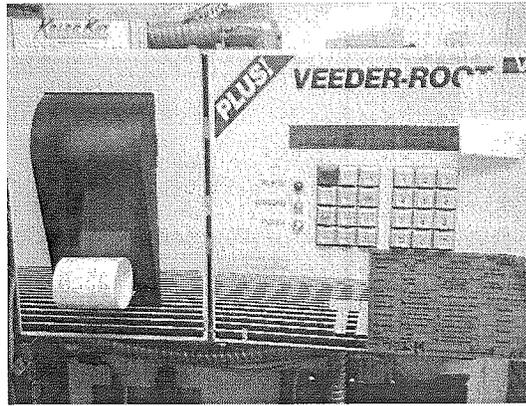
Electronic release detection is monitored through the TLS-350 system.
Monthly Liquid Status reports are being run monthly for facility and all functions normal.
Audible and visual alarms working properly. Liquid status for all sensors (STP Sumps, and Interstitials) checked during today's inspection.

2014-9-3-All functions normal on TLS-350 system.
