APPENDIX "F" TO SPECIAL PROVISIONS
STRUCTURES LOAD RATING CALCULATIONS

PW Project No. 20200315, EDP-MT-20200315

**Matheson Hammock Park Road (Bridge No.874294) over
Matheson Hammock Canal**

DEPARTMENT OF TRANSPORTATION AND PUBLIC WORKS

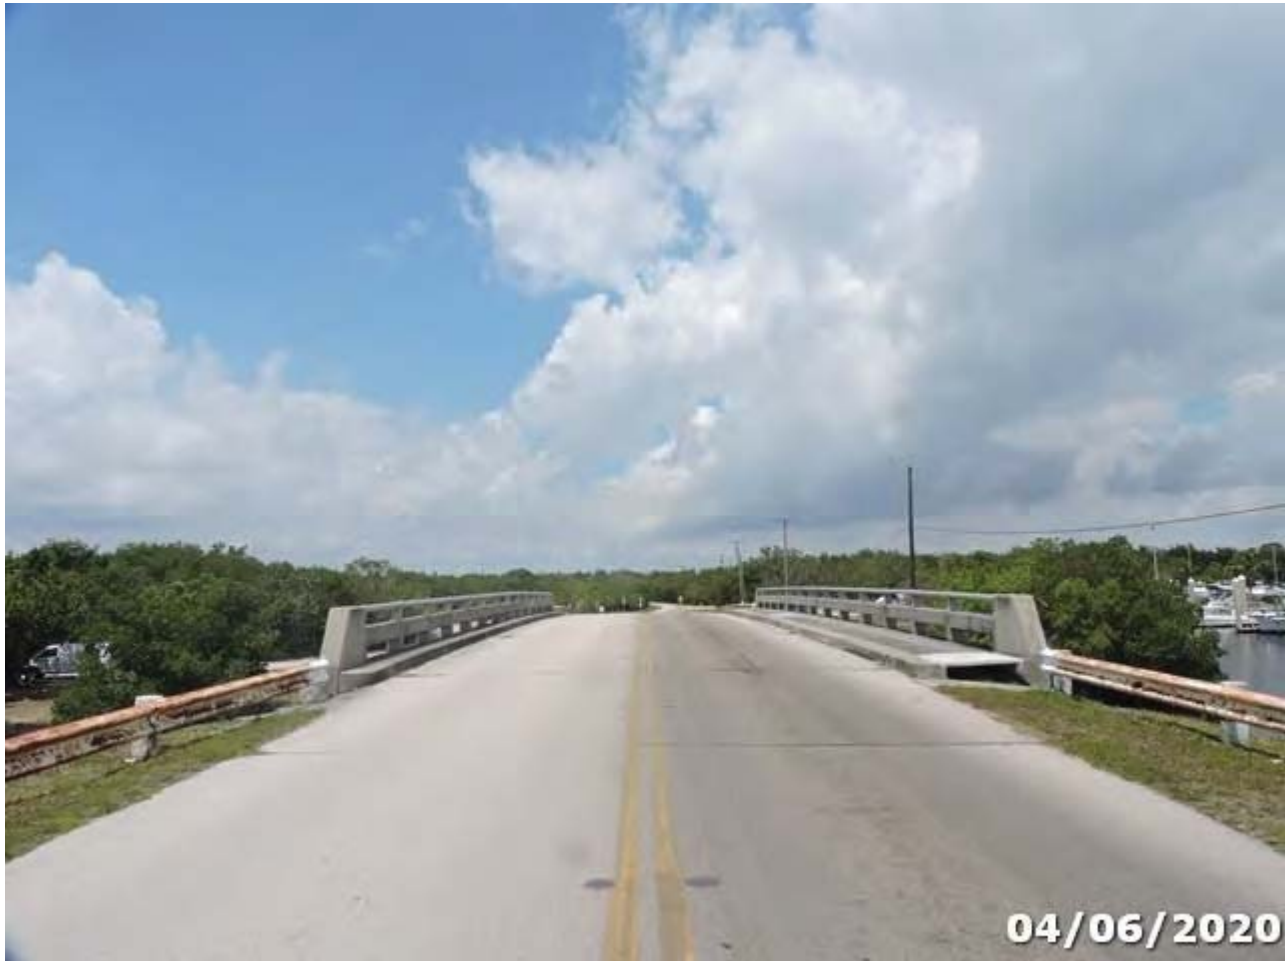
Photo 01 Element/Env 8099/3: PS Conc Slab (Sonovoid)

Object markers and centerline raised pavement markers are missing on the structure.

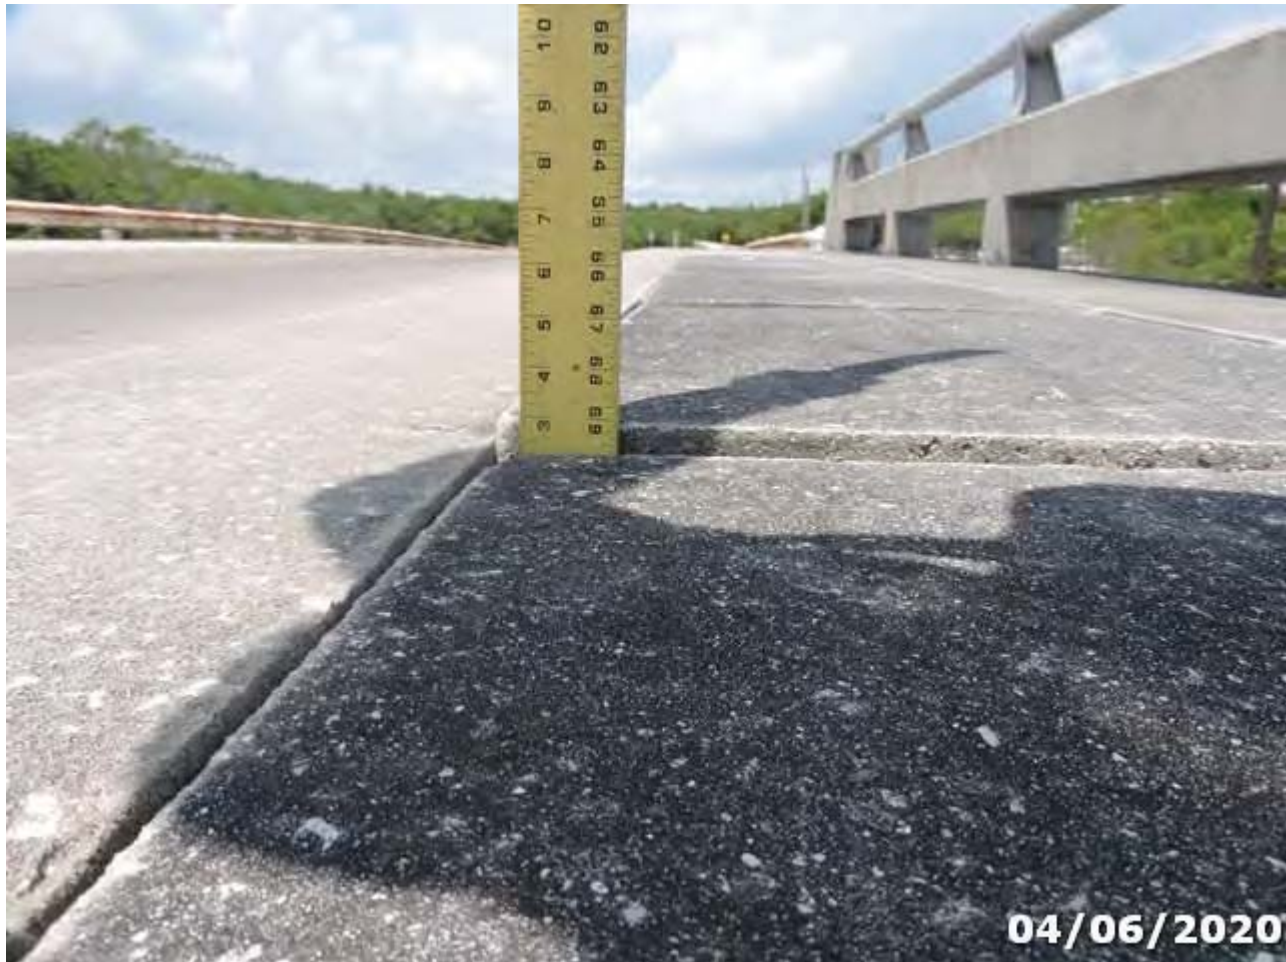
Photo 02 Element/Env 8099/3: PS Conc Slab (Sonovoid)

Sidewalk panels are loose and moves under pedestrian load.

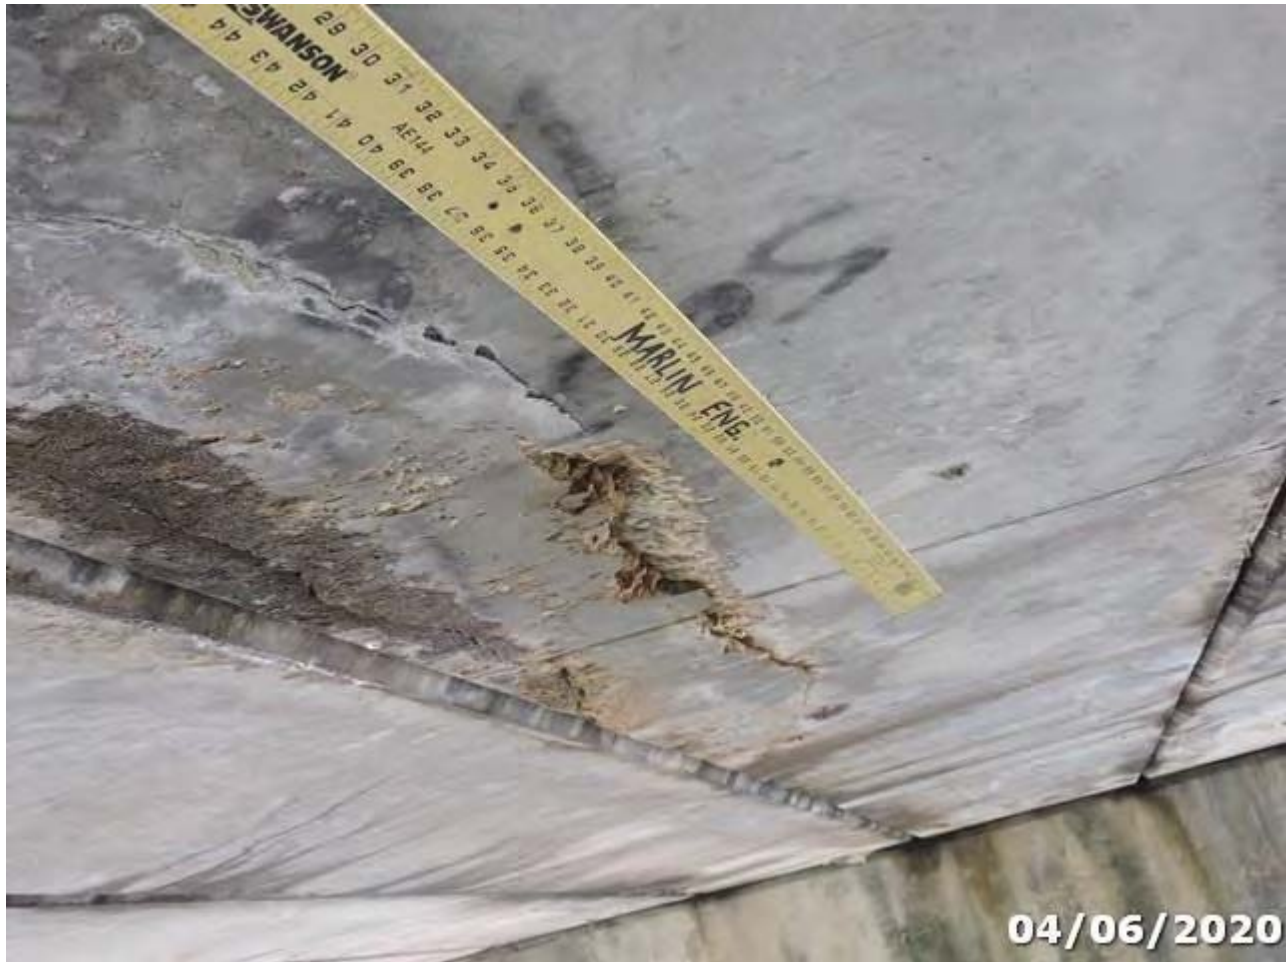
Photo 03 Element/Env 8099/3: PS Conc Slab (Sonovoid)

Slab Unit 1-8 east edge has a spall/delamination 4ft. L x 15in. W x 2in. D and associated cracks with corrosion bleed-out near mid-span.

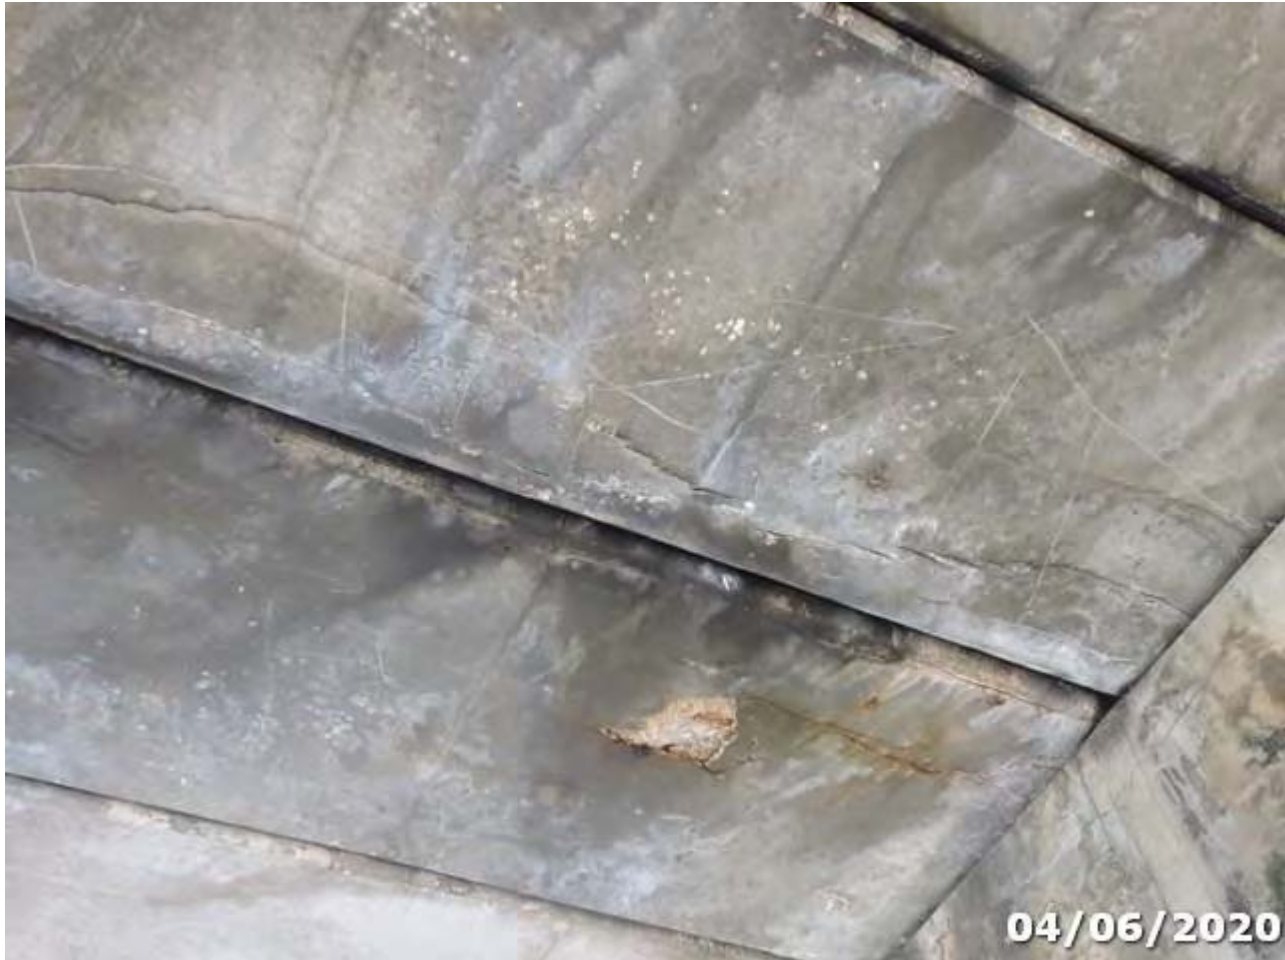
Photo 04 Element/Env 8099/3: PS Conc Slab (Sonovoid)

Slab Unit 1-9, center line has a spall/delamination up to 36in. L x 24in. W x 2in. D over Abutment 1.

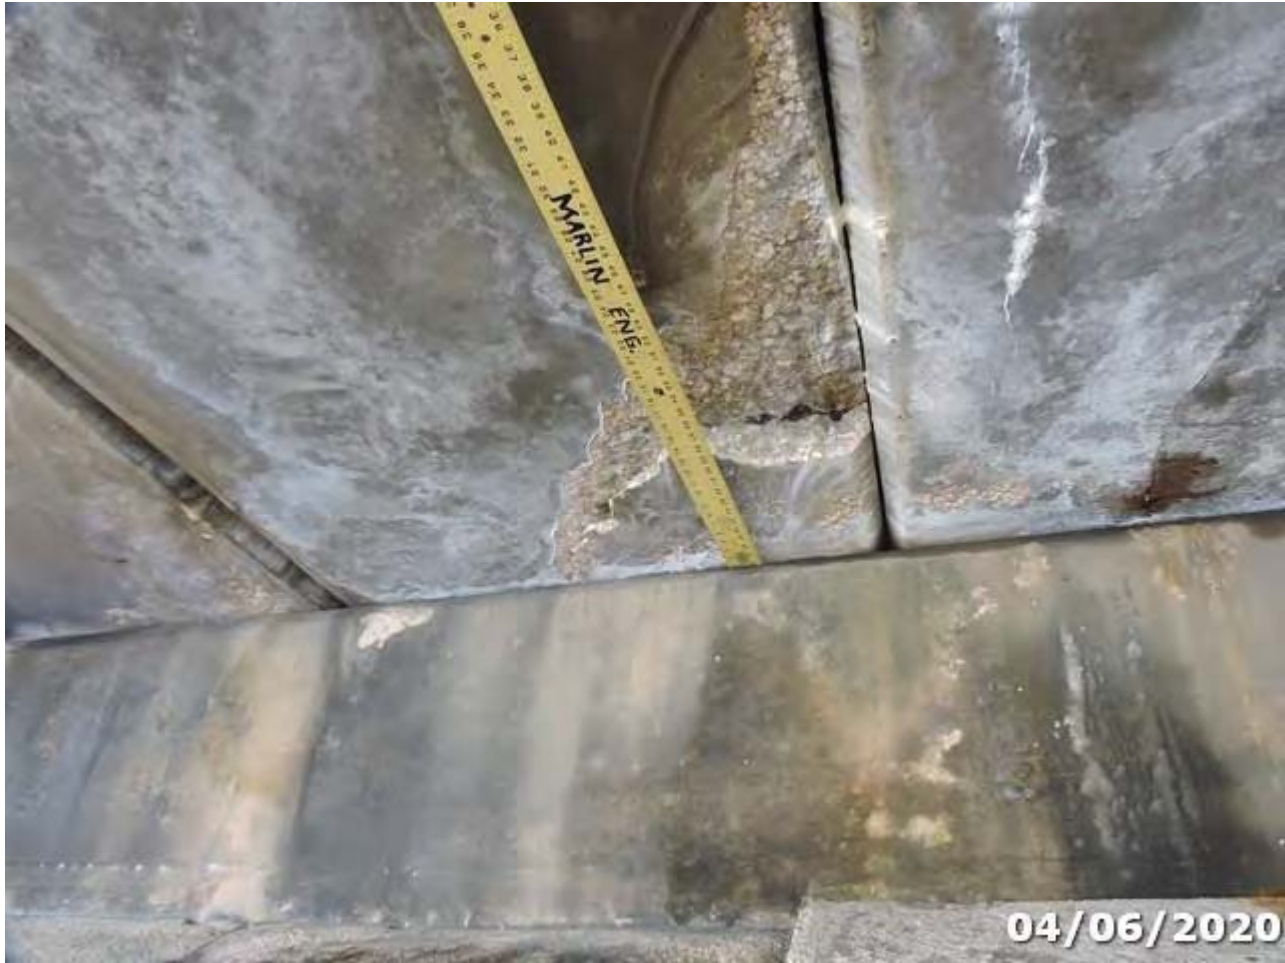
Photo 06 Element/Env 8099/3: PS Conc Slab (Sonovoid)

Slab Unit 3-8 has a spall/delamination up to 7ft. L x 3ft. W x 1in. D and associated cracks with corrosion bleed-out starting at Pier 3.

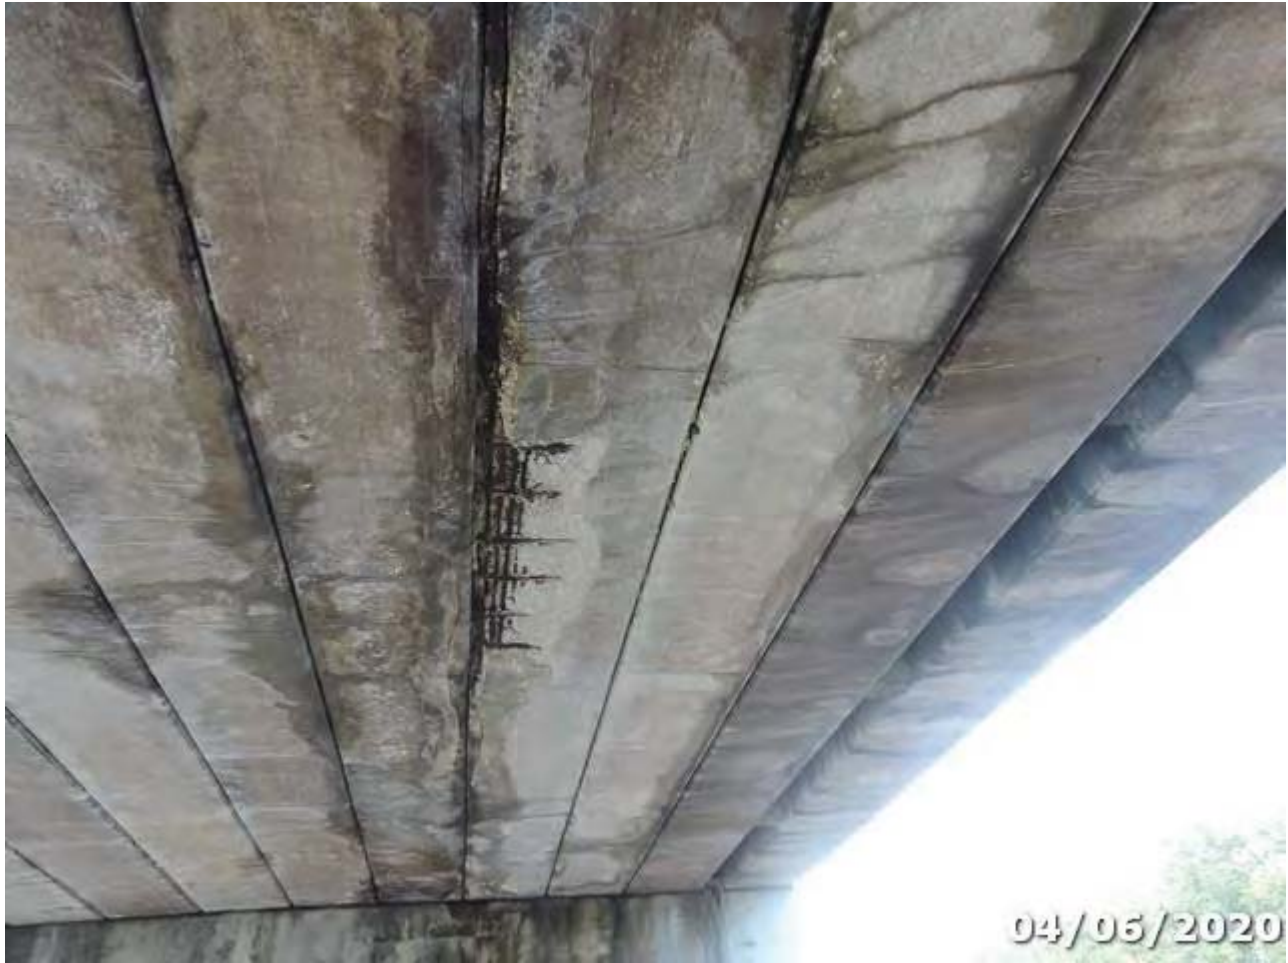
Photo 08 Element/Env 8099/3: PS Conc Slab (Sonovoid)

Slab Unit 2-8 west half has two delaminated areas up to 15ft. L x 18in. W (average width) at south and north ends, and at midspan has a spall 10ft. L x 24in. W x up to 4in. D with exposed strands. Refer to Photo 10 for additional information.

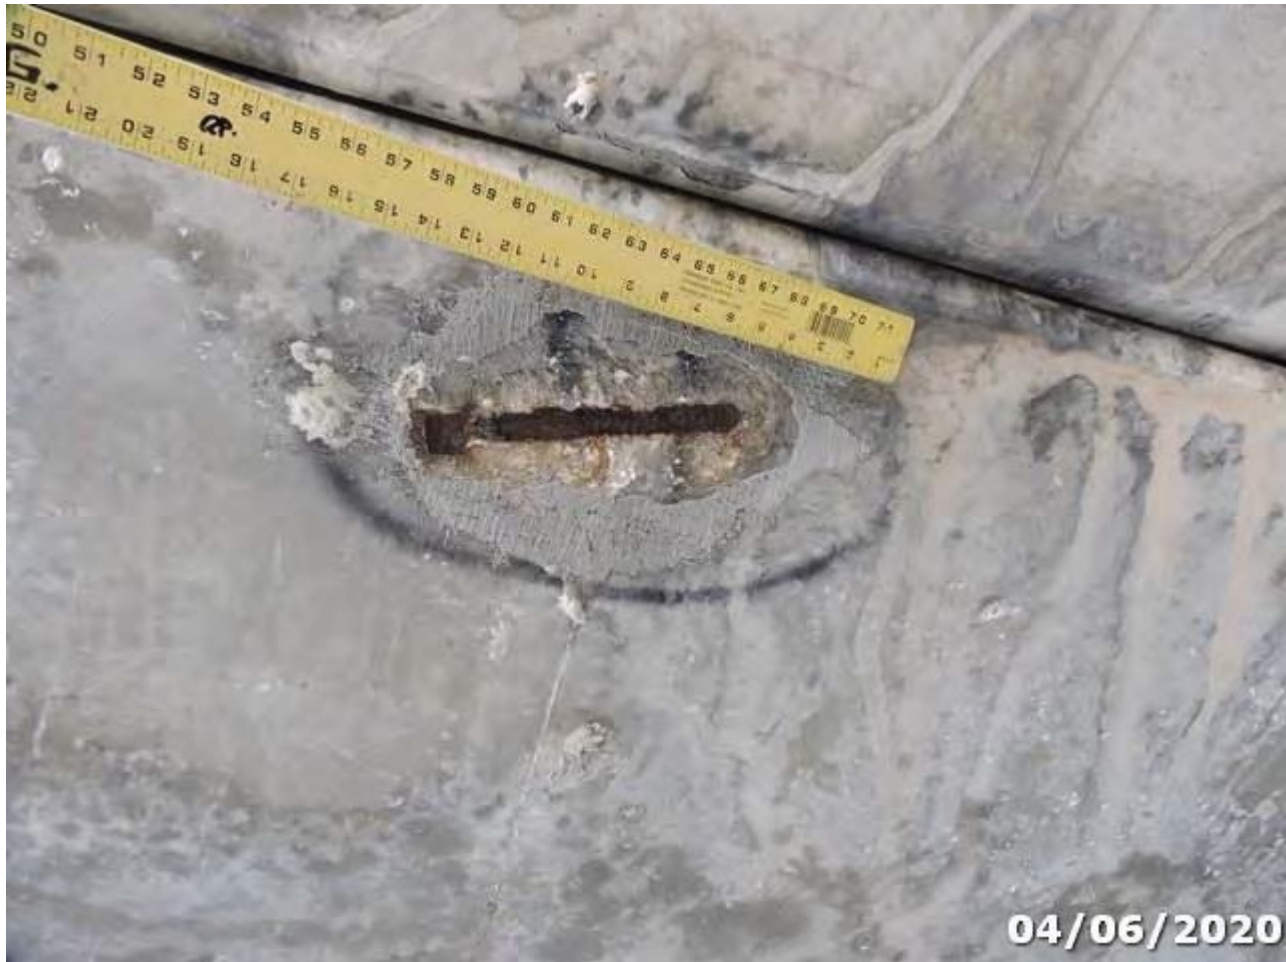
Photo 09 Element/Env 8099/3: PS Conc Slab (Sonovoid)

Slab Unit 1-6 exhibits a spall with exposed rebar up to 15in. L x 6in. W x 1/2in. D with evidence of previous failed repair, at 9ft. from Abutment 1.

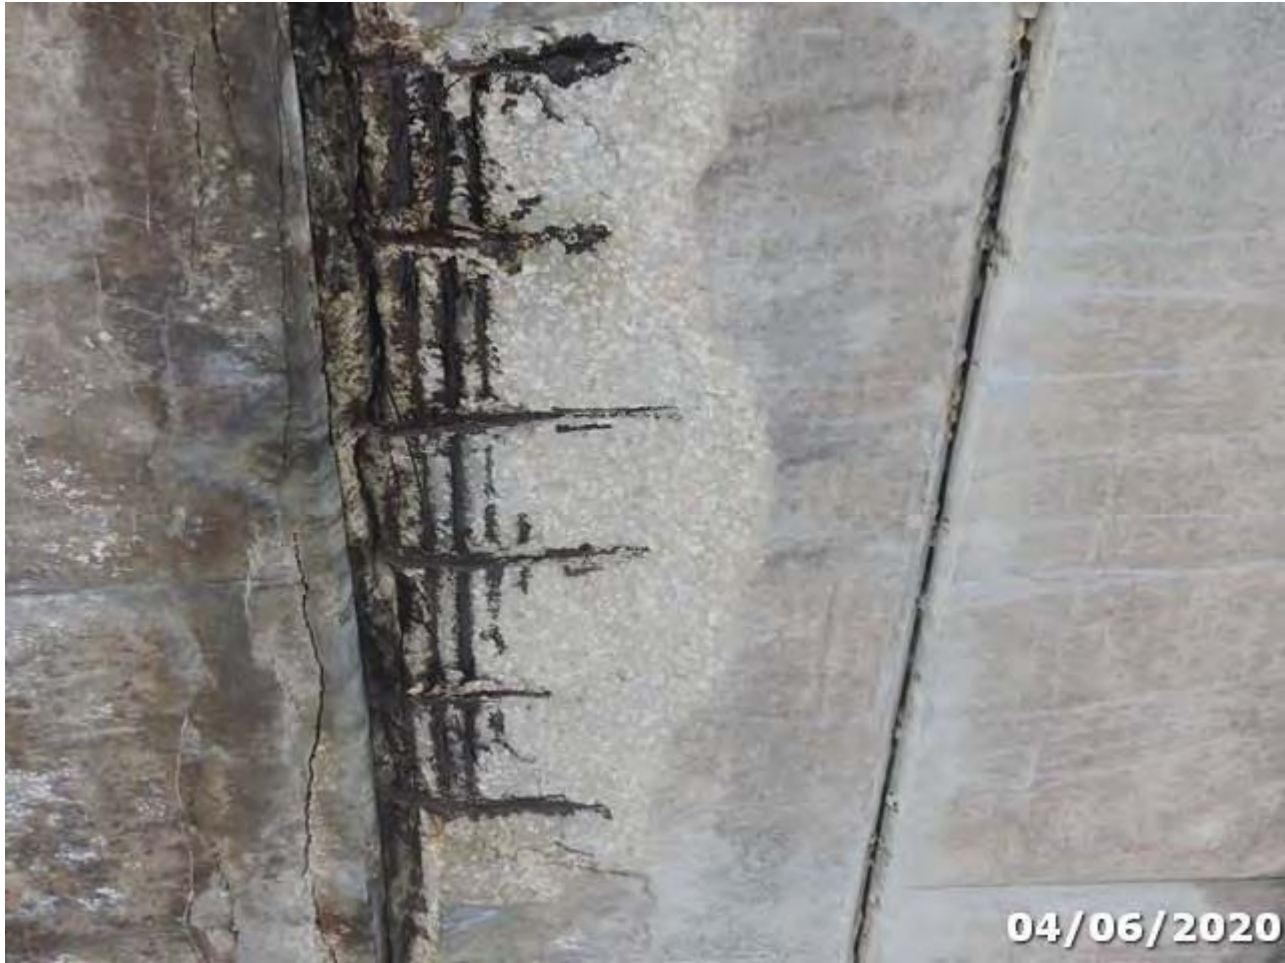
Photo 10 Element/Env 8099/3: PS Conc Slab (Sonovoid)

- 5 exposed strands, with 3 broken: Remove a total of 5 strands from the bottom layer of strands.
- Assume 50% of the adjacent strands along the same layer have been affected to account for the potential of damage in the adjacent strands. That is: Remove 1 additional strand from the bottom layer of strands.
- Assume 50% of the adjacent strands at the next layer have been affected to account for the potential of damage in the adjacent strands. That is: Remove 1 additional strand from the next layer of strands.
- Per recommendation from "Structural Technologies" on 10/01/2021, assume exterior stirrup leg to be deteriorated. In BrR, use 2 legs of shear reinforcement, conservatively for the critical case.

- Prestressed slab unit 1-8 displaying severe cracking with corrosion stain along the bottom face of the slab unit.
- Prestressed slab unit 2-8 displaying the worst deterioration: Five (5) exposed strands with three (3) broken.

Slab Unit 2-8 has a spall 10ft. L x 24in. W x up to 4in. D at mid-span with 6 exposed and corroded transverse rebars with up to 60% section remaining and 5 exposed and corroded prestressing strands with up to 0% section remaining (2 broken threads).

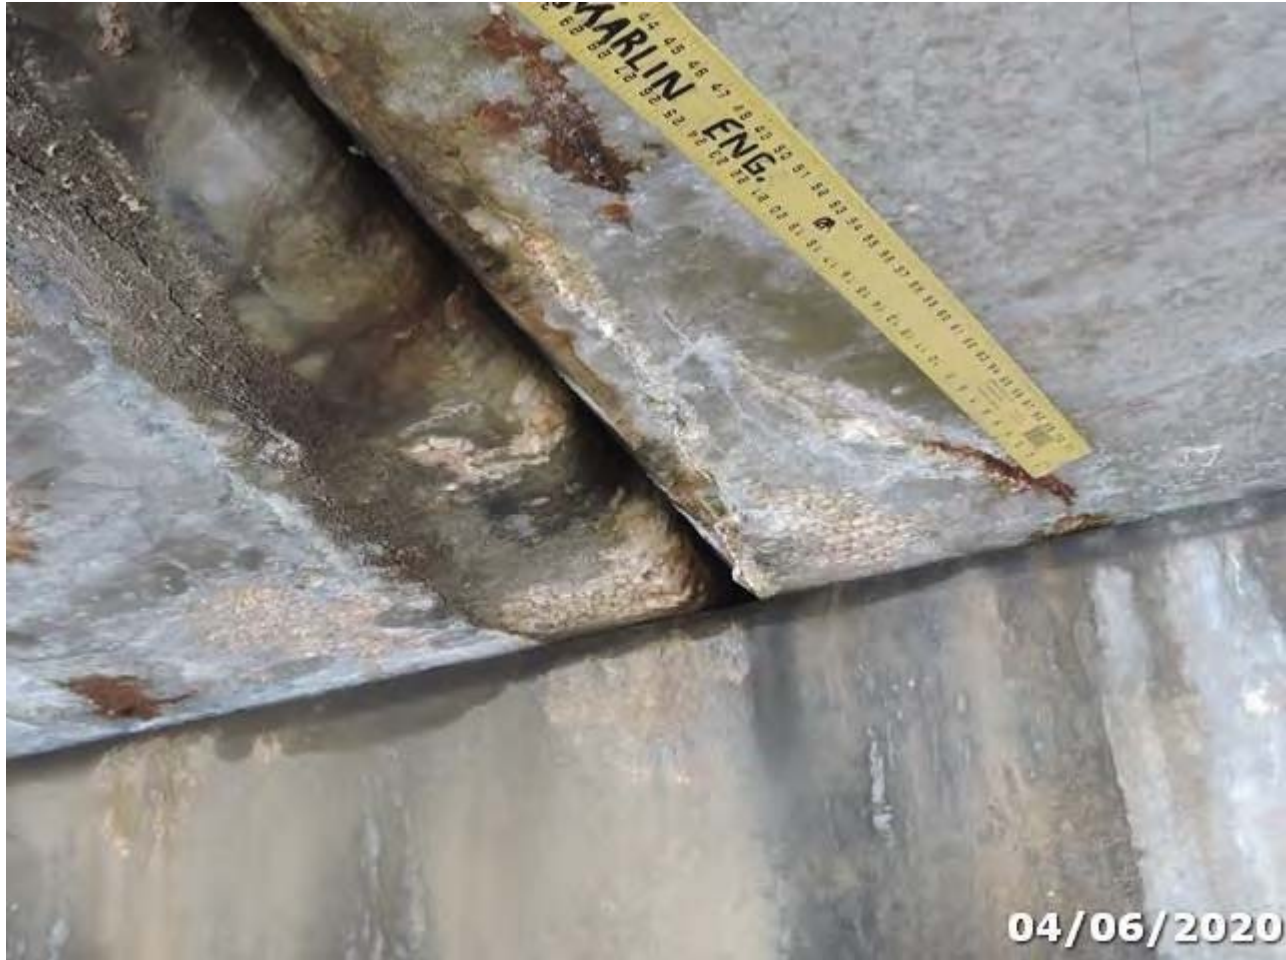
Photo 11 Element/Env 8099/3: PS Conc Slab (Sonovoid)

Slab Unit 1-7 east edge has a spall/delamination 24in. L x 12in. W with associated cracks up to 1/32in. W with efflorescence and corrosion bleed-out over Abutment 1. Slab Unit 1-8 west edge is intermittently delaminated up to 15ft. L x 15in. W with associated cracks up to 1/8in. W with efflorescence and corrosion bleed-out, starting at Abutment 1.

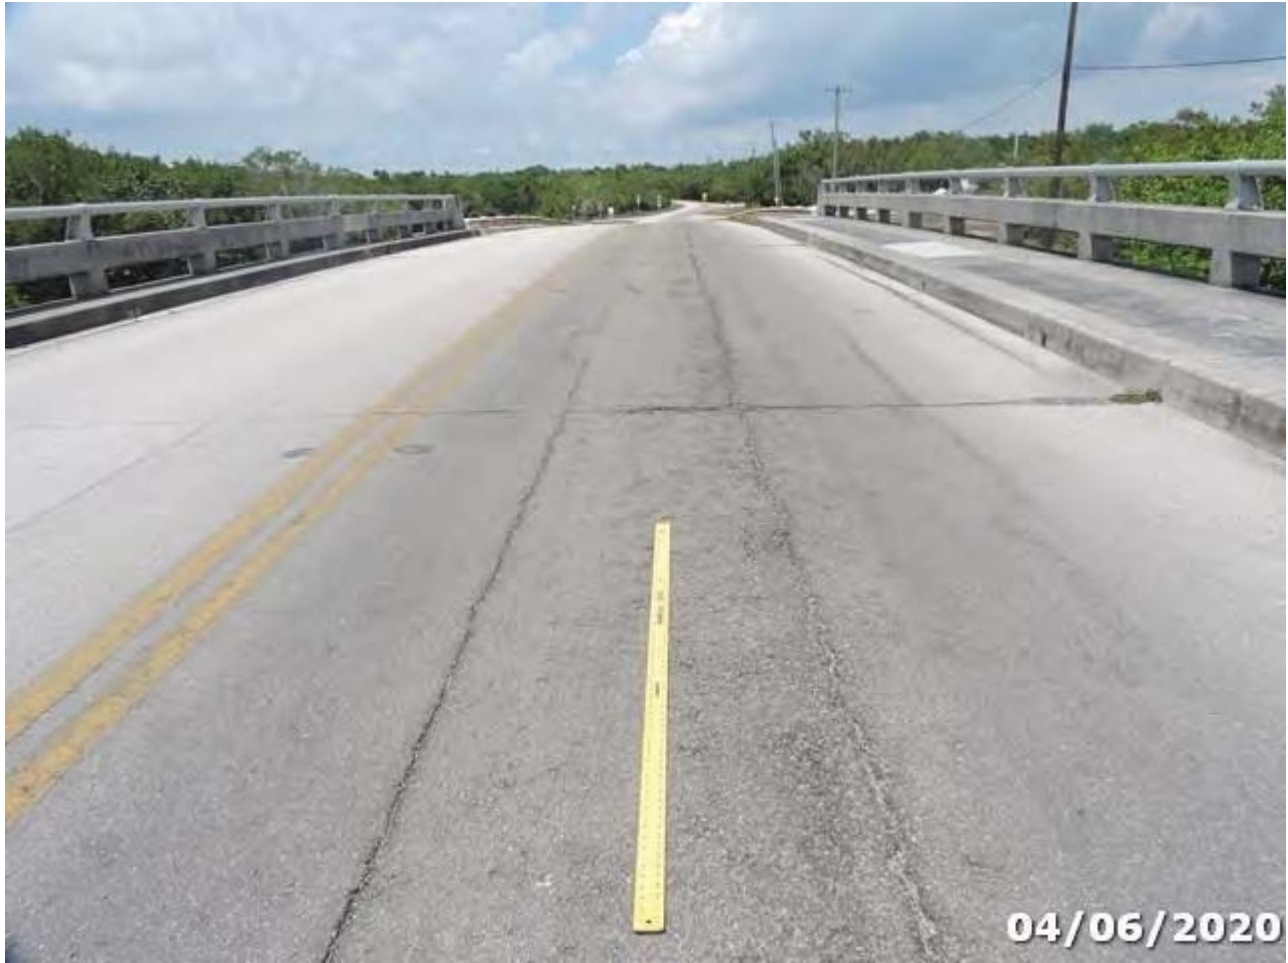
Photo 12 Element/Env 8099/ 510/3: PS Conc Slab (Sonovoid)/ Wearing Surfaces

The asphalt overlay has longitudinal cracks up to span length x 1/4in. W with associated rutting over the slab unit joints with upheaving up to 1in. H at the shoulders, possibly indicating independent slab units movement.

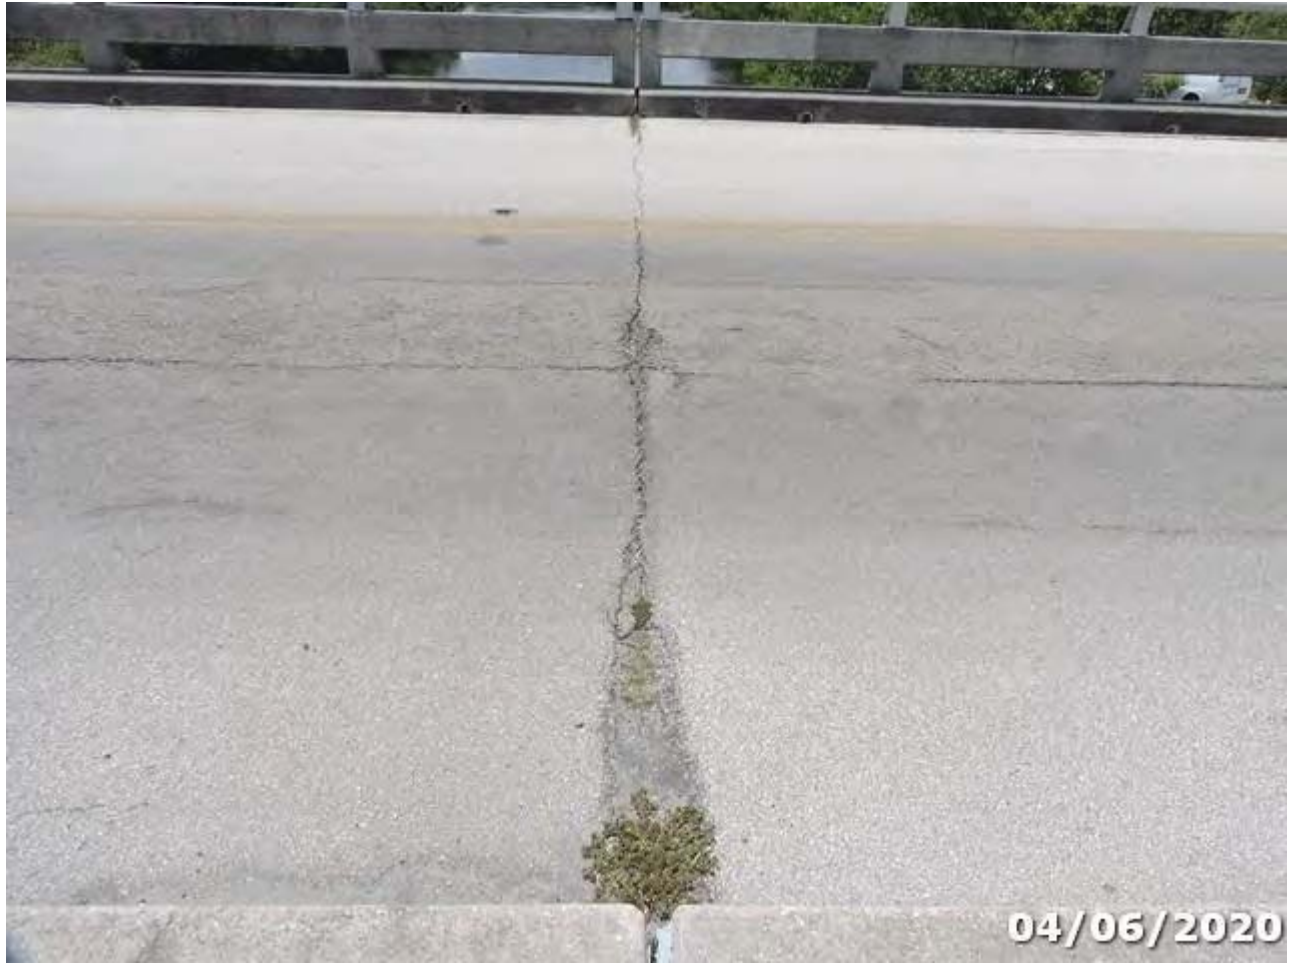
Photo 13 Element/Env 8099/ 510/3: PS Conc Slab (Sonovoid)/ Wearing Surfaces

The asphalt overlay has transverse cracks up to roadway width x 1/4in. W with rutting and upheaving up to 3in. H and vegetation growth over the expansion joints.

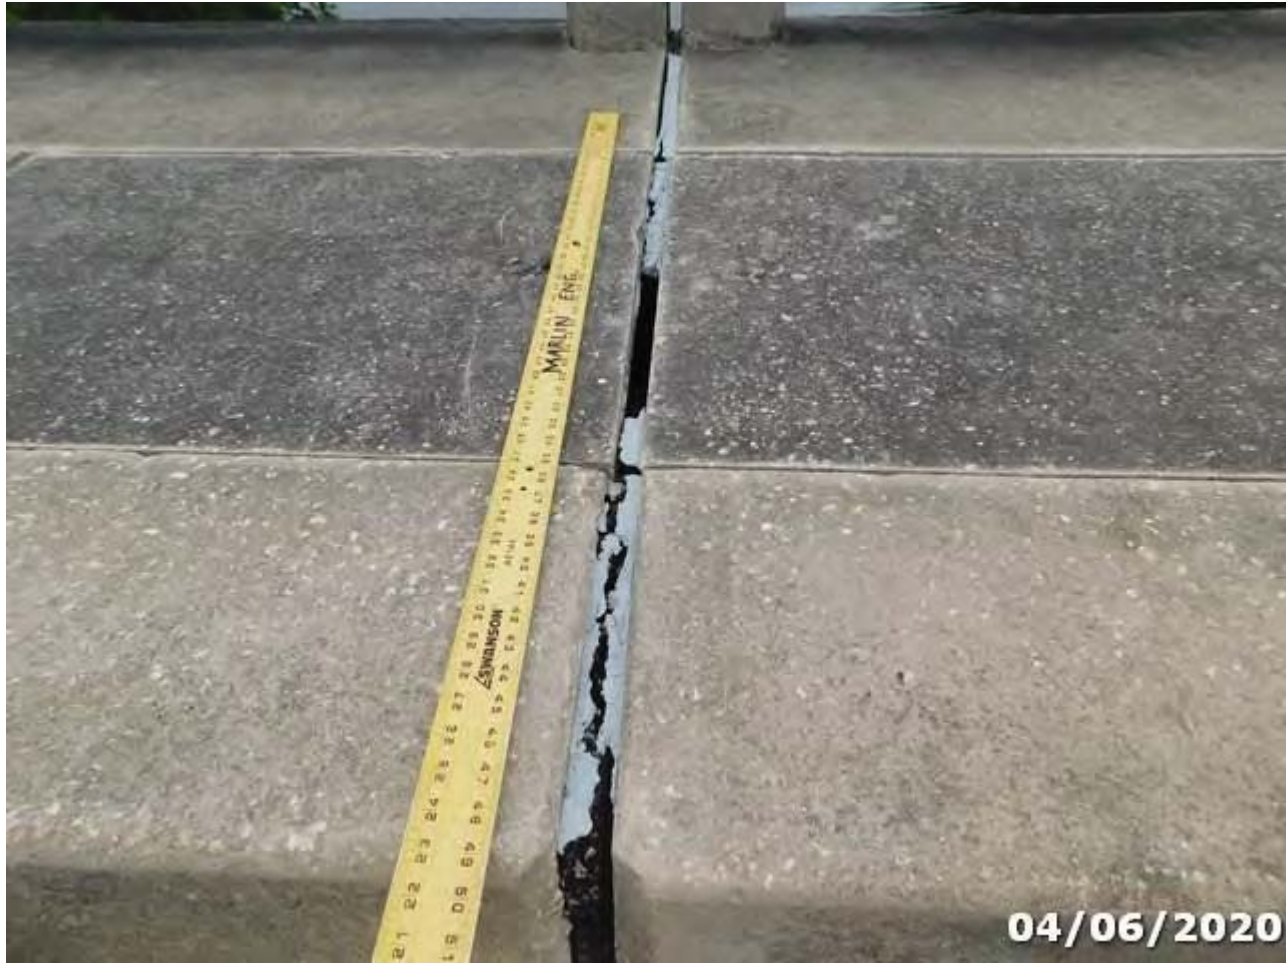
Photo 15 Element/Env 301/3: Pourable Joint Seal

The sealant along the sidewalk expansion joints has deteriorated.

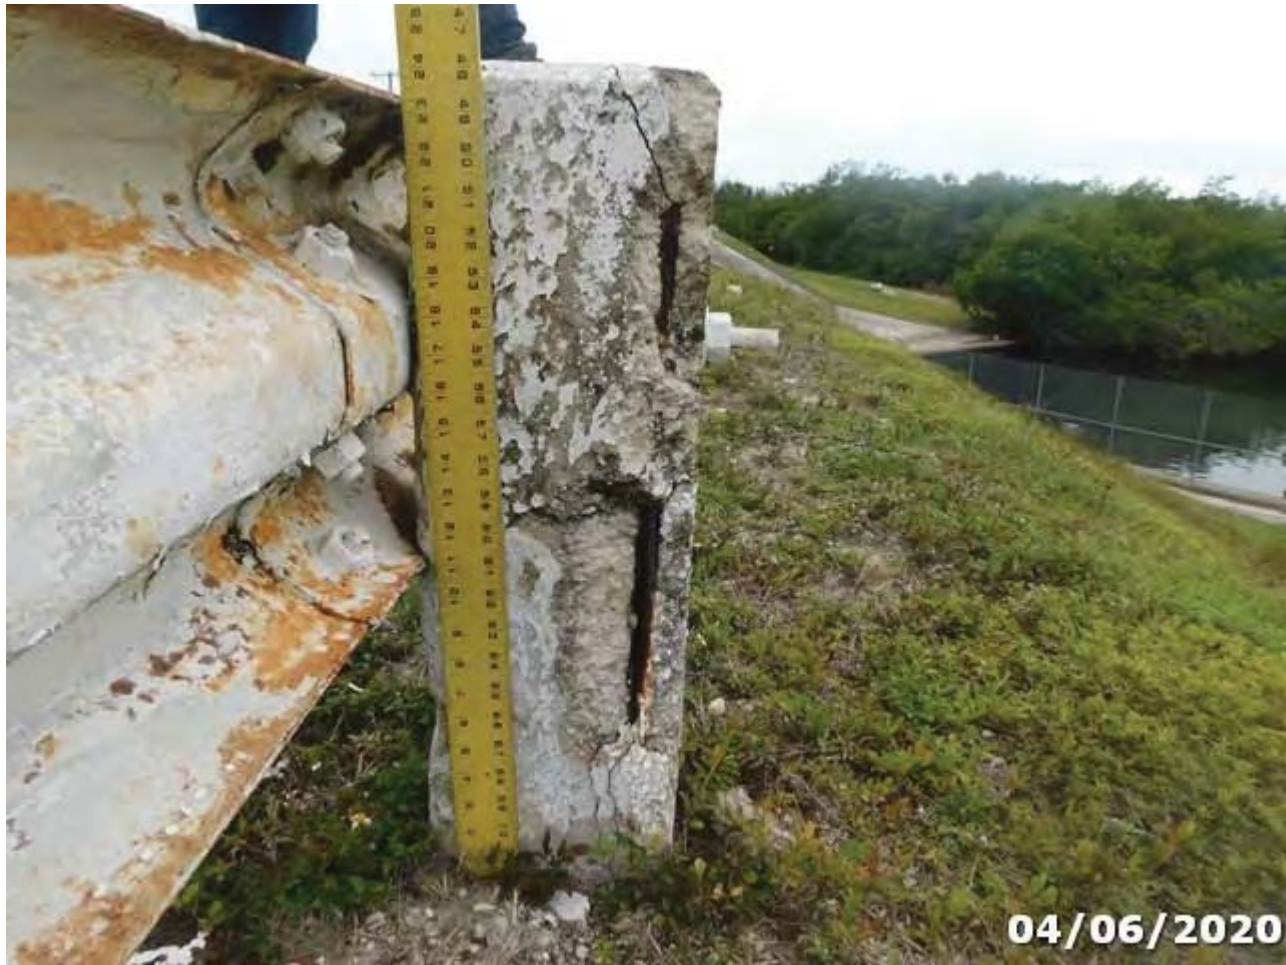
Photo 18 Element/Env 321/3: R/Conc Approach Slab

There are several approach roadway guardrails posts spalled/delaminated up to 14in. H x 3.5in. W x 1-1/4in D with exposed and corroded rebars. Shown Post 1 at NW approach guardrail.

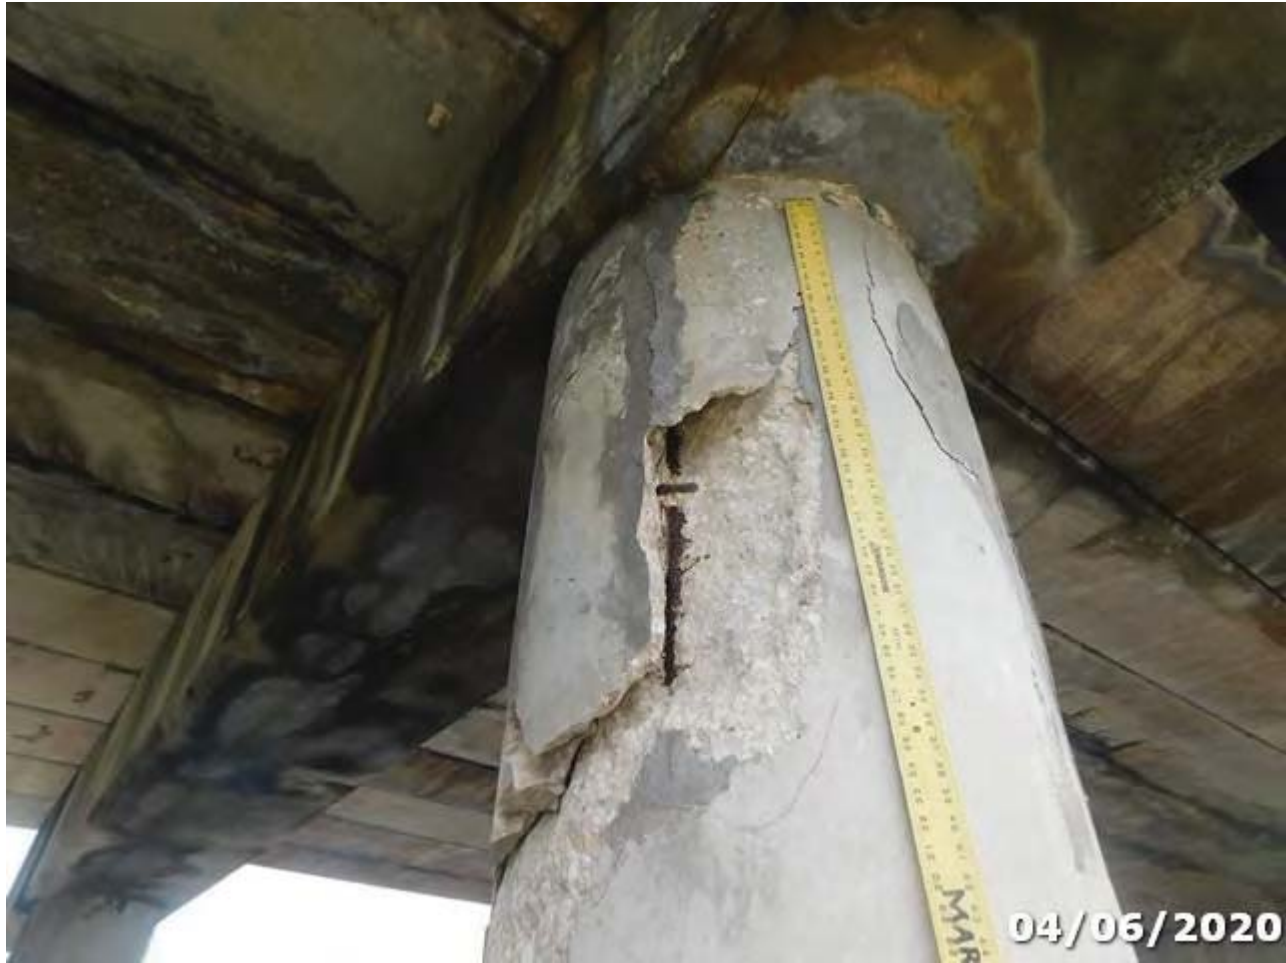
Photo 20 Element/Env 205/3: Re Conc Column

Column 2-2, south face has a spall/delamination up to 7ft. H x 3ft. W x 3in. D with one exposed rebar and one stirrup, having areas of up to 80% section remaining. Additionally, there are areas of delamination around the column circumference covering the entire column height with associated cracks up to 1/4in. W.

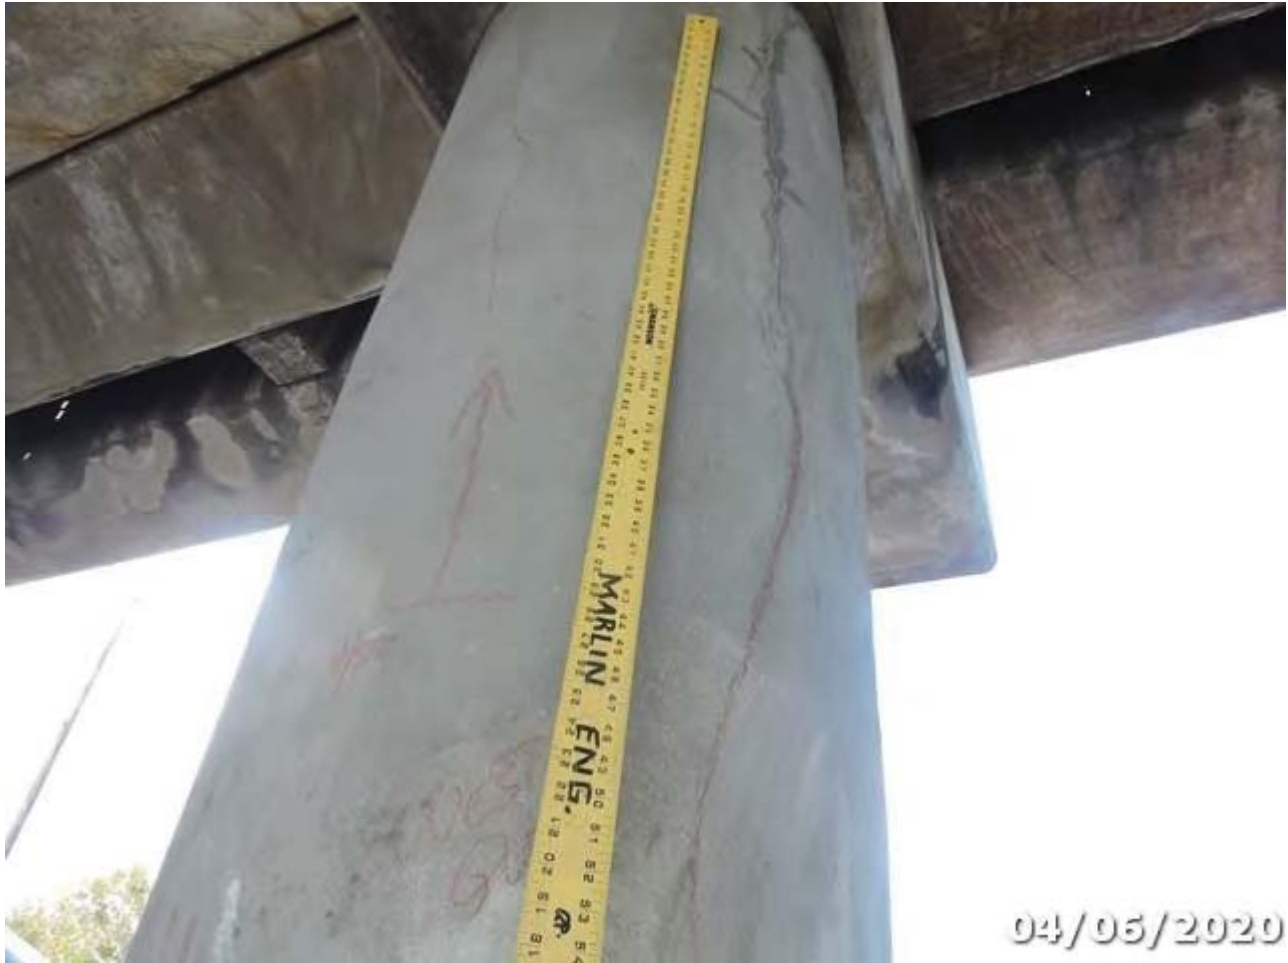
Photo 21 Element/Env 205/3: Re Conc Column

Columns 2-1, 3-1, and 3-2 have delaminated areas along their entire length with associated cracks up to full height x 1/16in. W, as a result of corrosion of the steel reinforcement.

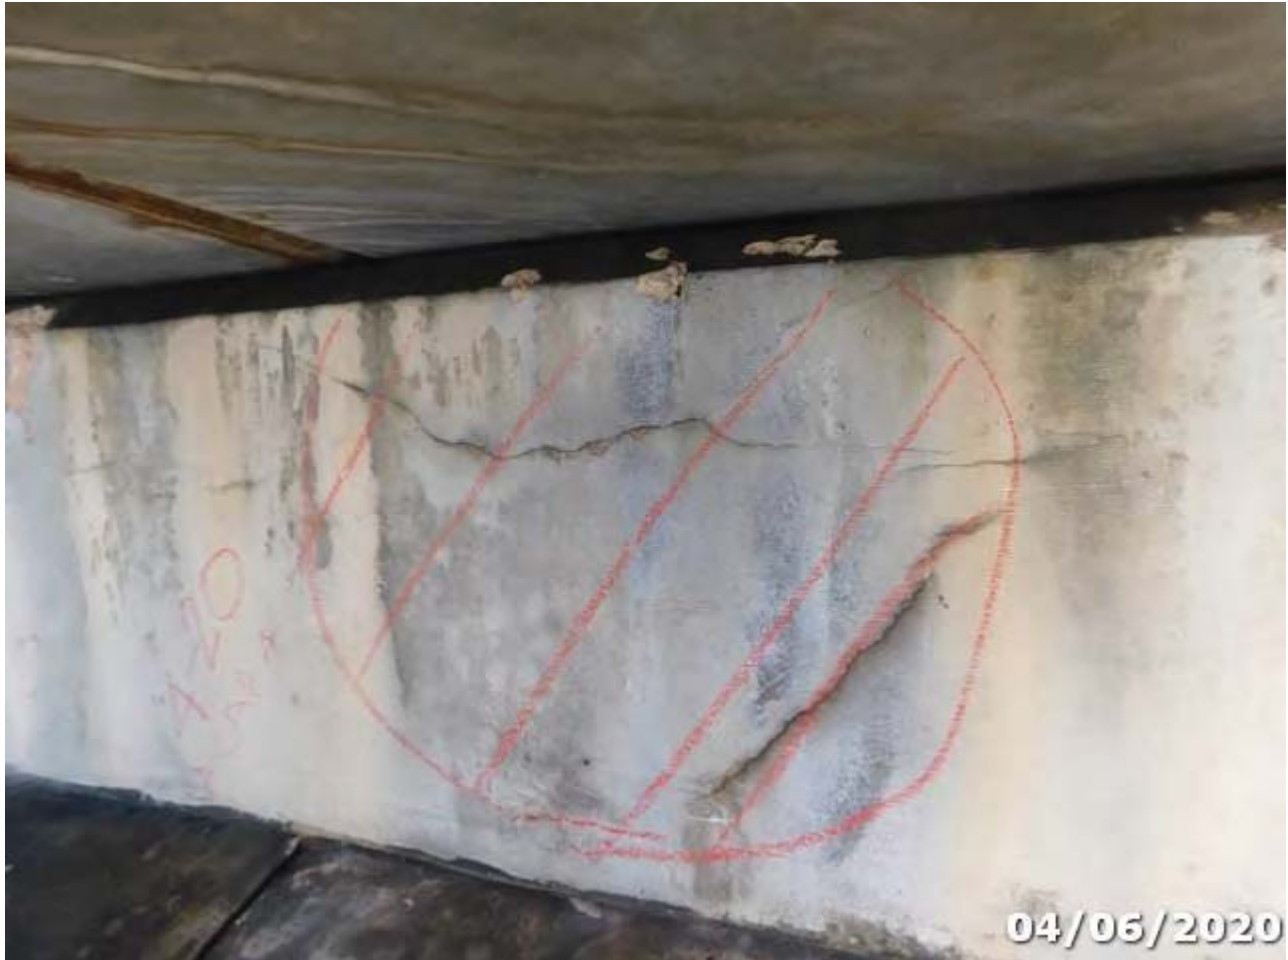
Photo 22 Element/Env 215/3: Re Conc Abutment

Abutment 4 cap has a spall/delamination up to 5ft. L x full height x 2in. D with associated cracks up to 1/16in. W under Slab Units 3-10 and 3-11.

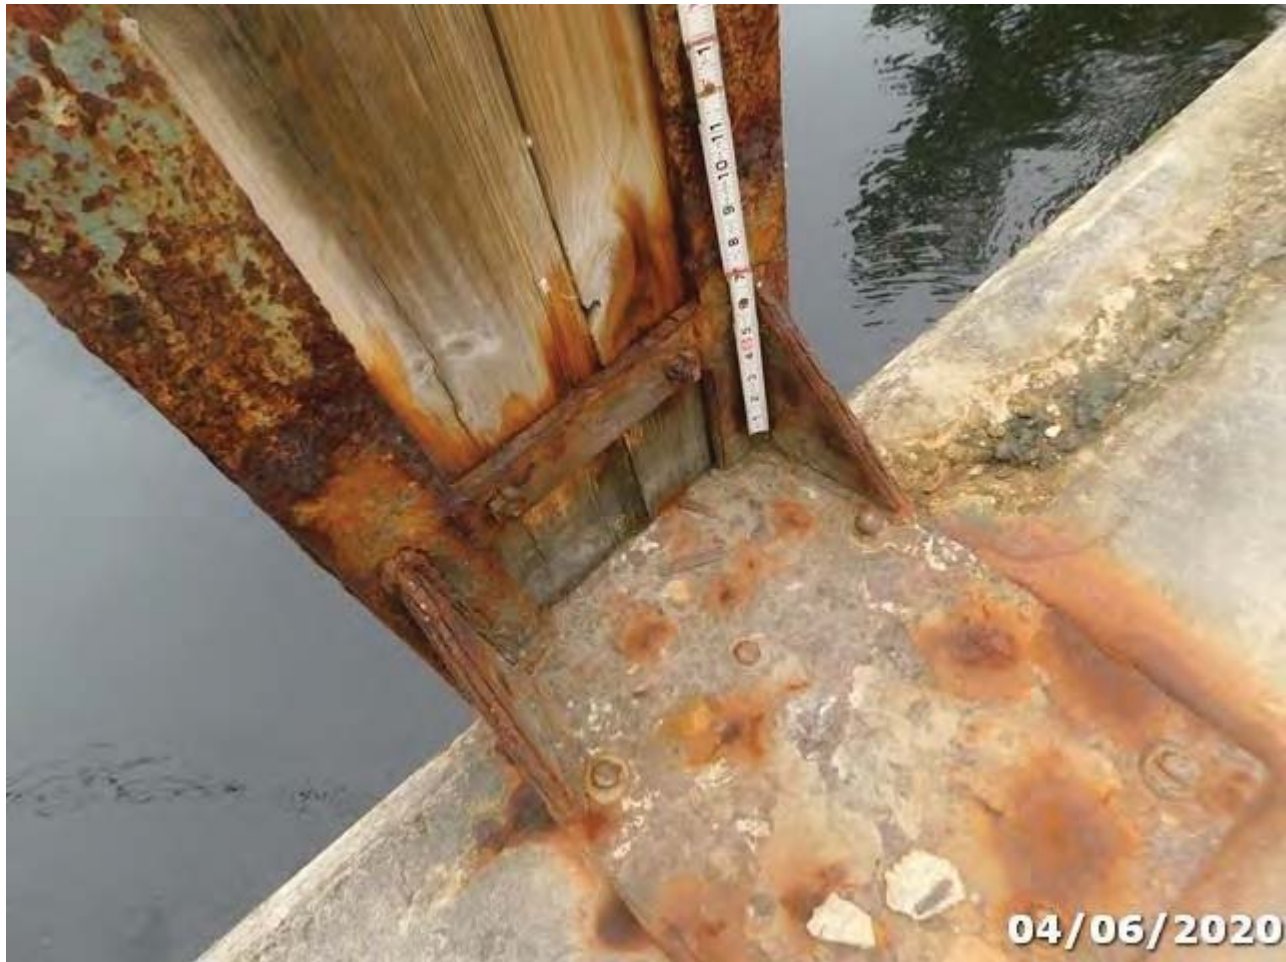
Photo 25 Element/Env 8393/3: Bulkhead Seawall Any Material

The brackets and fasteners attaching the clearance gauges to the seawalls exhibit heavy to severe corrosion.
