APPENDIX "F" TO SPECIAL PROVISIONS
STRUCTURES LOAD RATING CALCULATIONS

PW Project No. 20200315, EDP-MT-20200315

**Matheson Hammock Park Road (Bridge No.874294) over
Matheson Hammock Canal**

DEPARTMENT OF TRANSPORTATION AND PUBLIC WORKS

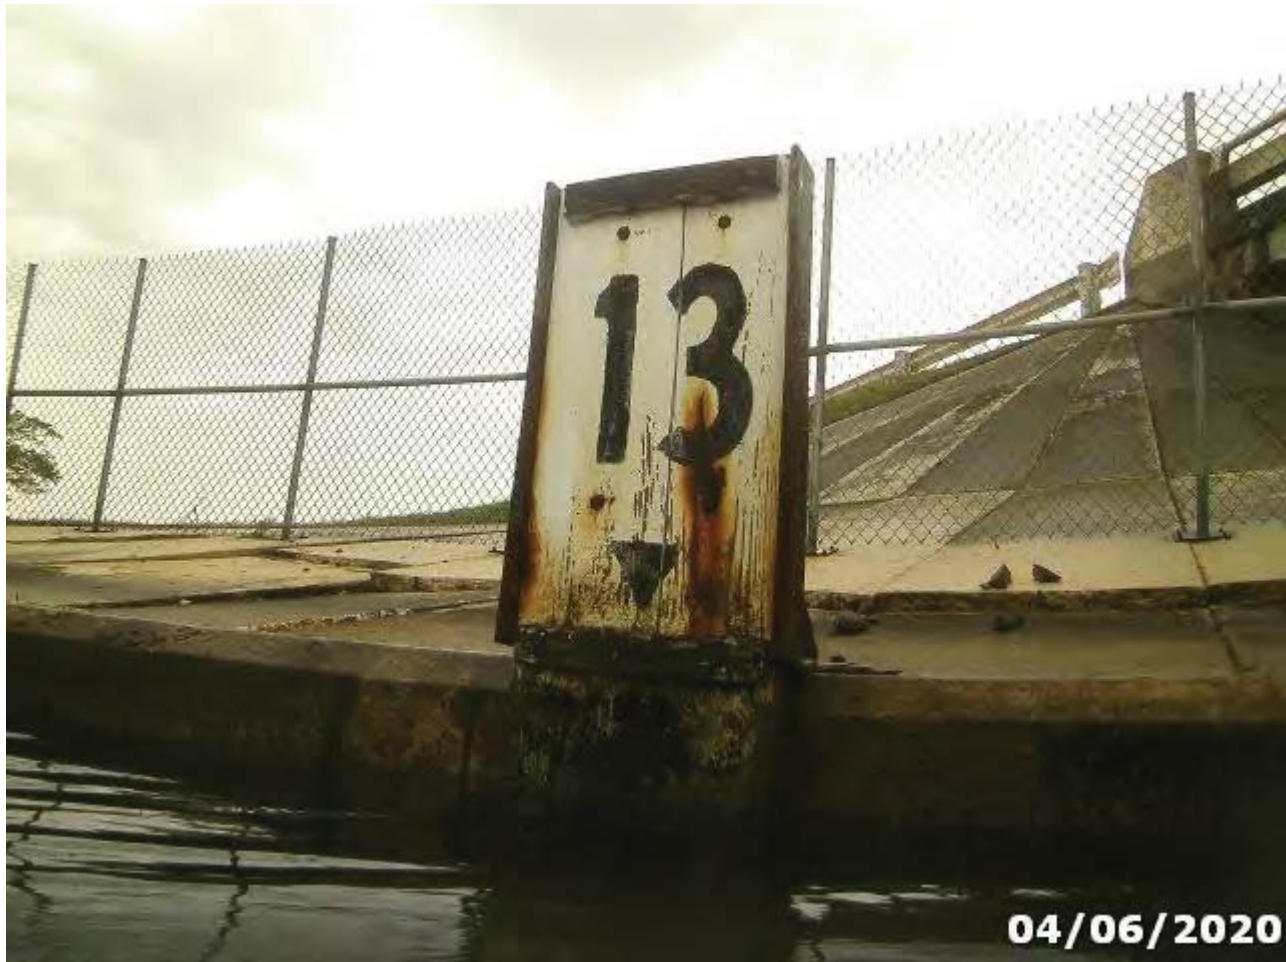
Photo 26 Element/Env 8393/3: Bulkhead Seawall Any Material

SE and NW clearance gauges have moderate decay at bottom 3ft.

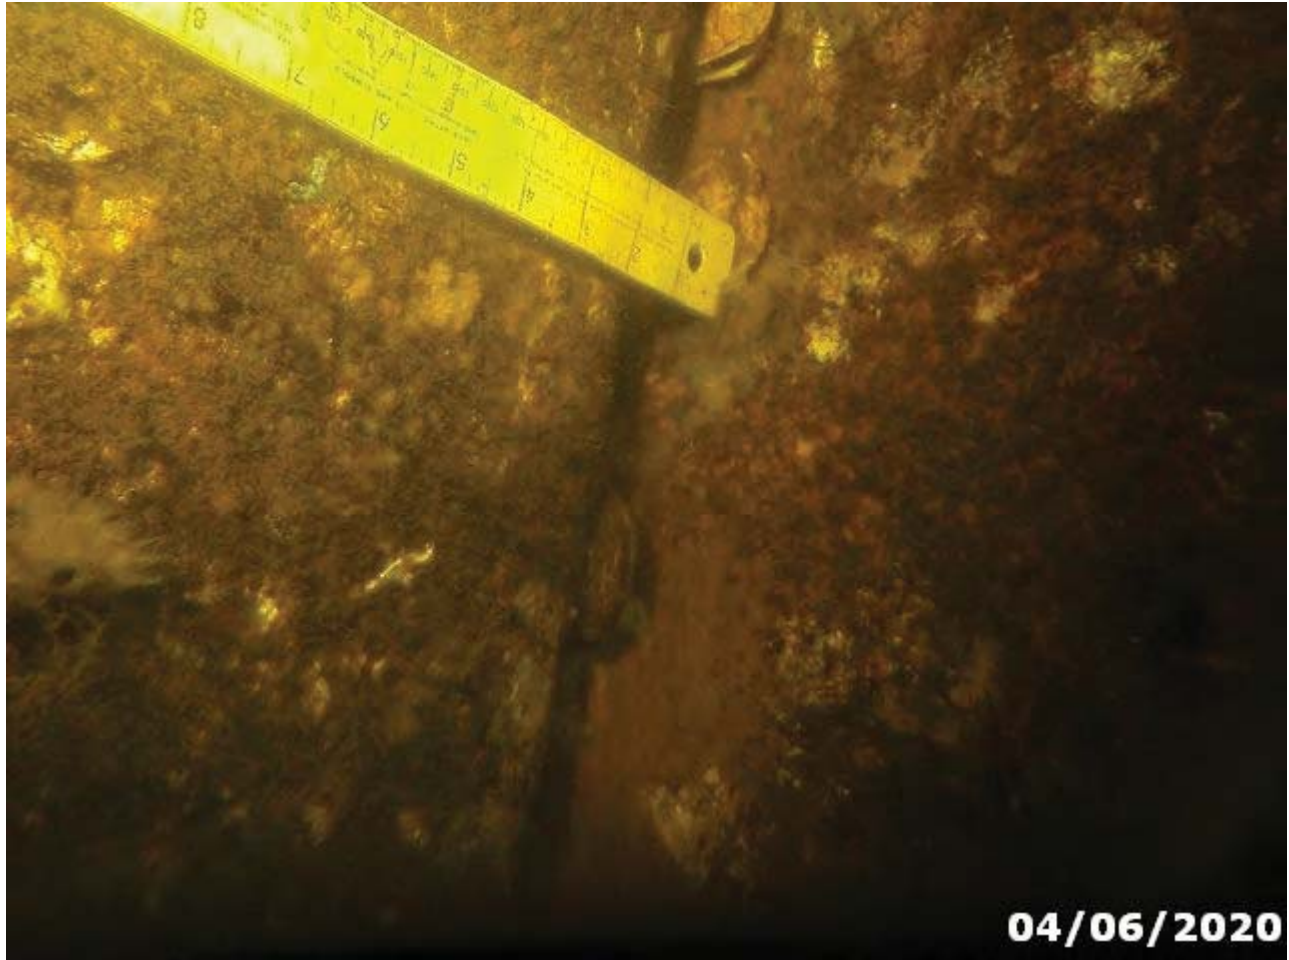
Photo 27 Element/Env 8393/3: Bulkhead Seawall Any Material

The south seawall has two open joints up to 4in. W with backfill leakage behind Piles 15 and 18 from west.

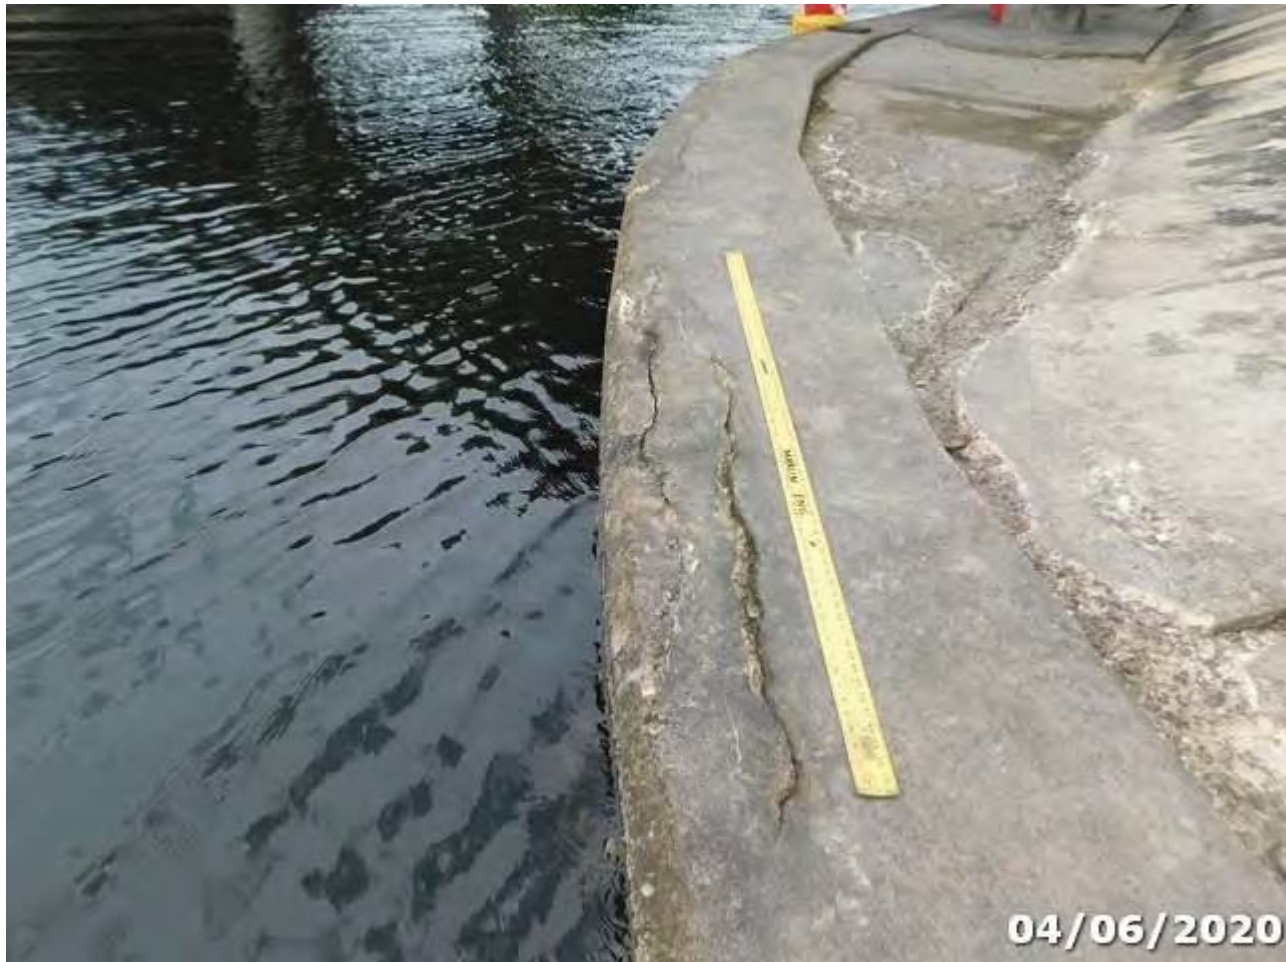
Photo 28 Element/Env 8393/3: Bulkhead Seawall Any Material

The seawall caps on the north and south walls have up to 1/4in W cracks, with associated delaminations/spalls throughout their entire lengths.

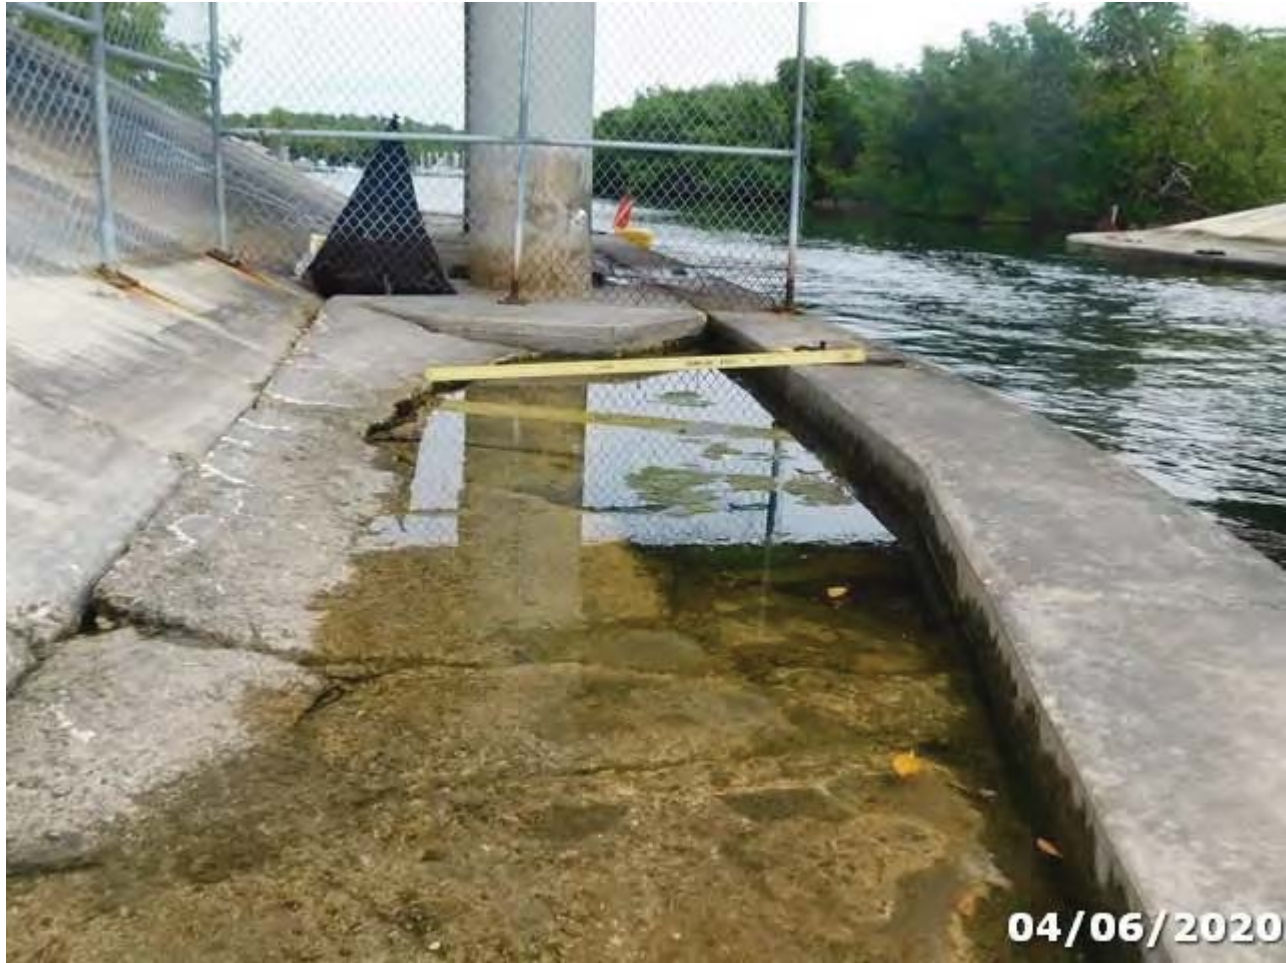
Photo 29 Element/Env 8394/3: R/Conc Abut Slope Protection

The slope protection toe has a fractured and settled area of 15ft. x 7ft. x 2ft deep at the NW corner behind the seawall cap. The channel water reach this area at high tide.

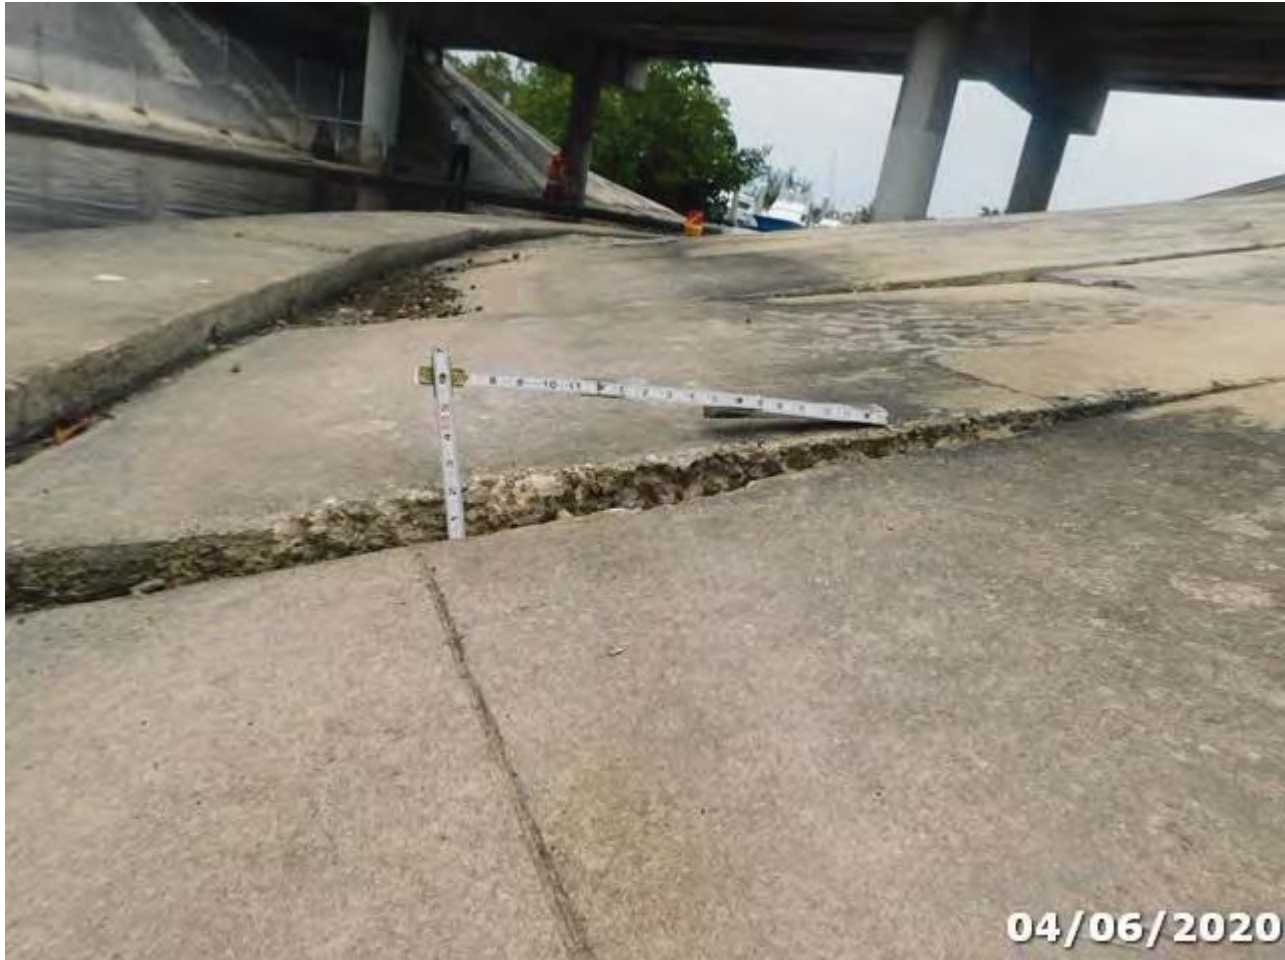
Photo 30 Element/Env 8394/3: R/Conc Abut Slope Protection

The SW slope protection toe has 5 fractured panels that have settled up to 3in. H. The channel water reach this area at high tide.

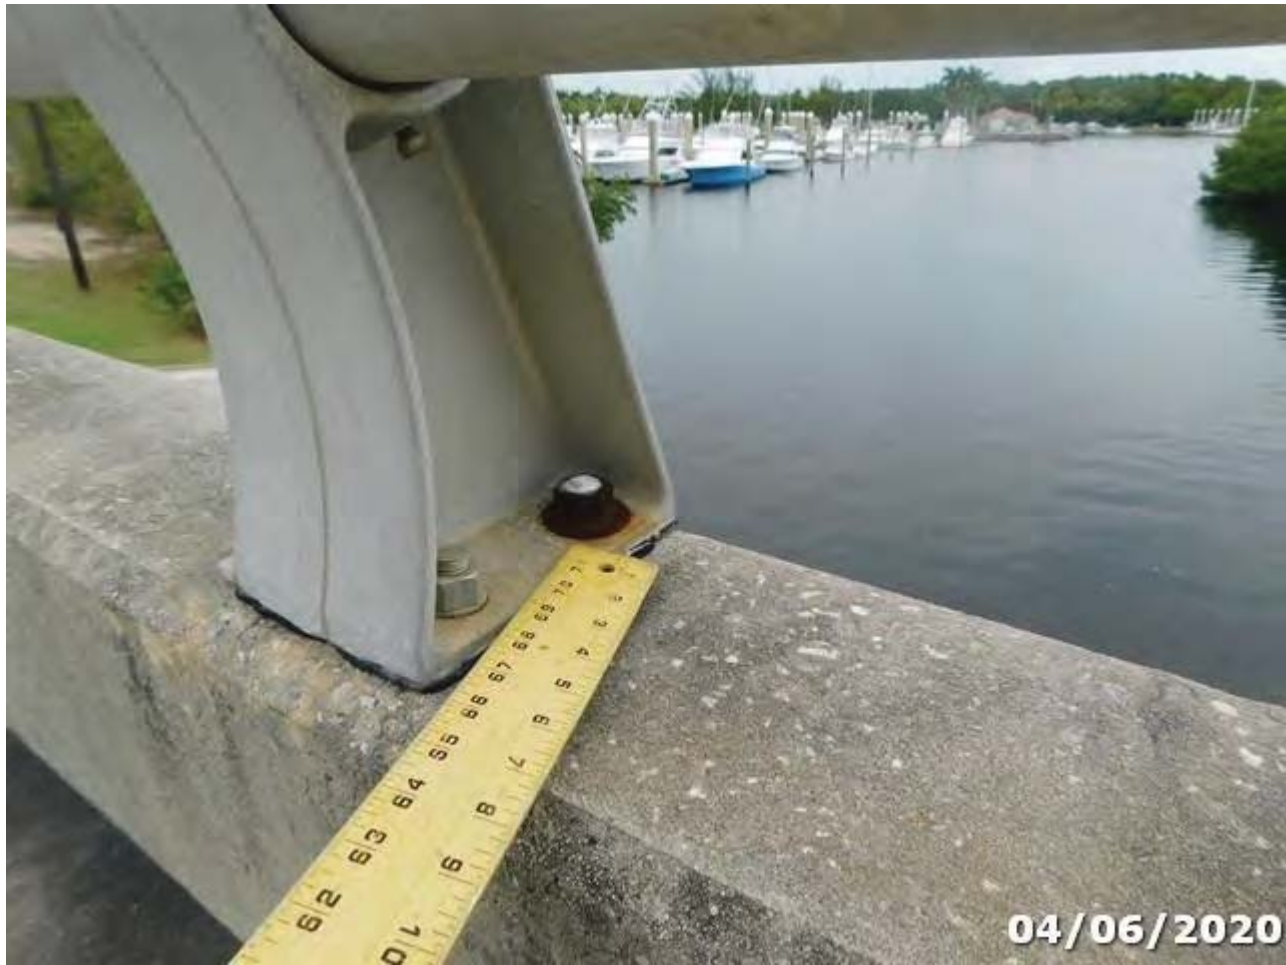
Photo 31 Element/Env 333/3: Other Bridge Railing

The rail anchor bolt nuts and washers have moderate corrosion at random locations: 25 nuts at west railing, and 5 nuts at east railing.

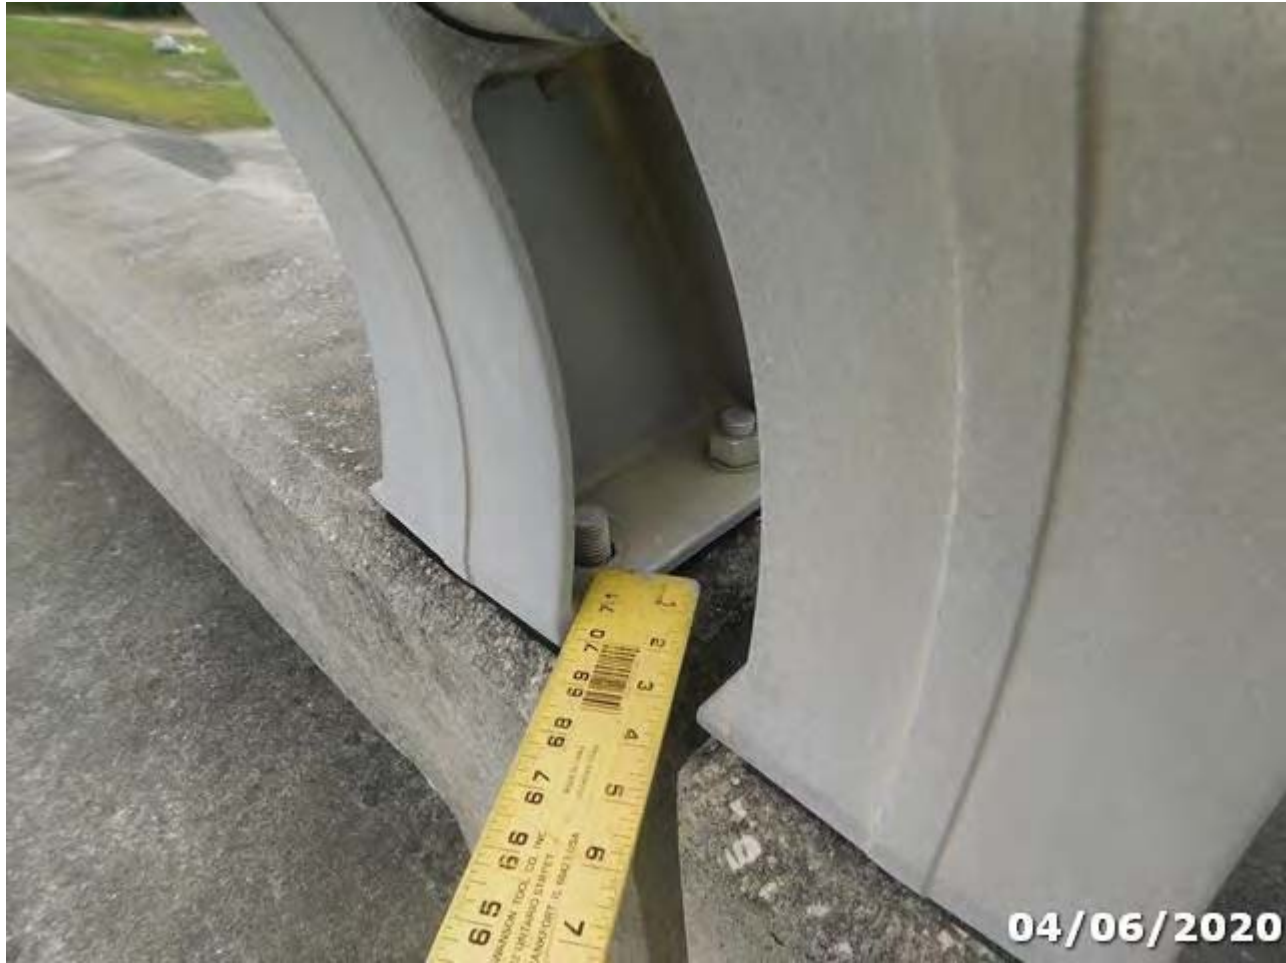
Photo 32 Element/Env 333/3: Other Bridge Railing

There are several missing anchor bolt nuts at the aluminium rail posts: west rail, Posts 1-1 and 2-6; and east rail, Post 1-5.

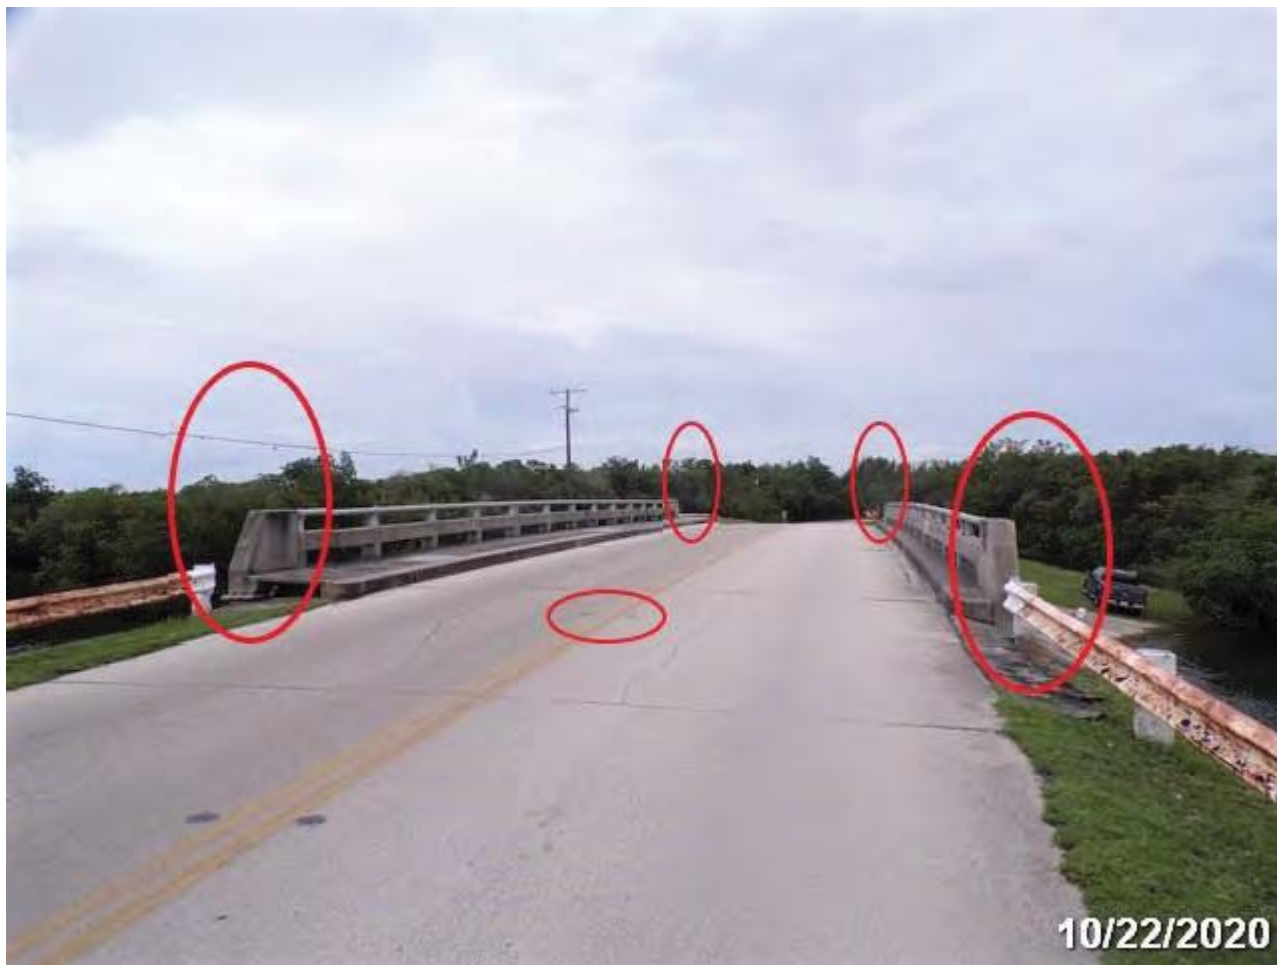
PHOTO 01: ELEMENT/ENV: 8099/3 PS Conc Slab (Sonovoid)

Object markers and centerline raised pavement markers are missing on the structure.

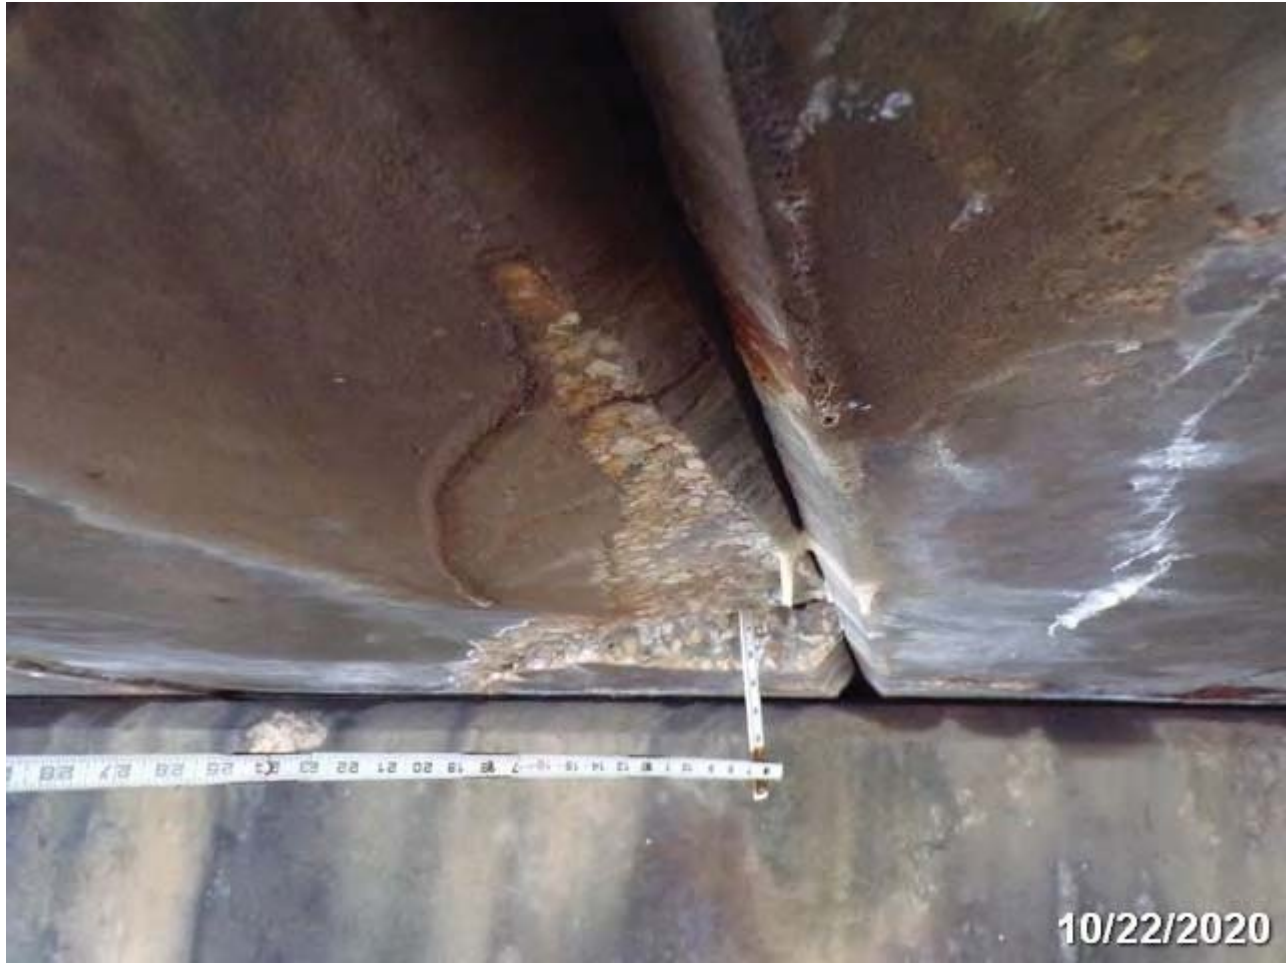
PHOTO 02: ELEMENT/ENV: 8099/3 PS Conc Slab (Sonovoid)

Slab Unit 1-9, center line has a spall/delamination up to 36in. L x 24in. W x 2.5in. D over Abutment 1, with an exposed stirrup.

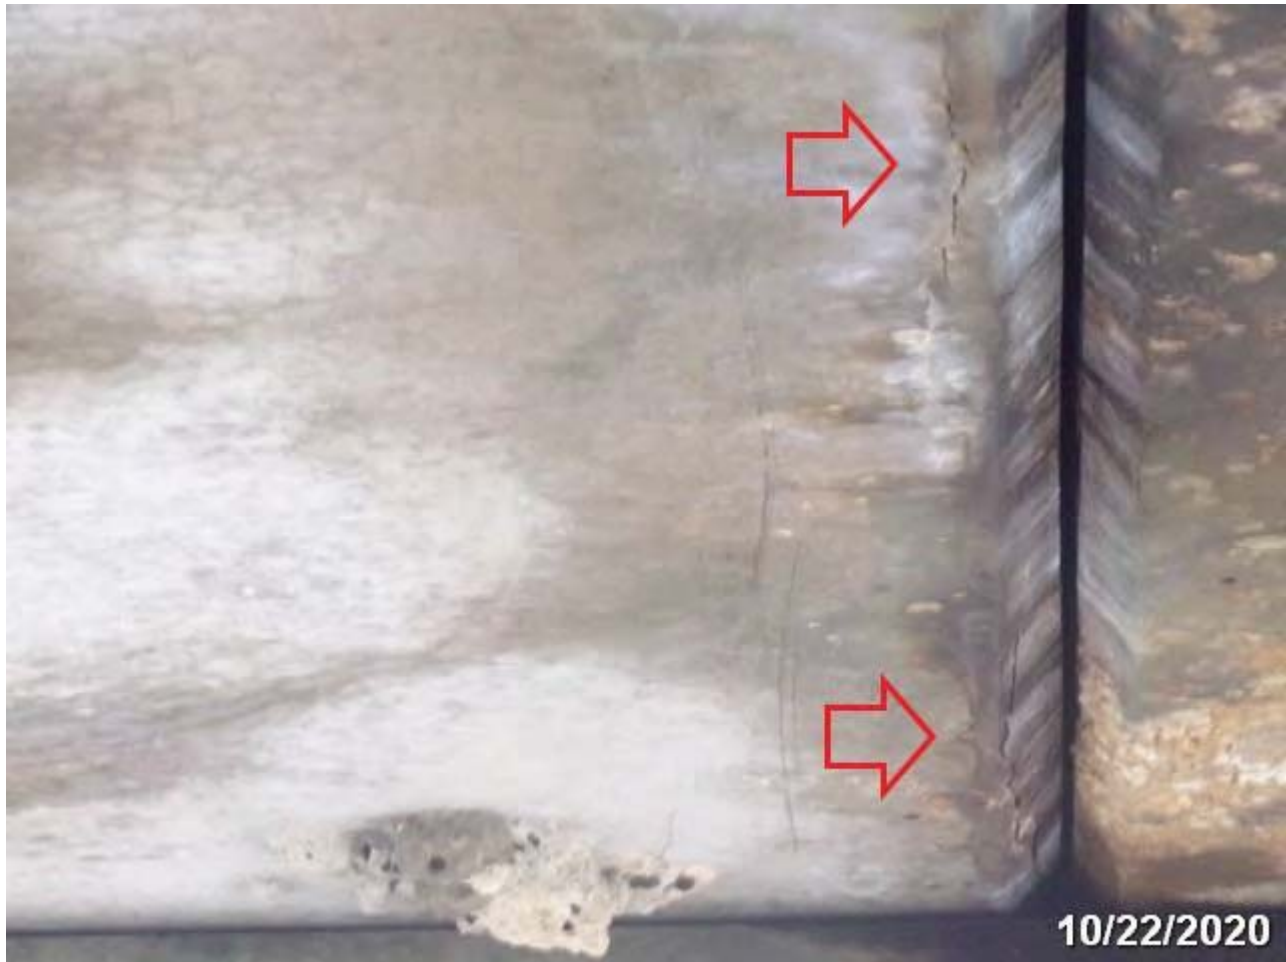
PHOTO 08: ELEMENT/ENV: 8099/3 PS Conc Slab (Sonovoid)

Slab Unit 1-7, east edge has a delamination 7ft. L x 4in. W, with an associated crack of up to 1/16in. starting at Pier 2 cap.
