# LUDLAM TRAIL CORRIDOR BRIDGE INSPECTION REPORT

Structure No: Ludlam Bridge-1

Prepared by: Marlin Engineering, Inc.

Structure Name: Ludlam Trail Corridor Bridge-1

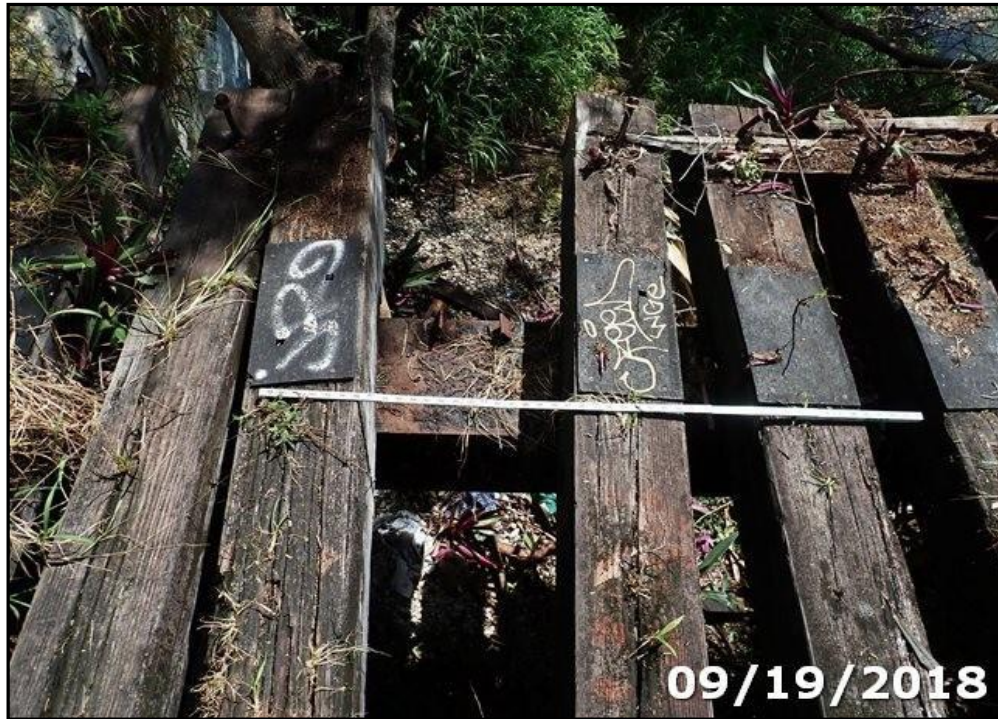
1. The right (east) timber guard is decayed and rotted up to 100% section loss at north and south ends, missing up to 15ft. L at the north end, also, the 4th railroad tie from the north is not attached and displaced. **See Photos 01 and 02.**
2. There is a missing section 16ft. L on the left timber guard at Span 2. **See Photo 03.**
3. The railroad ties typically exhibit splits and checks, some have severe decay with areas up to 5ft. L x 3in. W x 3in. D having 100% section loss and vegetation growth. Worst cases are Ties 20, 21, 24, 26, 28, 31, 32, 33, and 37. **See Photos 04 and 05.**
4. There is a tree growing between the railroad ties at north of Bent 7. **See Photo 06.**

**Photo 01:** The right (east) timber guard is decayed up to 100%, having the north end missing. The 4th railroad tie from the north is not attached and displaced.

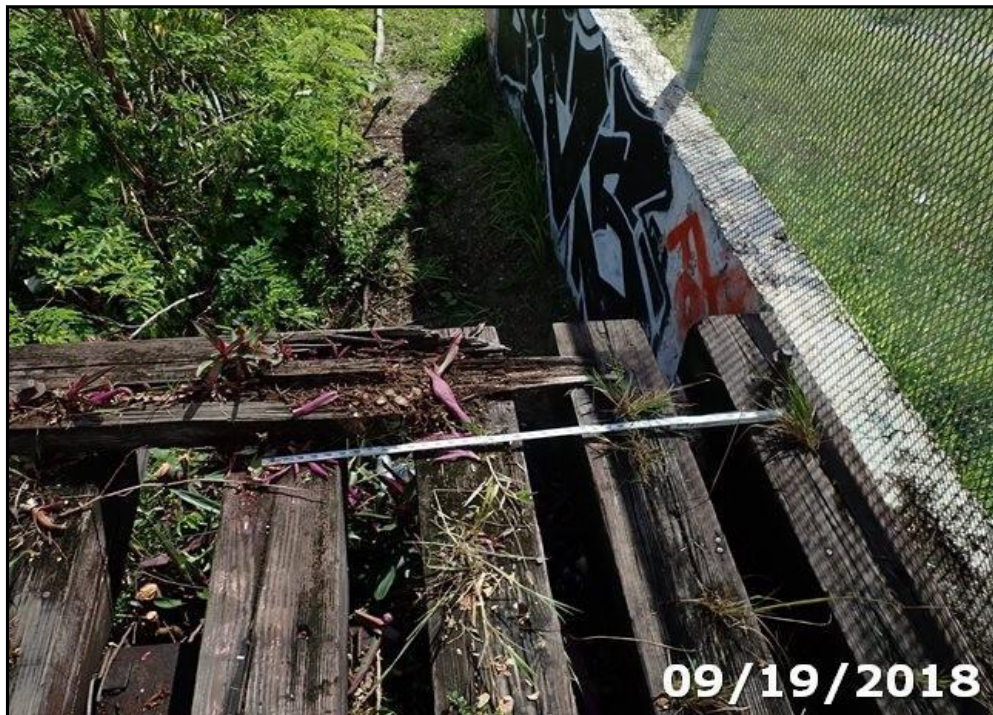
**Photo 02:** Decayed and missing south end of the right (east) timber guard.

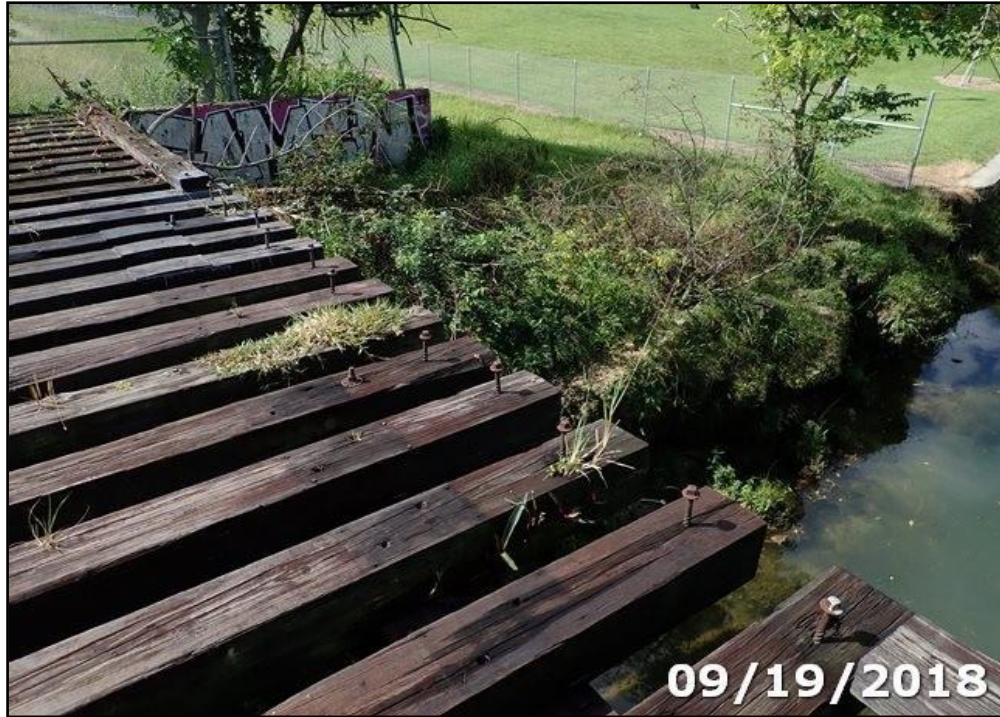
**Photo 03:** Missing section 16ft. L on the left timber guard at Span 2.

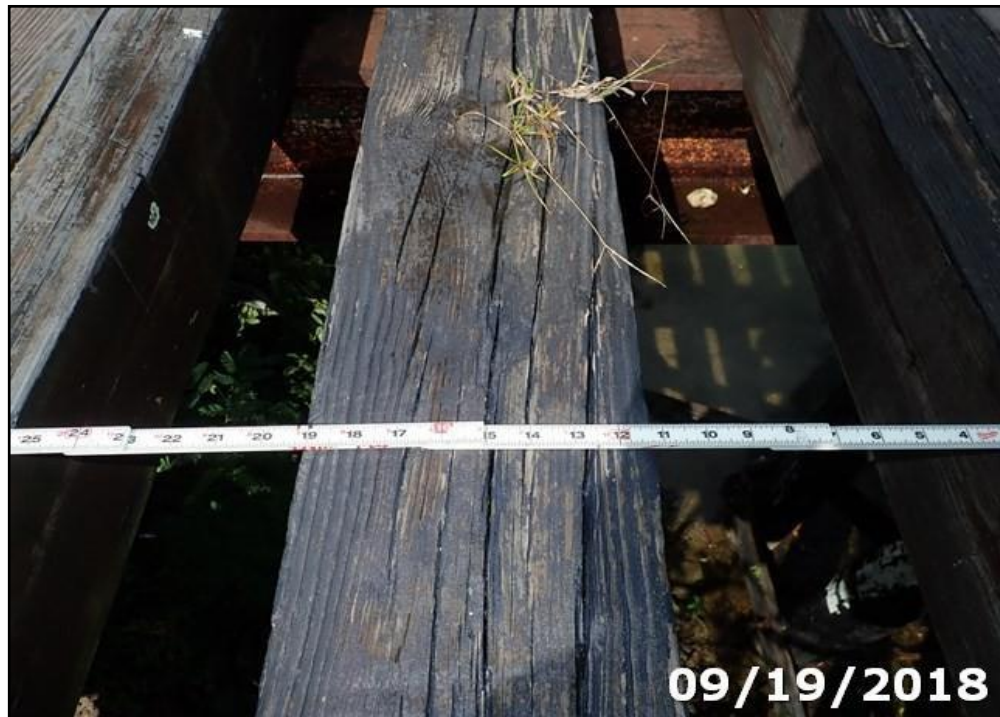
**Photo 04:** Typical splits and checks on the railroad ties.

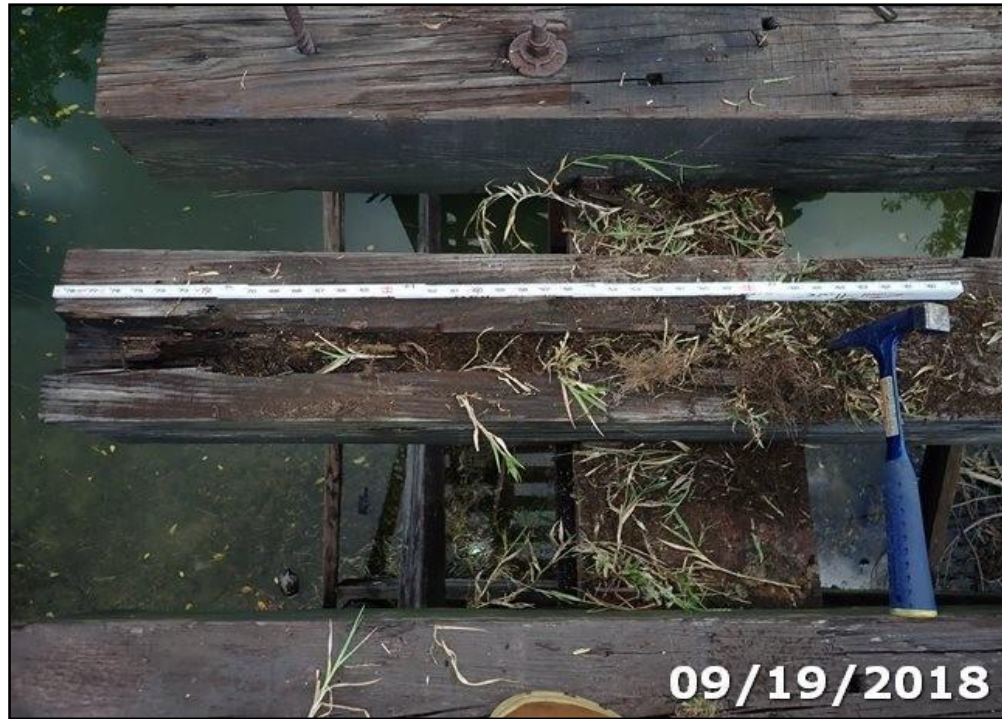
**Photo 05:** Typical severe decay and vegetation growth on some railroad ties.

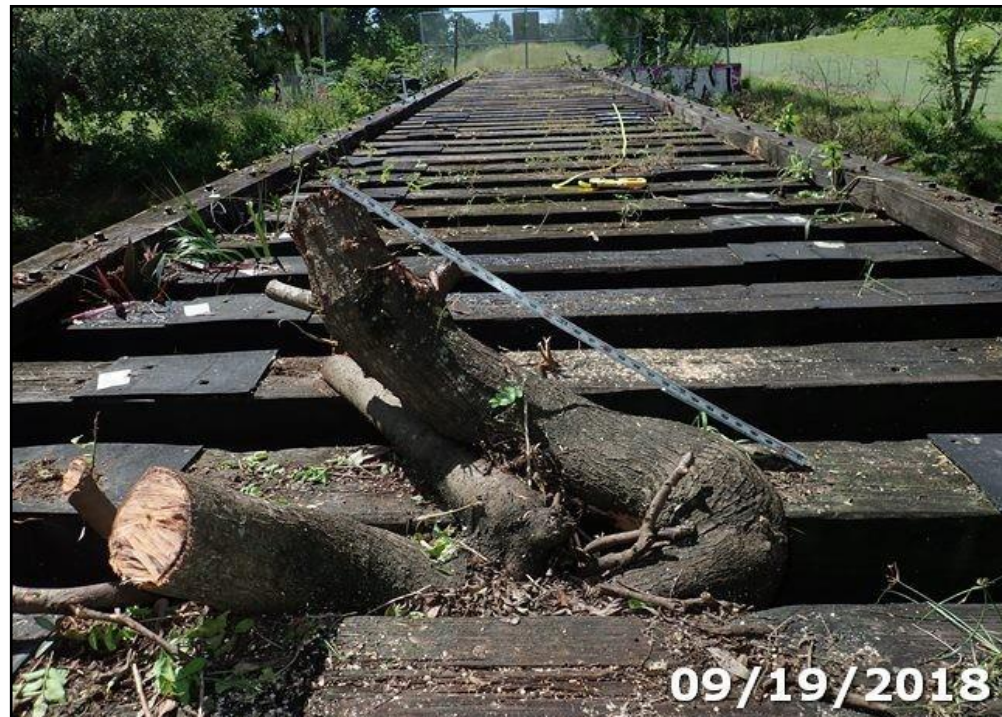
**Photo 06:** There is a tree growing between the railroad ties at north of Bent 7.

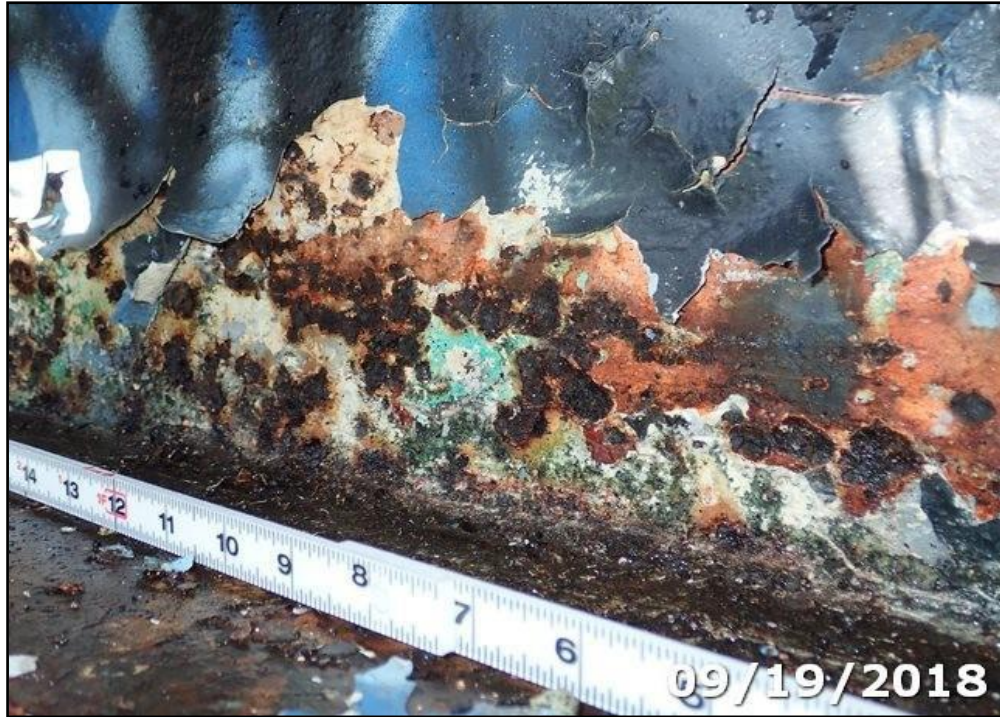
1. Both beams exhibit severe corrosion throughout with pitting at the lower portion of the web, having **areas** of 95% section remaining. **See Photo 07.**
2. The outboard faces of the beams exhibit graffiti. **See Photo 08.**

**Photo 07:** Both beams exhibit severe corrosion throughout with pitting.

- \_Clean and coat corrosion at the steel beams. Photo 07.

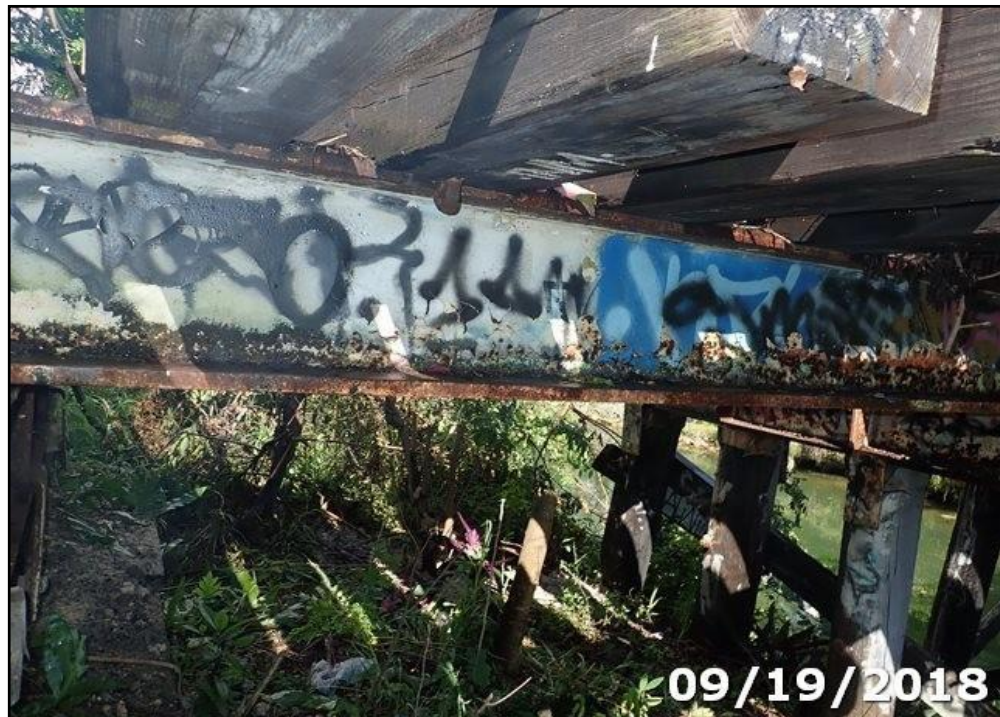
**Photo 08:** The outboard faces of the beams exhibit graffiti.

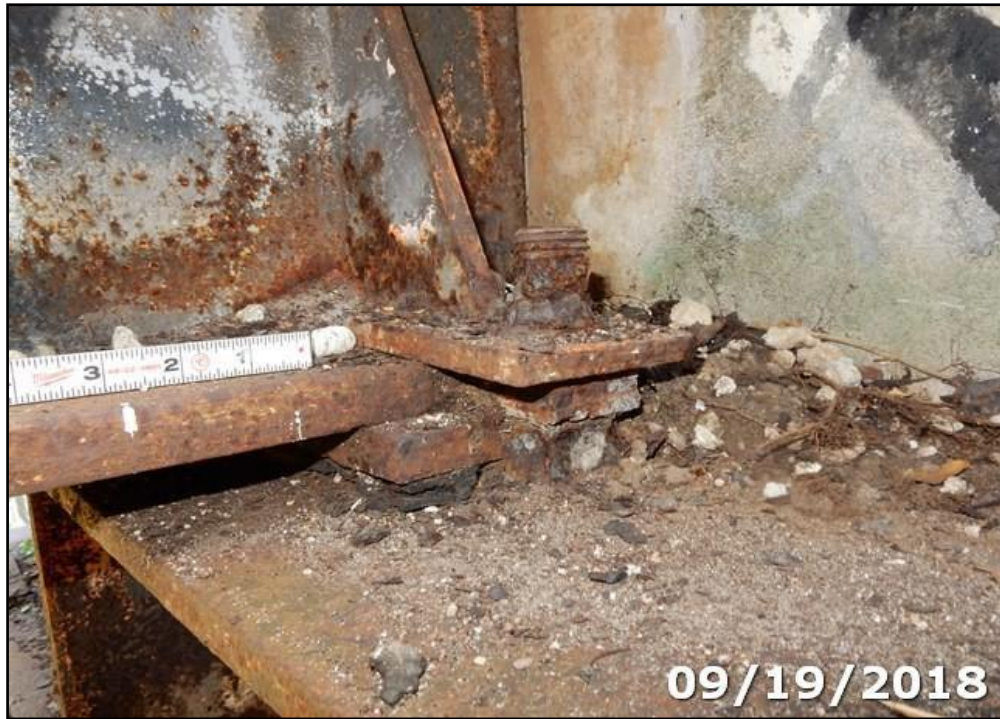
1. The bearing plates and anchorage hardware have severe corrosion with section loss up to 100%. There are neoprene pads at the abutments bearings only. **See Photos 09 and 10.**

**Photo 09:** The bearing plates and anchorage hardware are heavily corroded with up to 100% section loss. Neoprene pads at abutment bearings.

- \_Clean and coat corrosion on bearing plates and hardware. Photos 09 and 10.

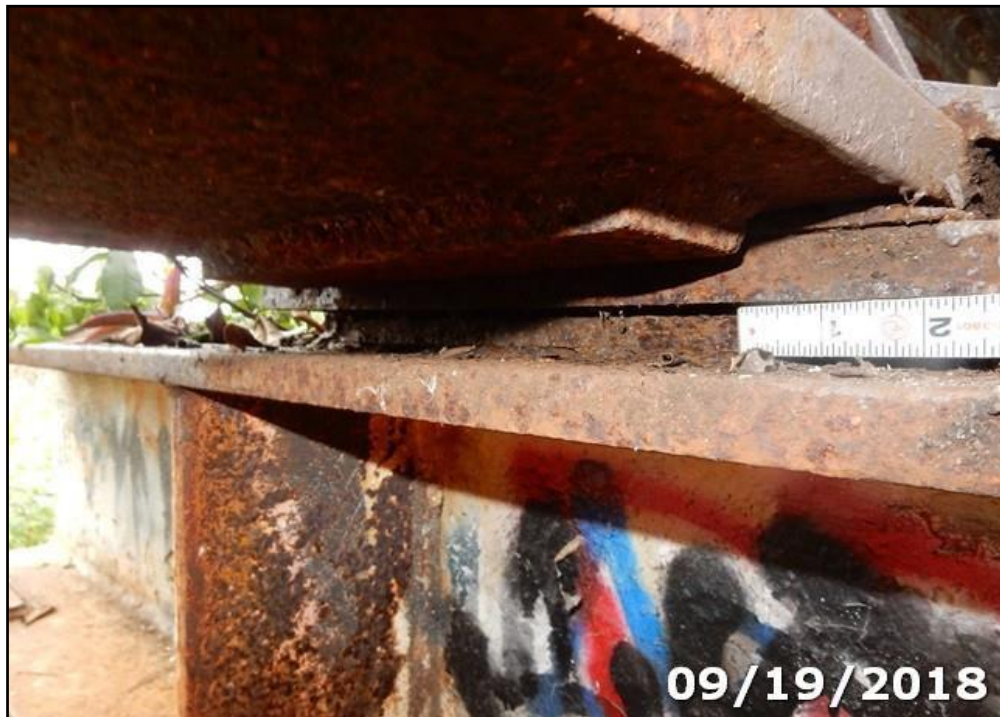
**Photo 10:** Typical corrosion with pitting at the intermediate bents bearing plates.

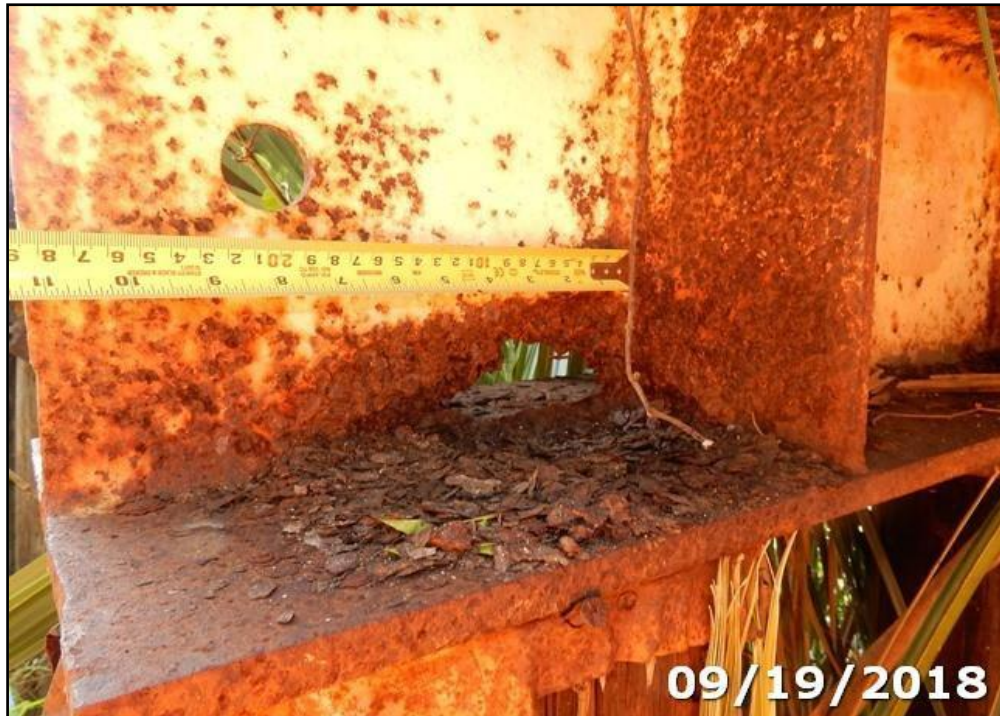
1. All steel caps exhibit moderate to severe corrosion, having areas of up to 100% section loss at random locations. Worst cases are Pier caps 2 and 7. **See Photos 11 and 12.**
2. The pier caps exhibit graffiti throughout.

**Photo 11:** All steel caps exhibit moderate to severe corrosion, having areas of up to 100% section loss at random locations. Shown Pier cap 7, east end.

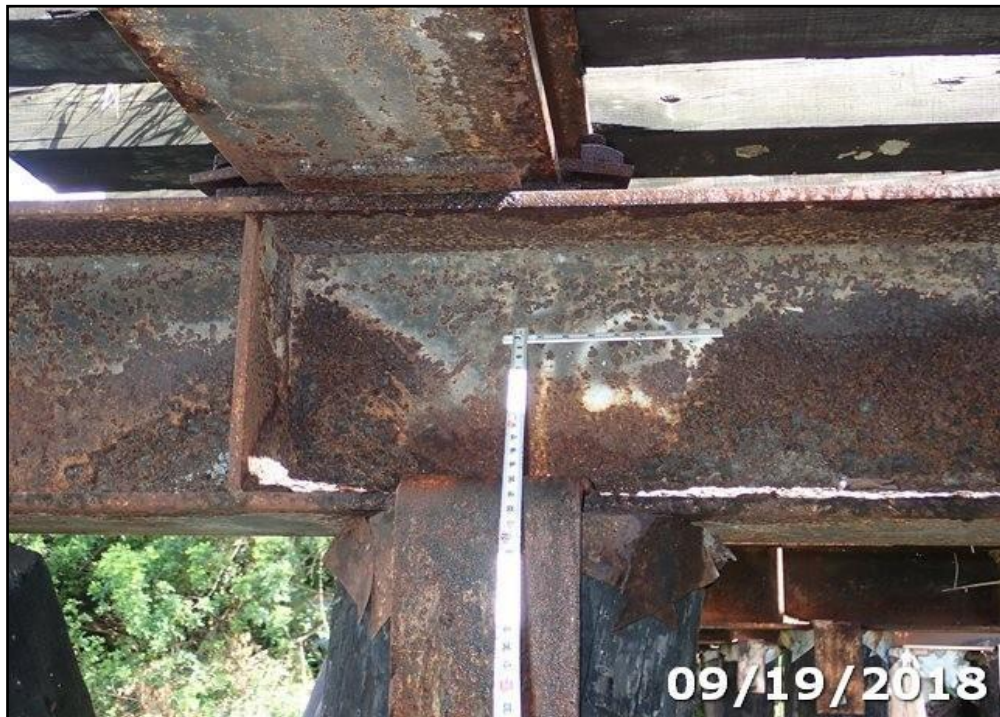
**Photo 12:** Typical corrosion with pitting on the steel pier caps.

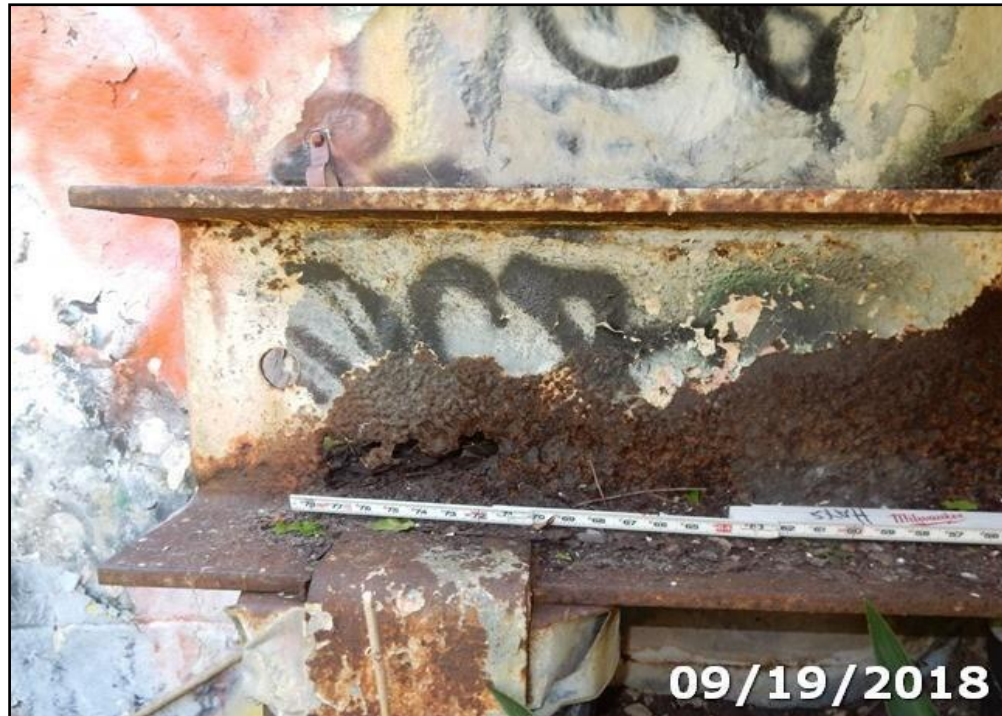
1. The abutment caps exhibit moderate to severe corrosion, having areas with section loss up to 100% at the ends of Abutment 1 cap. **See Photos 13 and 14.**

**Photo 13:** Severe corrosion with section loss up to 100% at east end of Abutment 1 cap. (Front view)

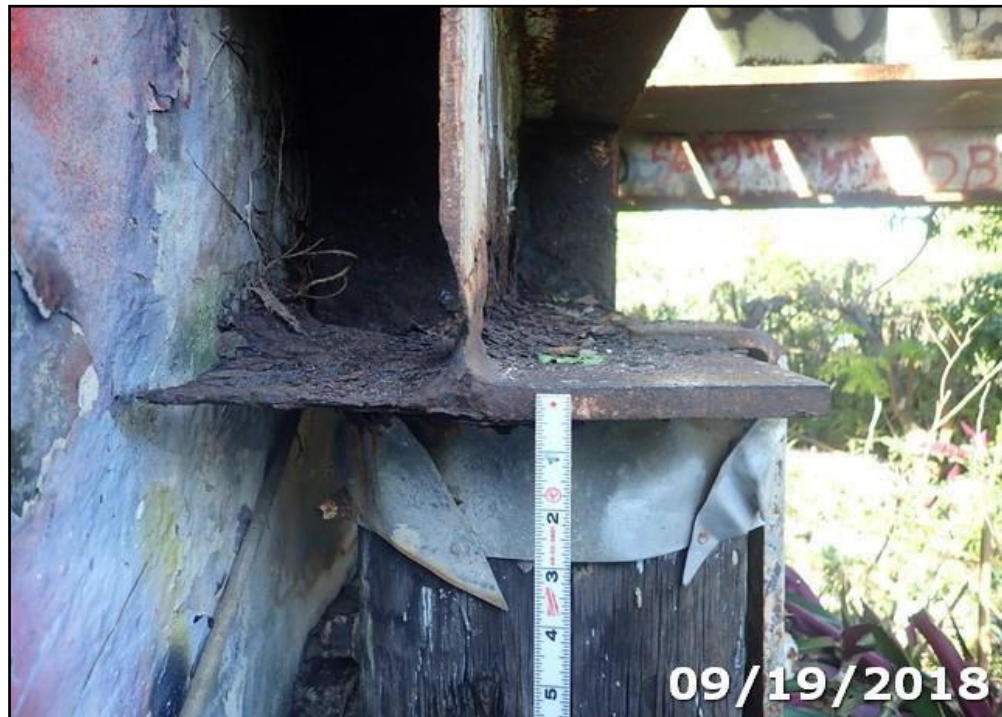
**Photo 14:** Severe corrosion with section loss up to 100% at east end of Abutment 1 cap. (East view)

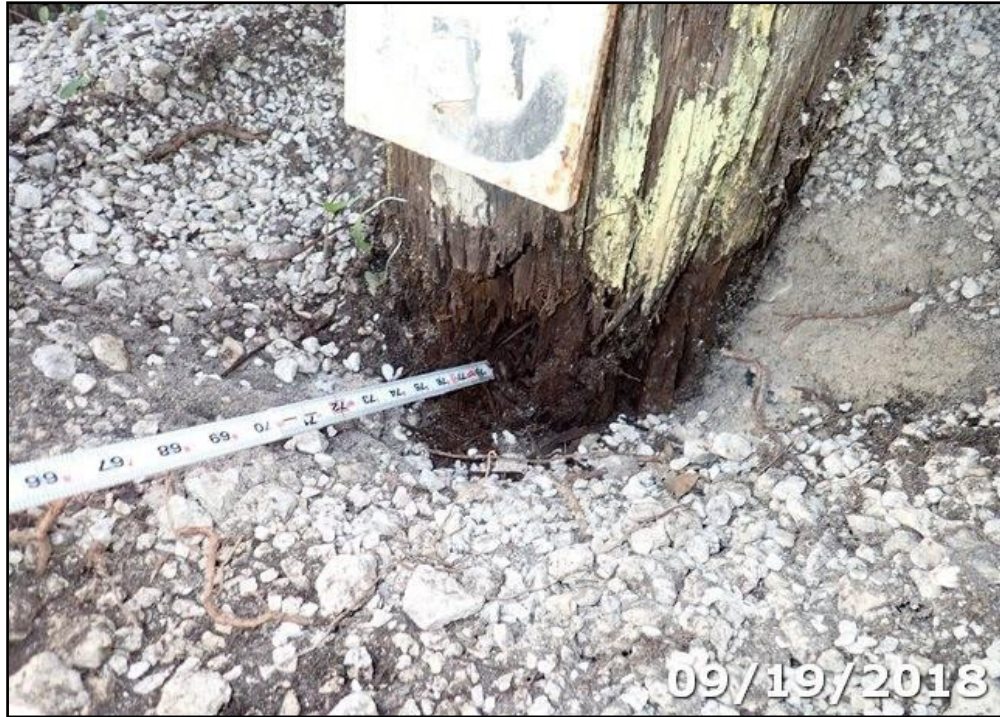
1. All piles exhibit severe decay below the groundline, having soft areas with up to 70% section loss. **See Photos 15, 16, and 17.**
2. Pile 4-1 and the cross bracing have severe decay, having up to 100% section loss at the west fascia cross bracing connection. **See Photo 18.**
3. The piles of Bents 3 thru 6 exhibit decay with soft areas up to 3/4in. D at the tide zone, having up to 5% section loss. Total 20 piles. **See Photo 19.**
3. The piles typically exhibit checks and splits.
4. Bent 2 piles have evidence of fire damage.
5. Spans 2, 3, and 5 are missing one of two fascia cross bracings.
6. Pier 6 has one broken cross bracing at Pile 6-4, and the horizontal is missing. **See Photo 20.**
7. The cross bracing typically exhibit decay with section loss at the bottom ends. **See Photo 21.**

**Photo 15:** Pile 8-3 exhibits severe decay with section loss up to 70% below the groundline.

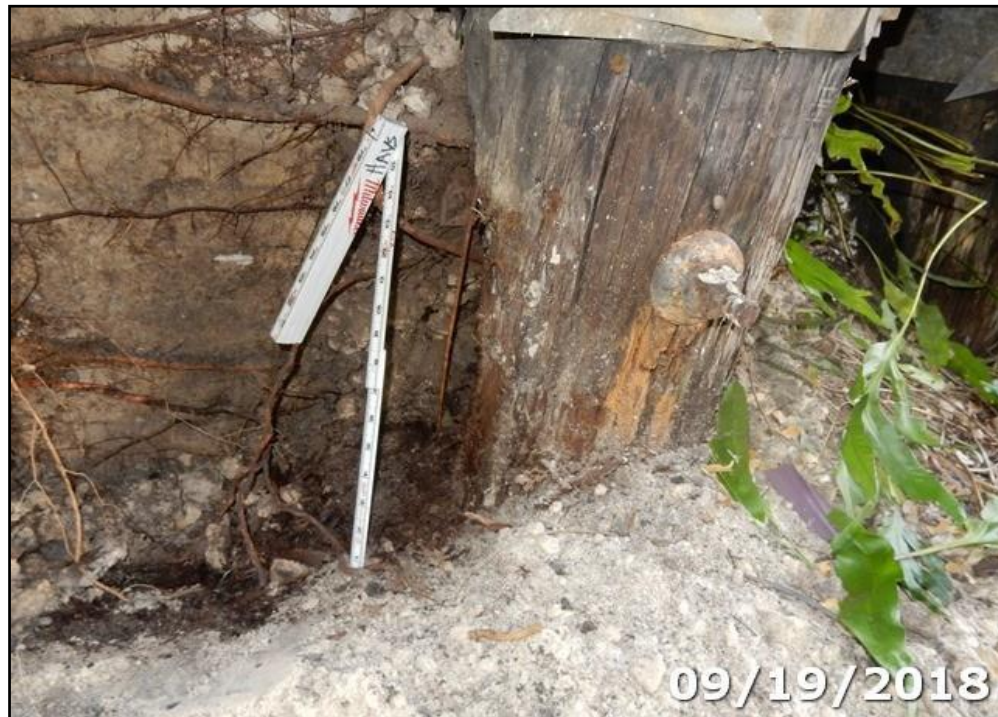
**Photo 16:** Severe decay with section loss up to 40% below the groundline on Pile 1-2.

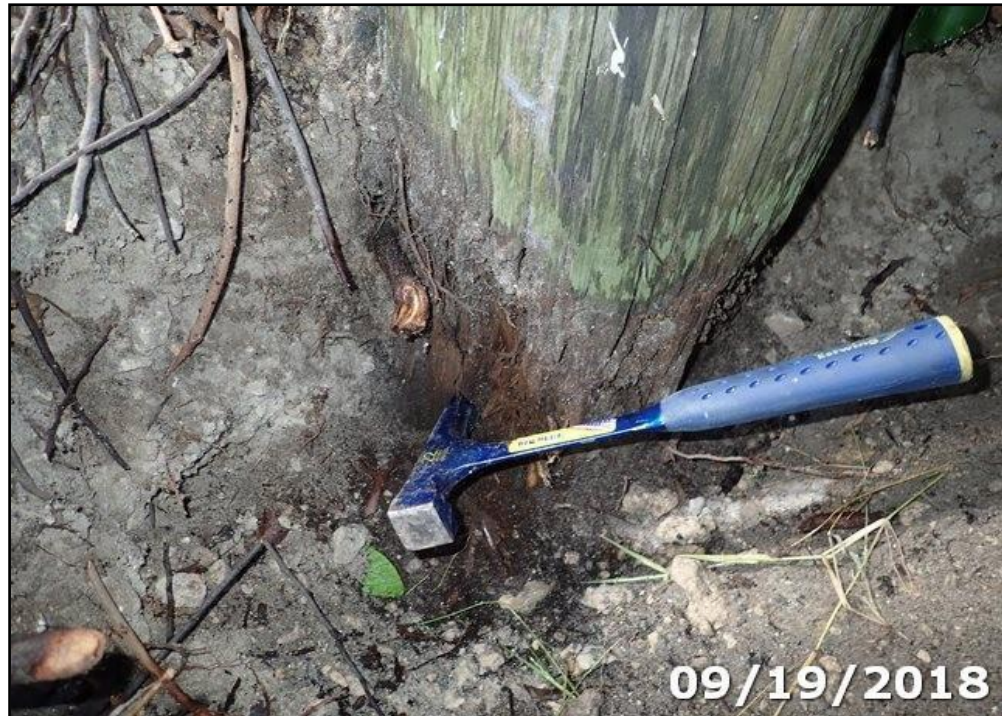
**Photo 17:** Severe decay with section loss up to 50% below the groundline on Pile 2-3.

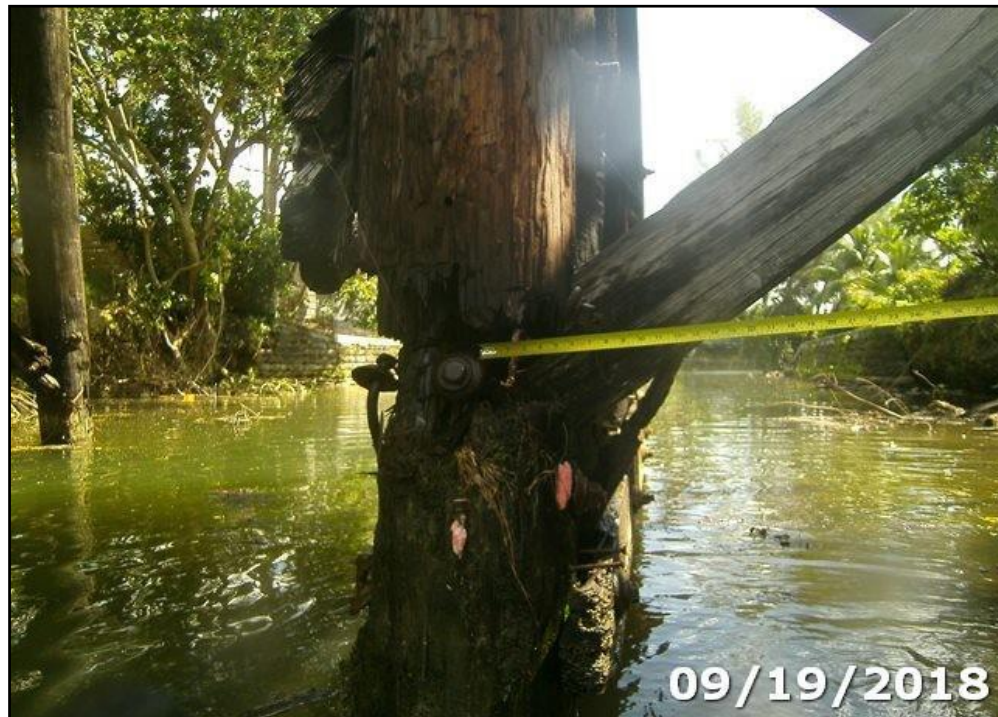
**Photo 18:** Pile 4-1 and the cross bracing have severe decay, having up to 100% section loss at the cross bracing connection.

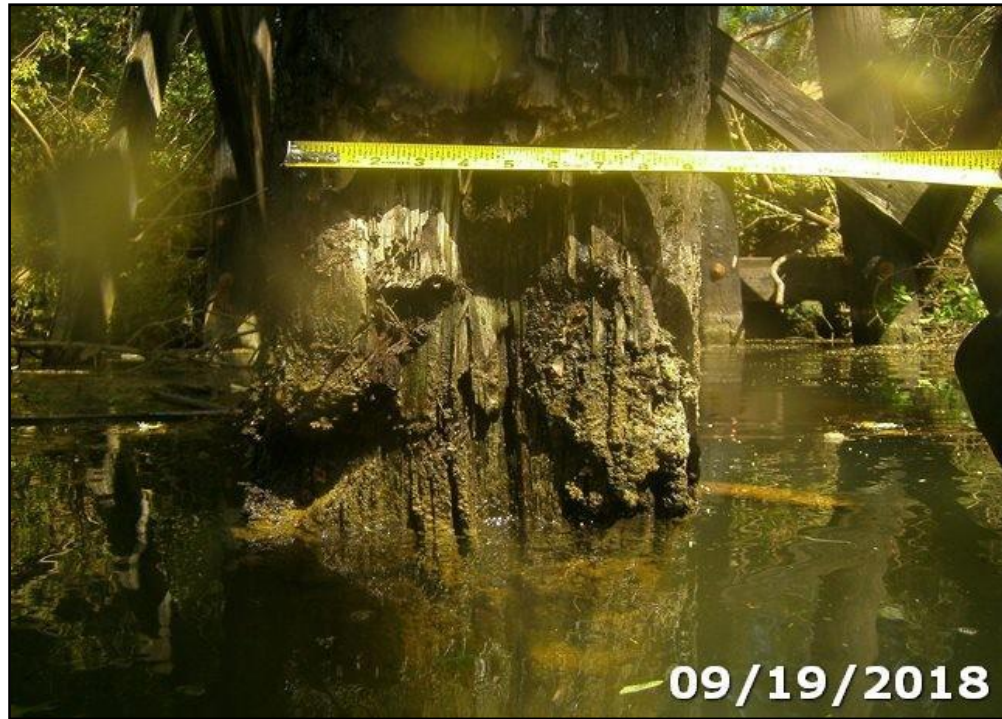
**Photo 19:** Typical decay on the piles of Bents 3 thru 6 at the tide zone.

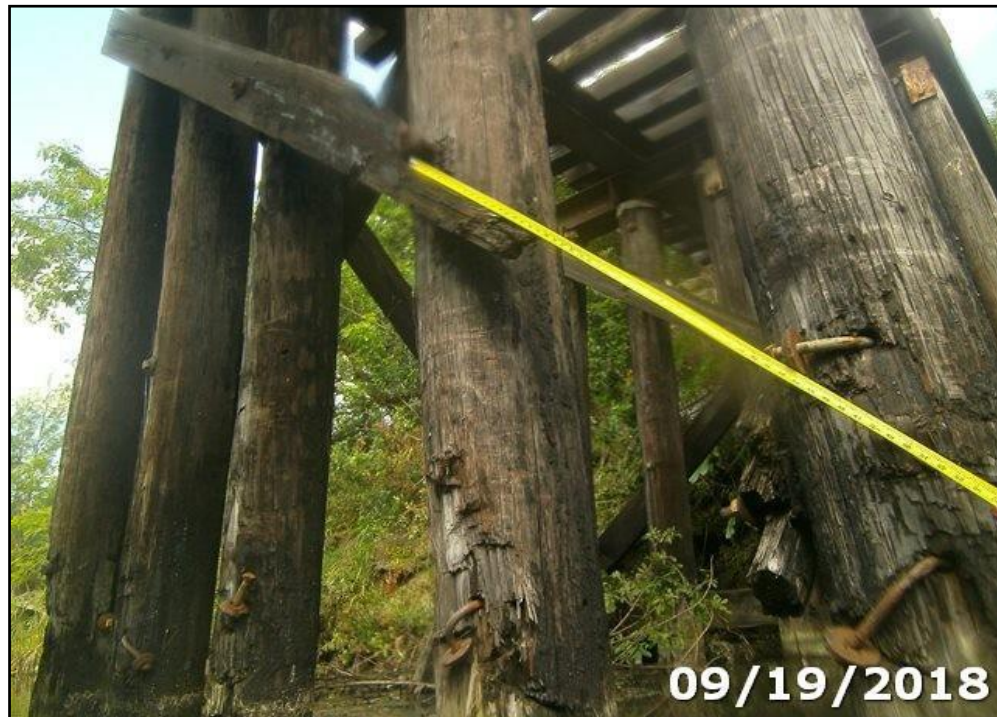
**Photo 20:** Pier 6 has one broken cross bracing at Pile 6-4, and the horizontal is missing.

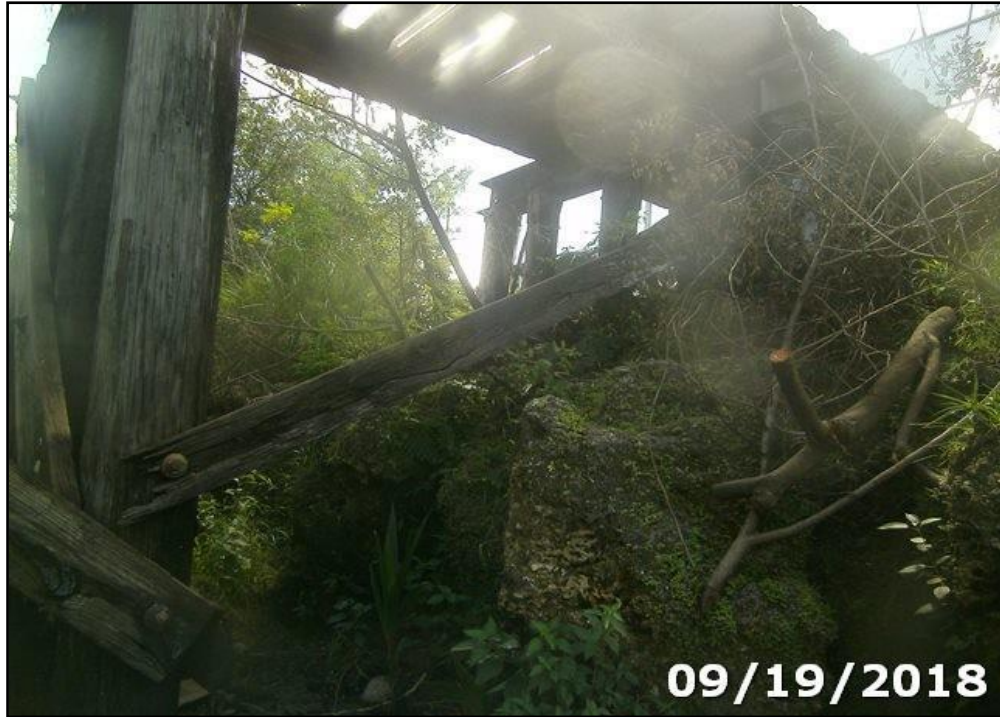
**Photo 21:** Typical decay with section loss at the bottom ends of the cross bracing members.

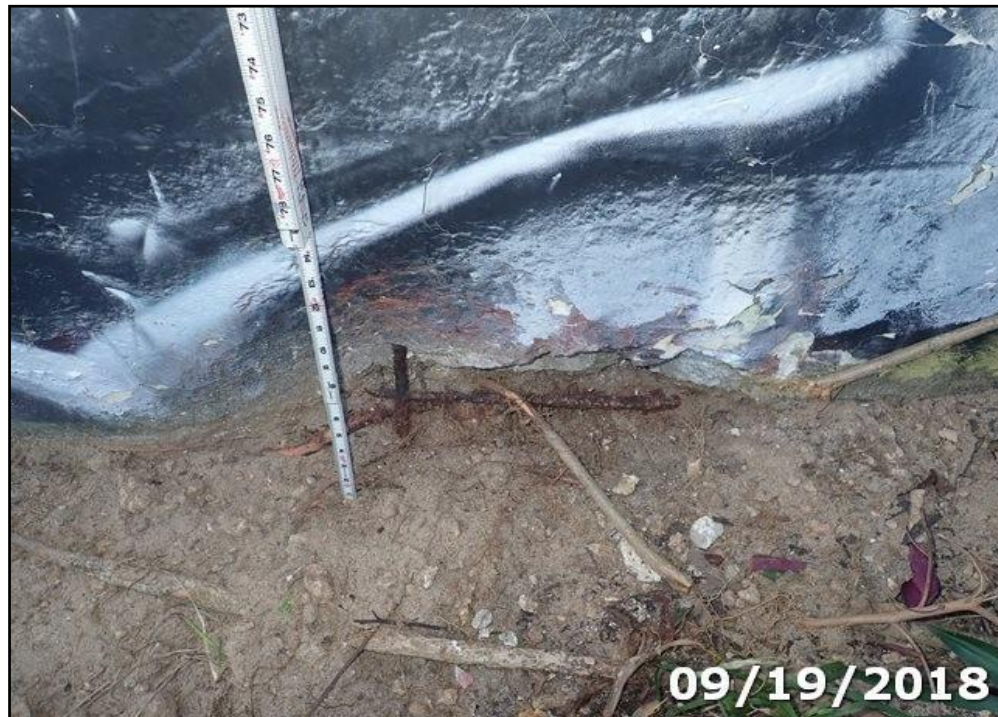
1. Abutment 1 concrete wall has a spall 30in. L x 15in. H x 3in. D with two exposed rebar, having corrosion with up to 50% section loss, 2ft. west of Pile 1-5. **See Photo 22.**
2. Both concrete walls exhibit graffiti throughout. **See Photo 23.**

**Photo 22:** Spall 30in. L x 15in. H x 3in. D with two exposed rebar at Abutment 1 concrete wall, 2ft. west of Pile 1-5.

- \_Clean and coat exposed rebar and repair spall at Abutment 1 concrete wall. Photo 22.

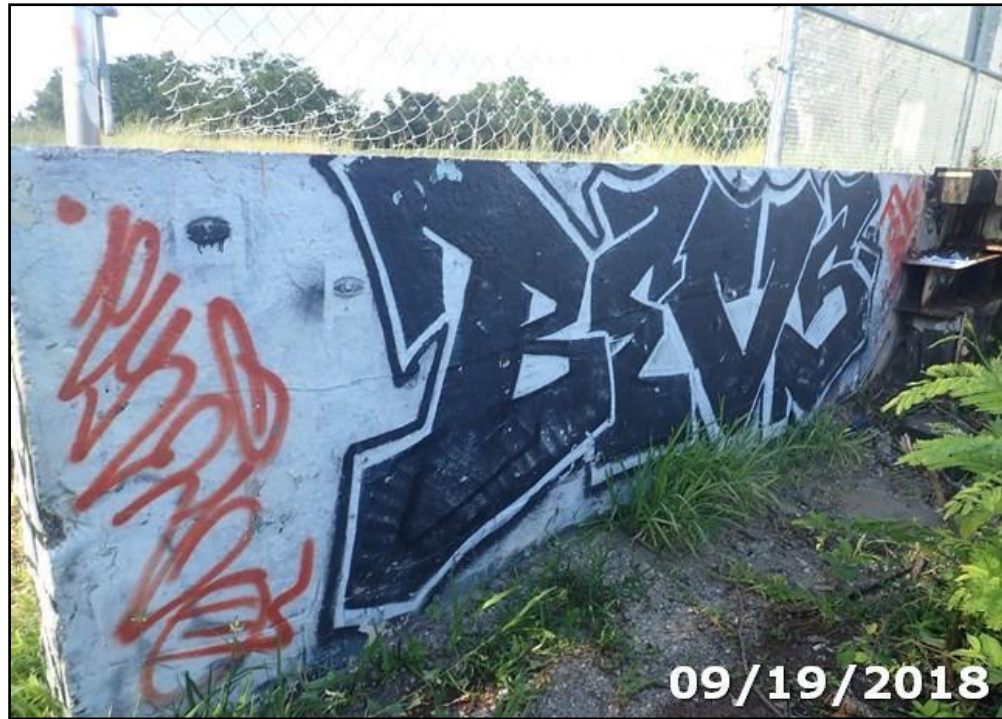
**Photo 23:** Both concrete walls exhibit graffiti throughout.

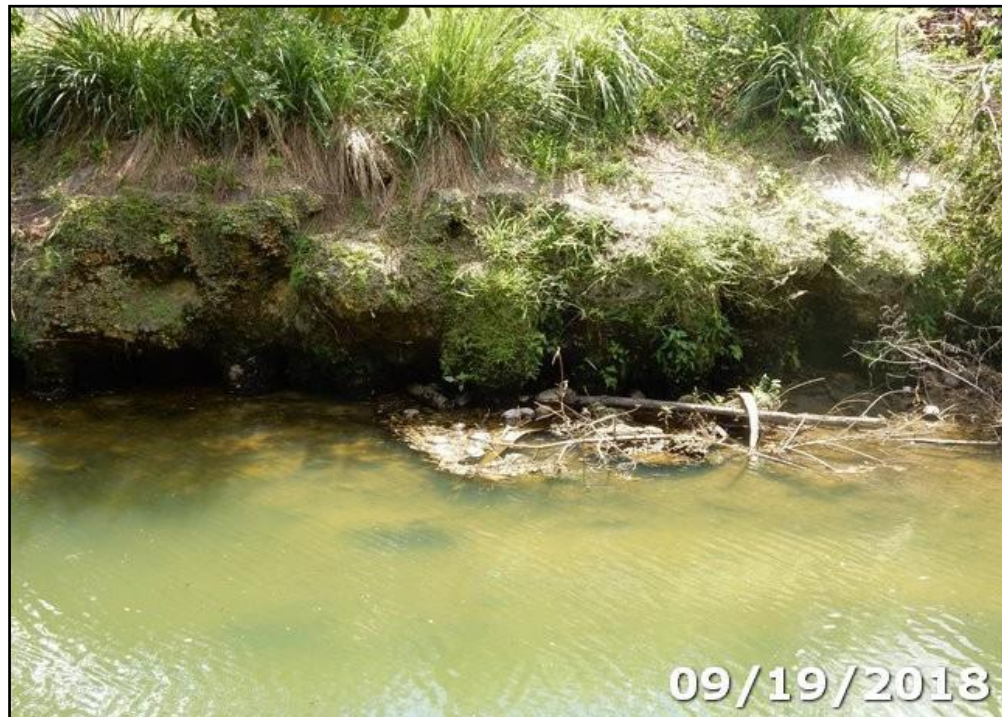
**Photo 24:** Typical erosion at the channel slopes.

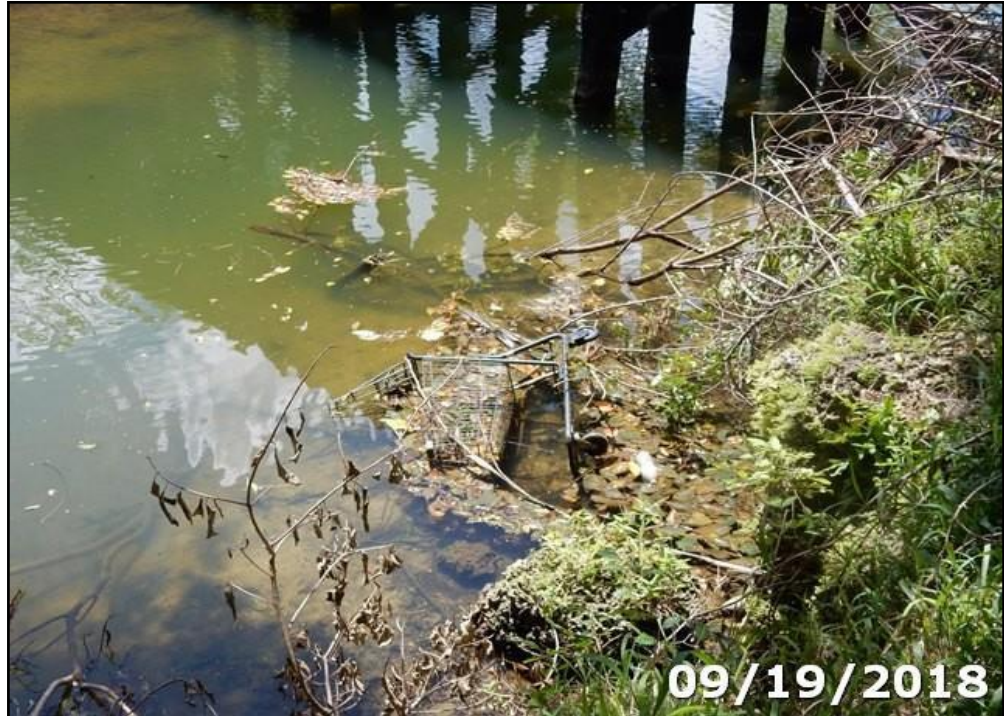
**Photo 25:** There is drift and debris scattered on the channel.

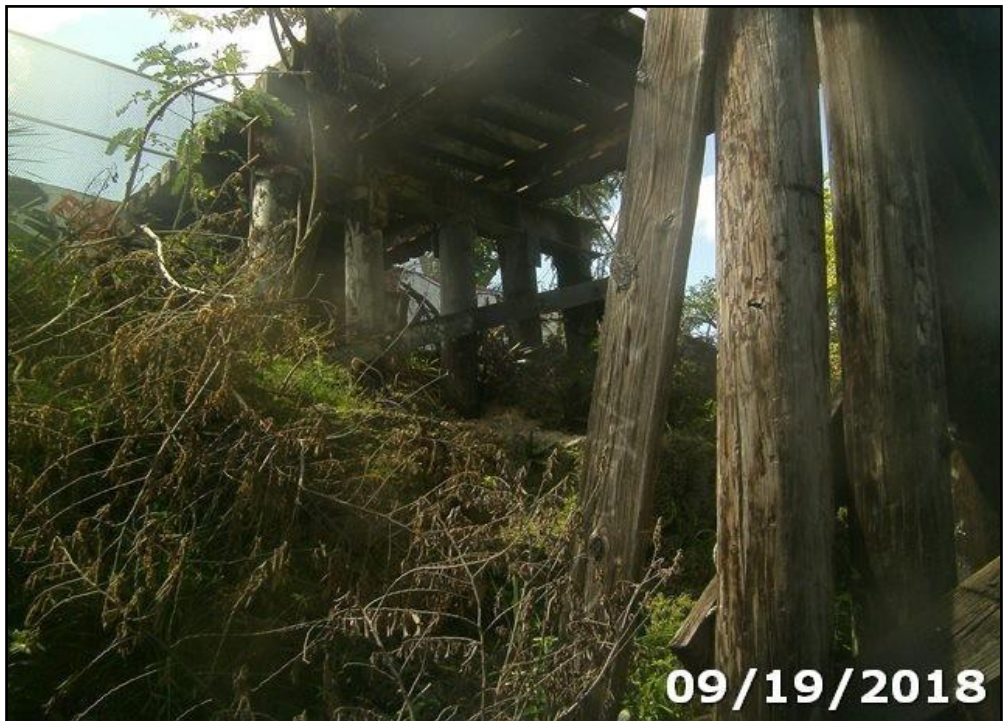
**Photo 26:** There is heavy vegetation growth at both channel slopes below the structure.

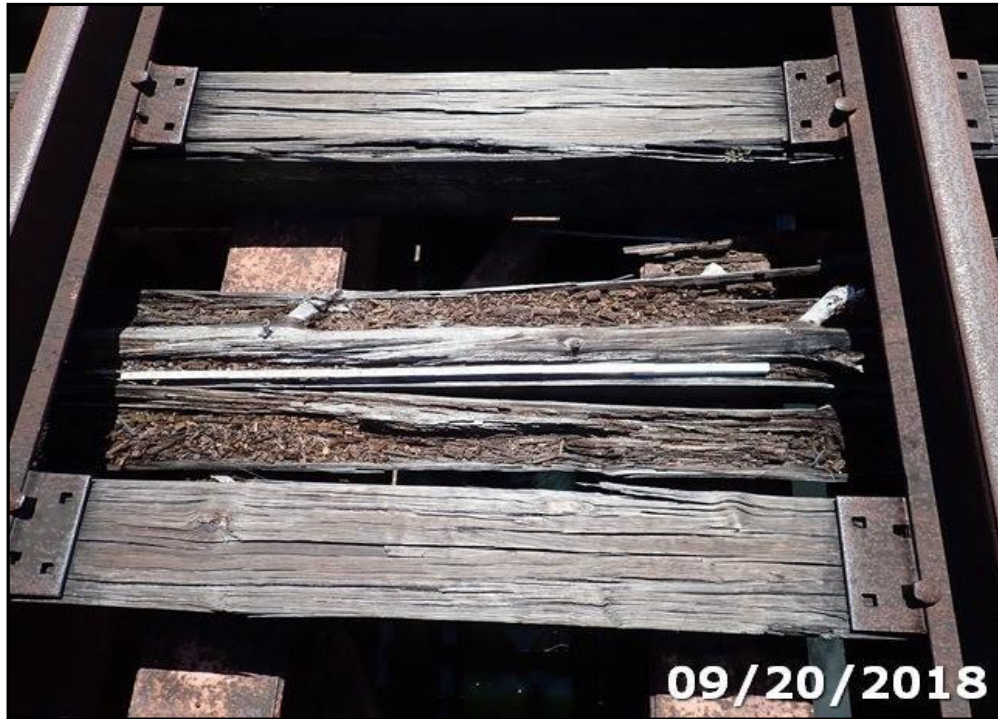
1. The railroad ties typically exhibit splits and checks, some have severe decay with soft and hollow areas, and vegetation growth. Worst cases are Ties 10, 11, 22, 28, 29, 30, 40, 41, 44, 49, 52, 53, 54, 69, 71, 76, 79, and 80. **See Photos 01 and 02.**
2. Railroad tie 36 is missing. **See Photo 03.**
3. The timber guards exhibit splits and checks, having areas of severe decay and missing sections over Bent 4. **See Photo 04.**

**Photo 01:** Typical splits and checks on railroad ties. Severe decay at Ties 10, 11, 22 ,28, 29, 30, 40, 41, 44, 49, 52, 53, 54, 69, 71, 76, 79, and 80.

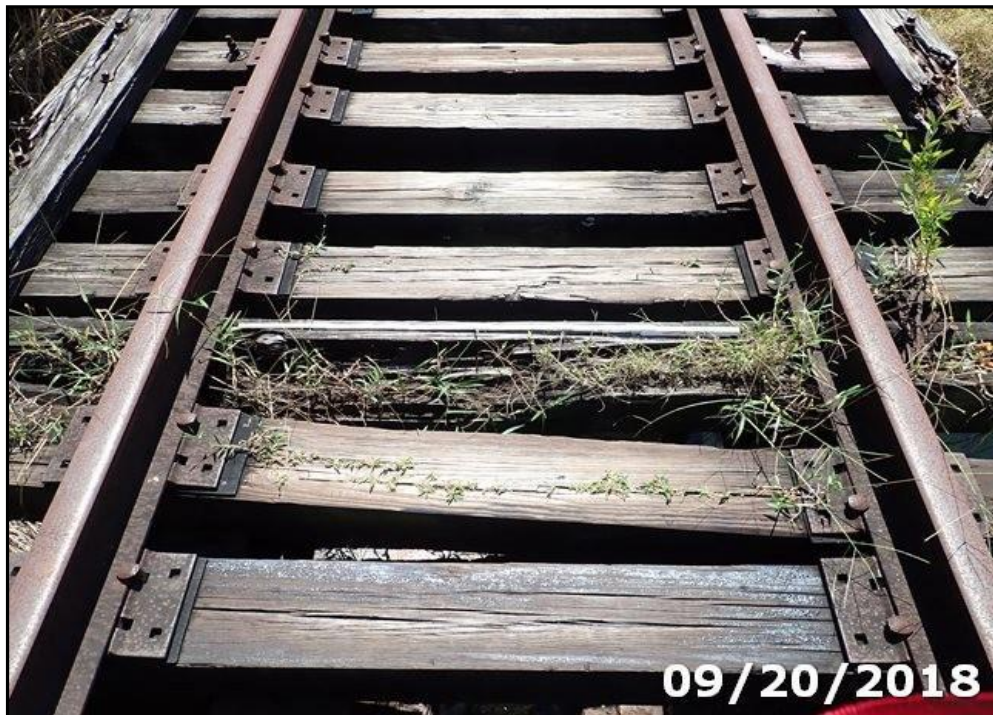
**Photo 02:** Typical decay with vegetation growth on railroad ties.

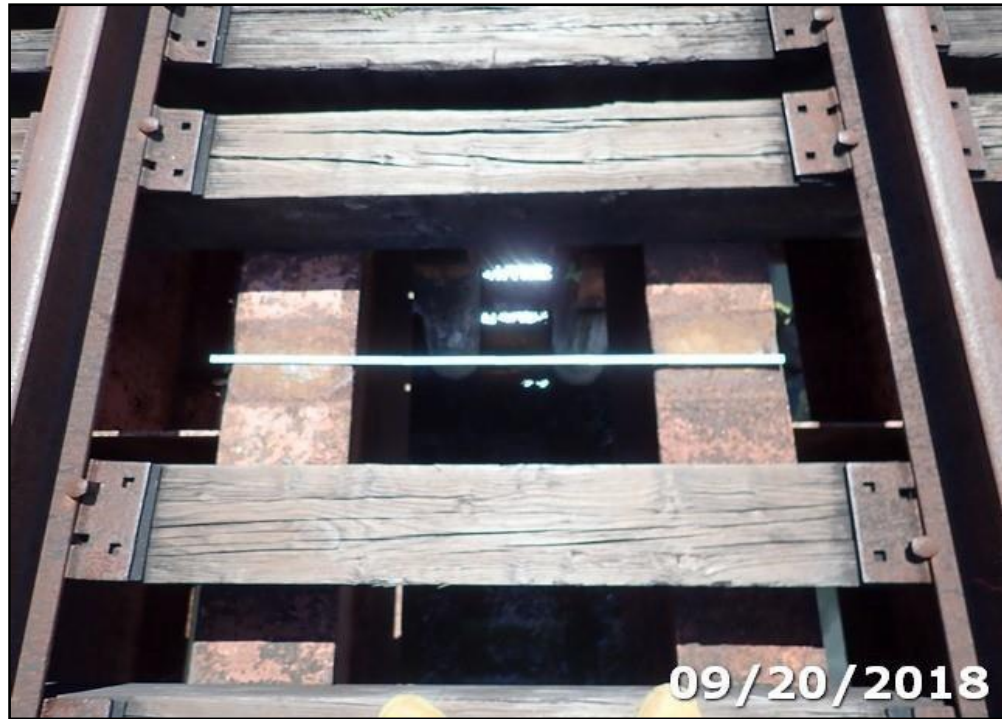
**Photo 03:** Railroad tie 36 is missing.

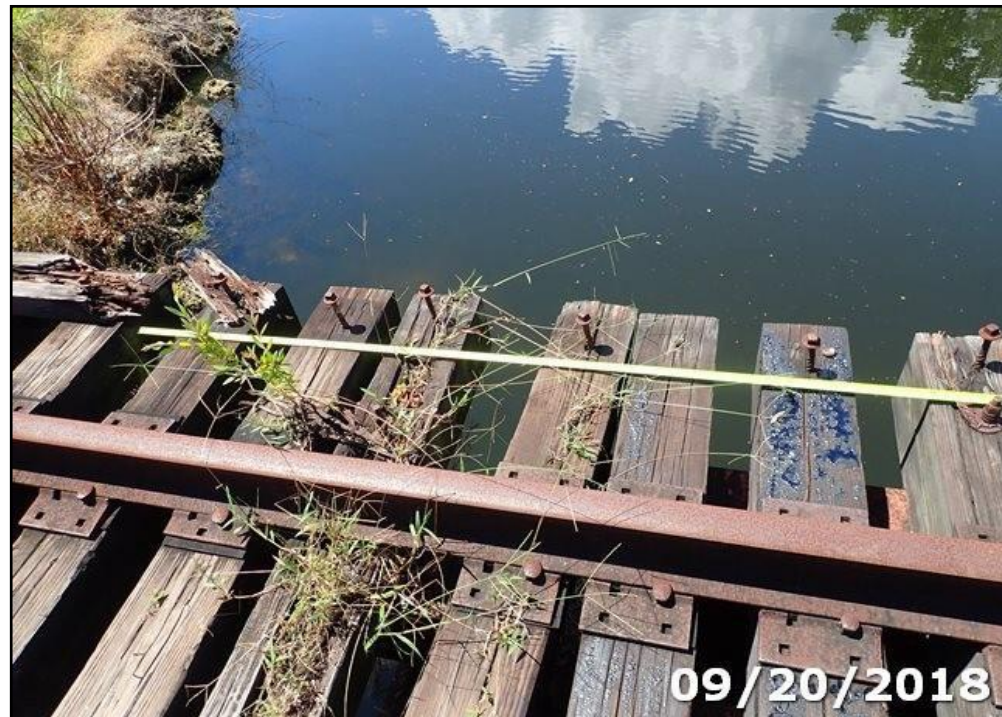
**Photo 04:** Severe decay and missing sections of the timber guards at both sides of the deck.
