# LUDLAM TRAIL CORRIDOR BRIDGE INSPECTION REPORT

Structure No: Ludlam Bridge-1

Prepared by: Marlin Engineering, Inc.

Structure Name: Ludlam Trail Corridor Bridge-1

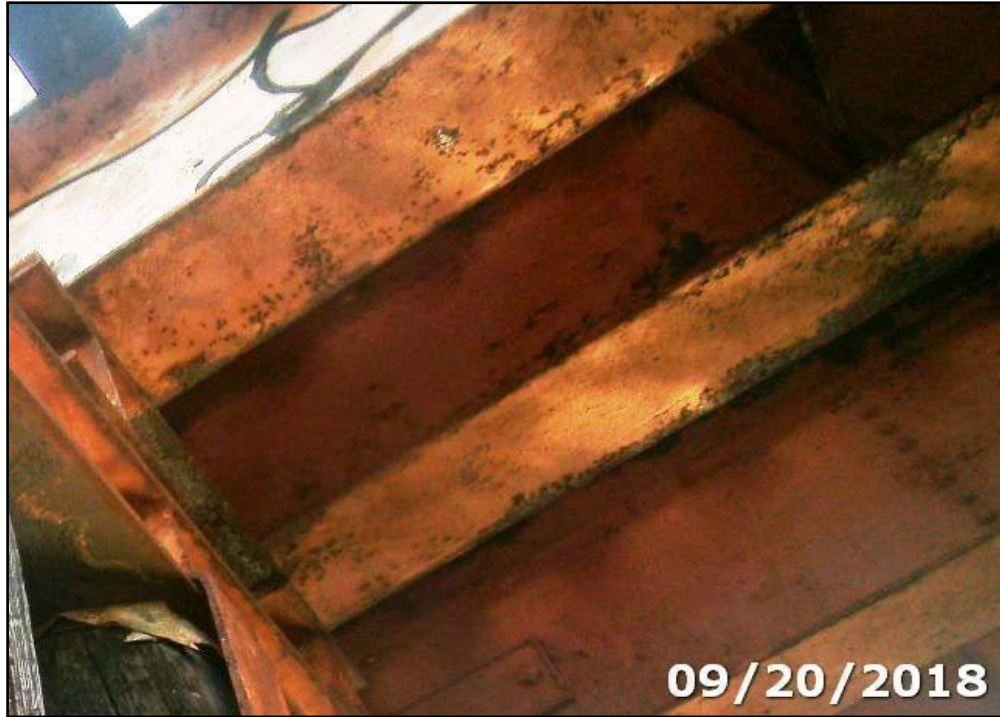
1. Steel beams exhibit light to moderate corrosion throughout with pitting on some areas at the bottom flanges. **See Photo 05.**
2. The faces of the beams exhibit graffiti. **See Photo 06.**

**Photo 05:** Typical corrosion on the bottom flanges of the steel beams.

\_Clean and coat corrosion on the steel beams. Photo 05.

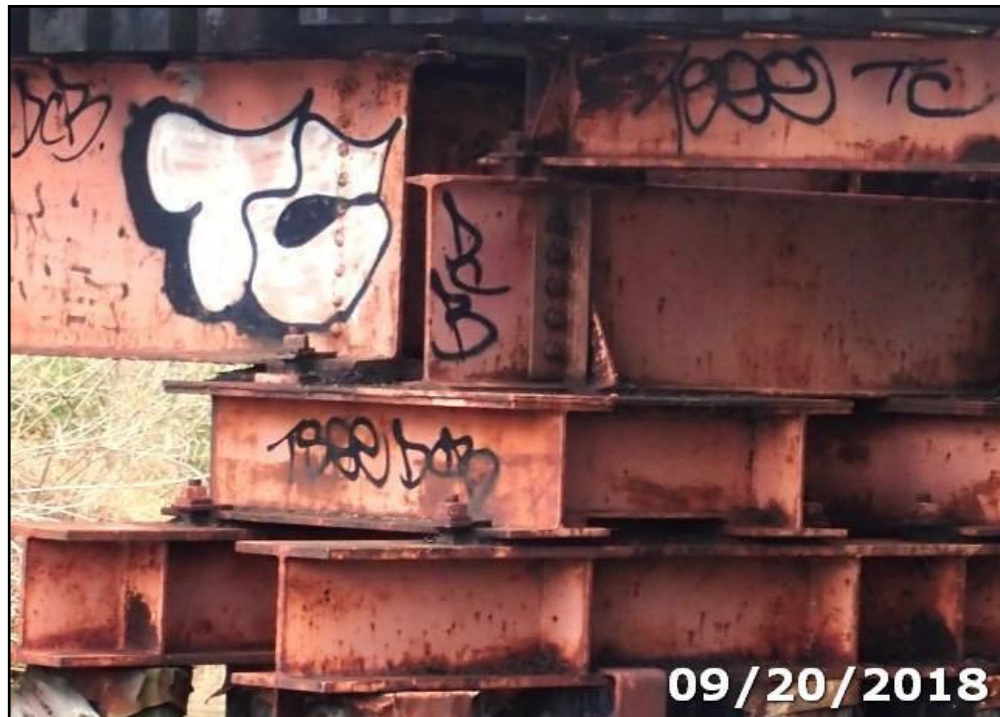
**Photo 06:** There is graffiti on the steel beams.

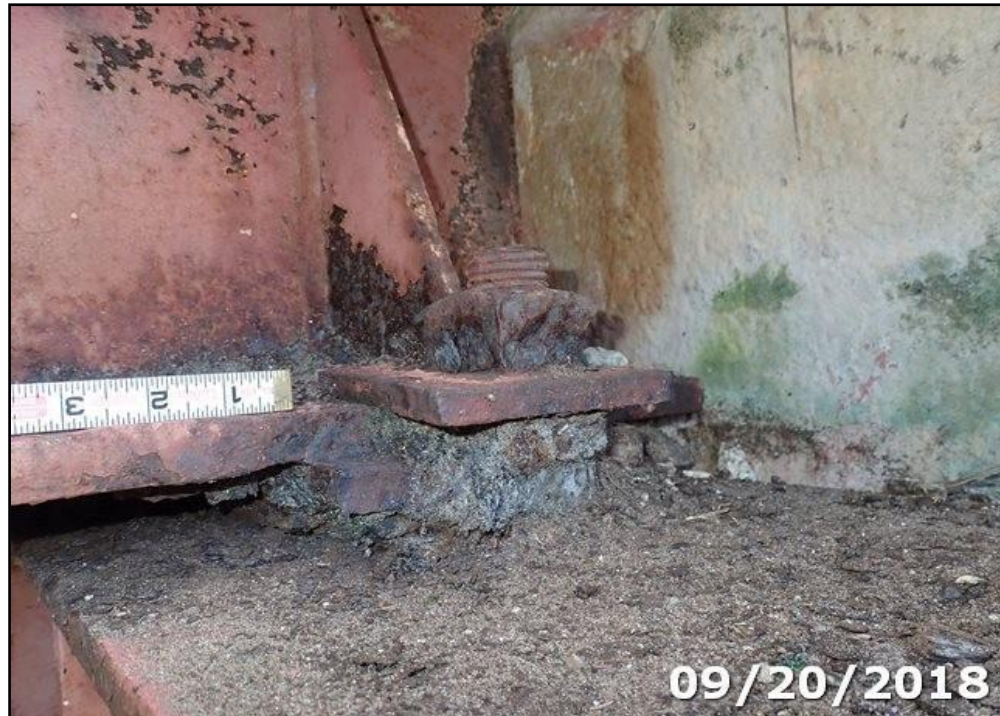
1. The bearing plates and anchorage hardware have severe corrosion with section loss up to 50%. **See Photo 07.**

**Photo 07:** Typical corrosion with section loss up to 50% on the bearing plates and anchorage hardware.

\_Clean and coat corrosion on bearing plates and anchorage hardware. Photo 07.

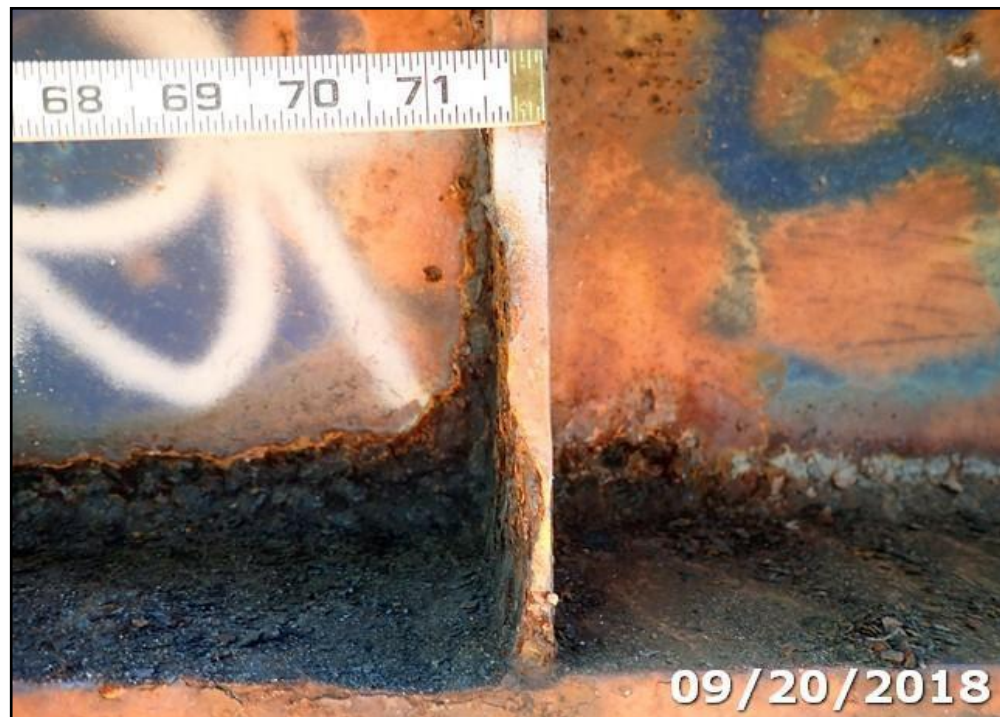
1. The steel caps exhibit moderate to severe corrosion, having areas of up to 40% section remaining at webs, bottom flanges and stiffeners. **See Photos 08 and 09.**
2. The pier caps exhibit graffiti on the north and south faces. **See Photo 08.**

**Photo 08:** Severe corrosion with up to 40% section remaining on the steel pier caps. There is graffiti on the faces of the pier caps. Shown Pier cap 2, north face.

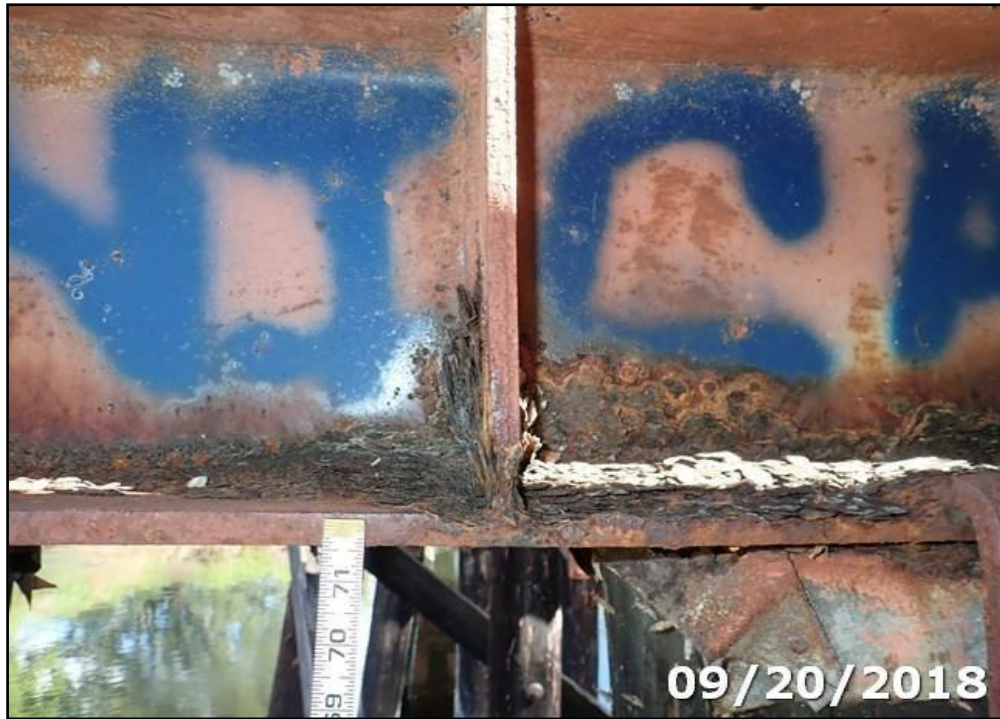
**Photo 09:** Severe corrosion with up to 40% section remaining on the steel pier caps. There is graffiti on the faces of the pier caps. Shown Pier cap 3, south face.

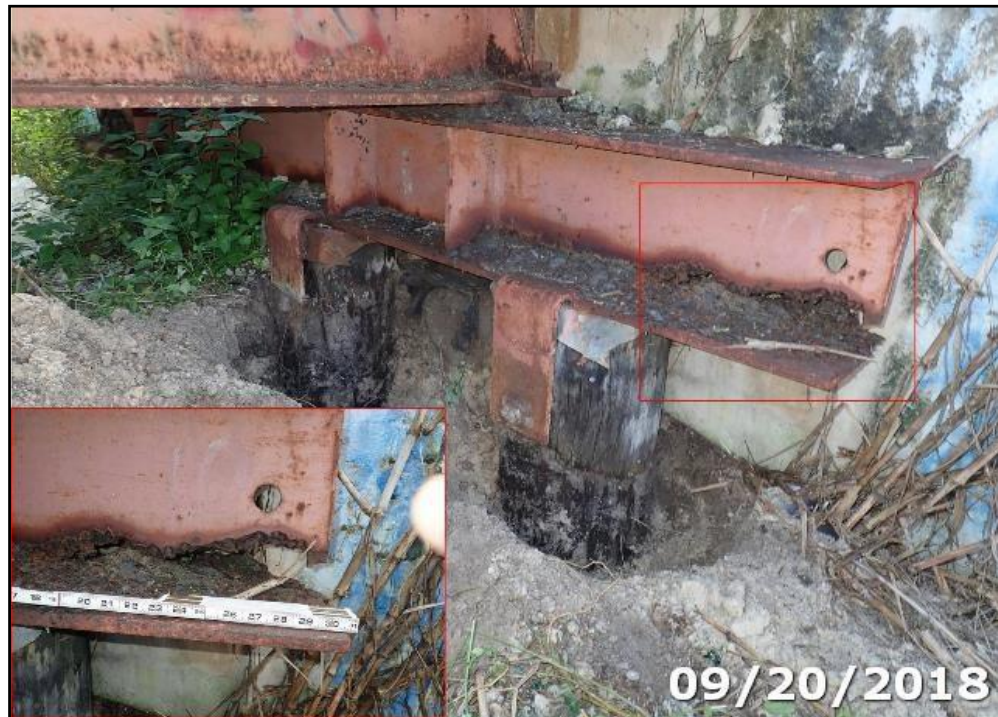
1. The abutment caps exhibit moderate to severe corrosion on the webs and bottom flanges, having areas of section loss up to 100% at both ends. **See Photo 10.**

**Photo 10:** Severe corrosion on the webs and bottom flanges of the abutment caps with up to 100% section loss at the ends.

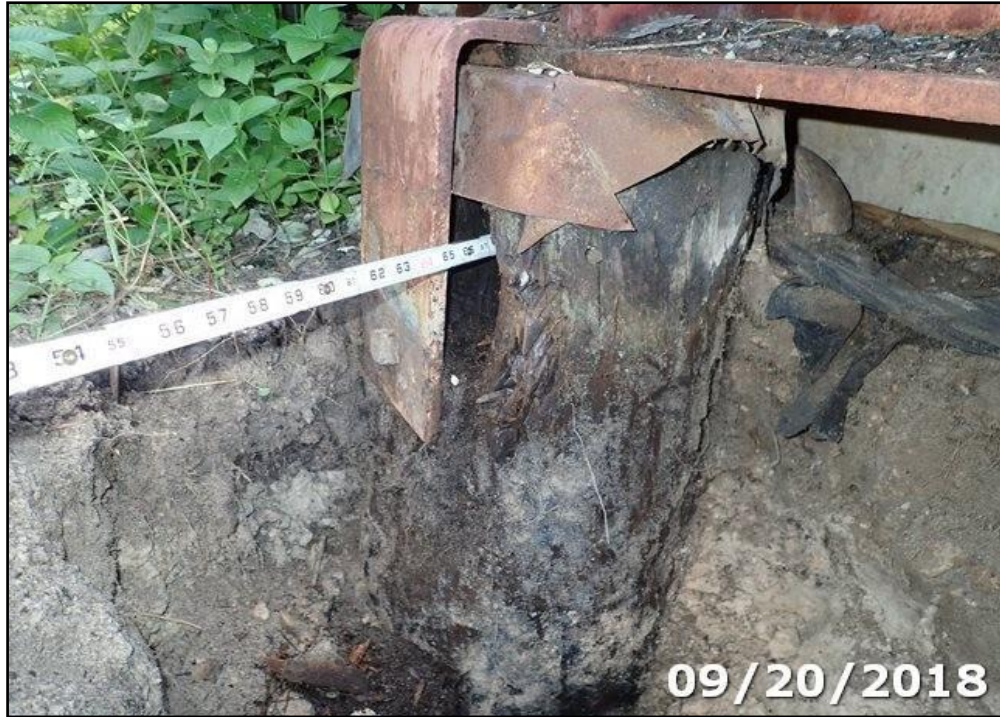
1. Piles 1-2, 2-1, 3-4, 9-1, 9-3, and 10-3 exhibits areas up to 24in. H x 12in. W of severe decay with up to 0% section remaining at the cap. **See Photos 11 and 12.**
2. The timber piles exhibit checks and splits throughout, and decay with soft areas below the ground line with up to 1-1/2in. D. **See Photo 13.**
3. Piles 6-1, 6-3, 6-11, and 6-12 exhibit severe decay and insect activity with up to 20% section remaining, most of them approximately 5ft. below the cap. **See Photos 14 and 15.**
4. The timber piles at Bents 2 and 3 exhibit minor fire damage. **See Photo 16.**
5. The cross bracing members exhibit areas of severe decay with up to 0% section remaining at the bottom ends. Worst cases are located in Bents 3, 4, 5, 6, 7, and 8. **See Photo 17.**

**Photo 11:** Severe decay with section loss at the top of the timber piles. Shown Pile 1-2.

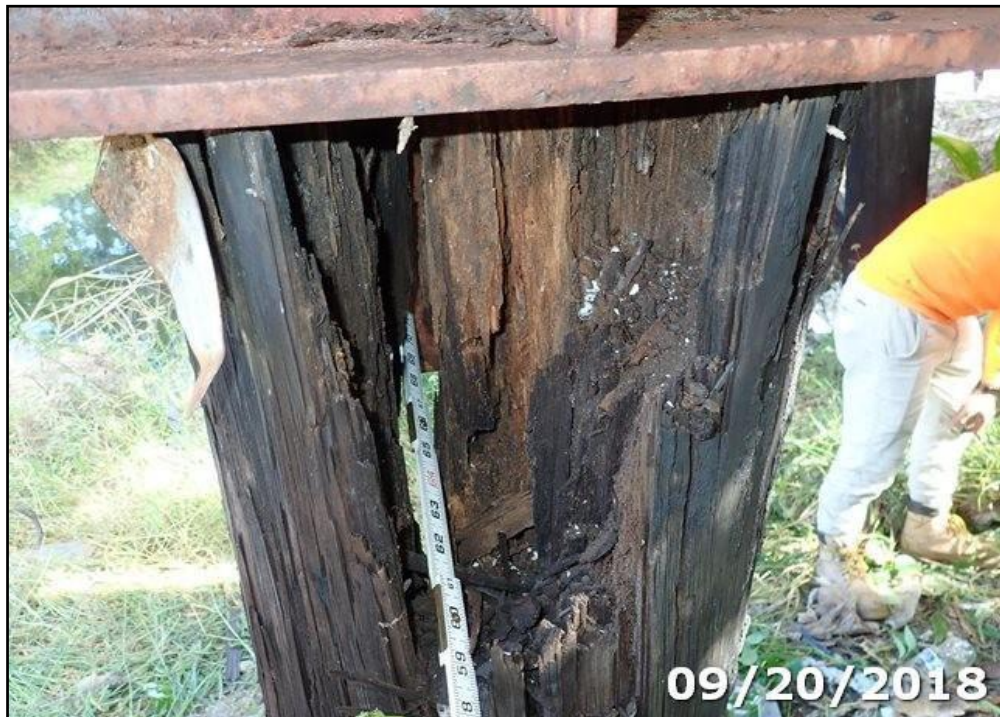
**Photo 12:** Severe decay with section loss at the top of the timber piles. Shown Pile 2-1.

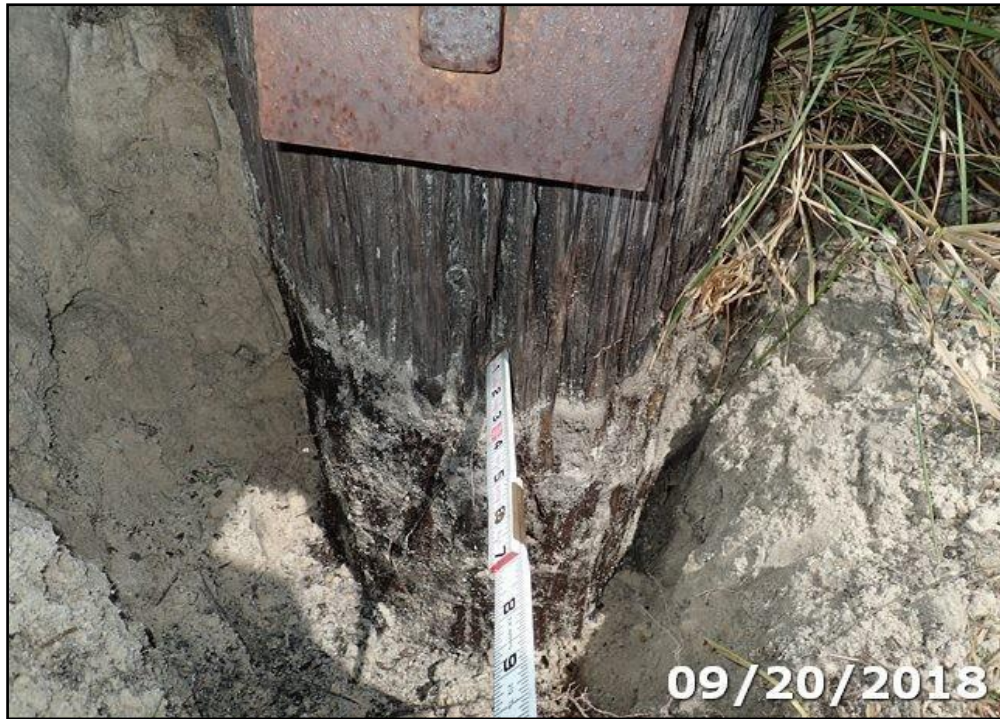
**Photo 13:** The timber piles typically exhibit checks and splits, and below the groundline have decay with soft areas up to 1-1/2in. D.

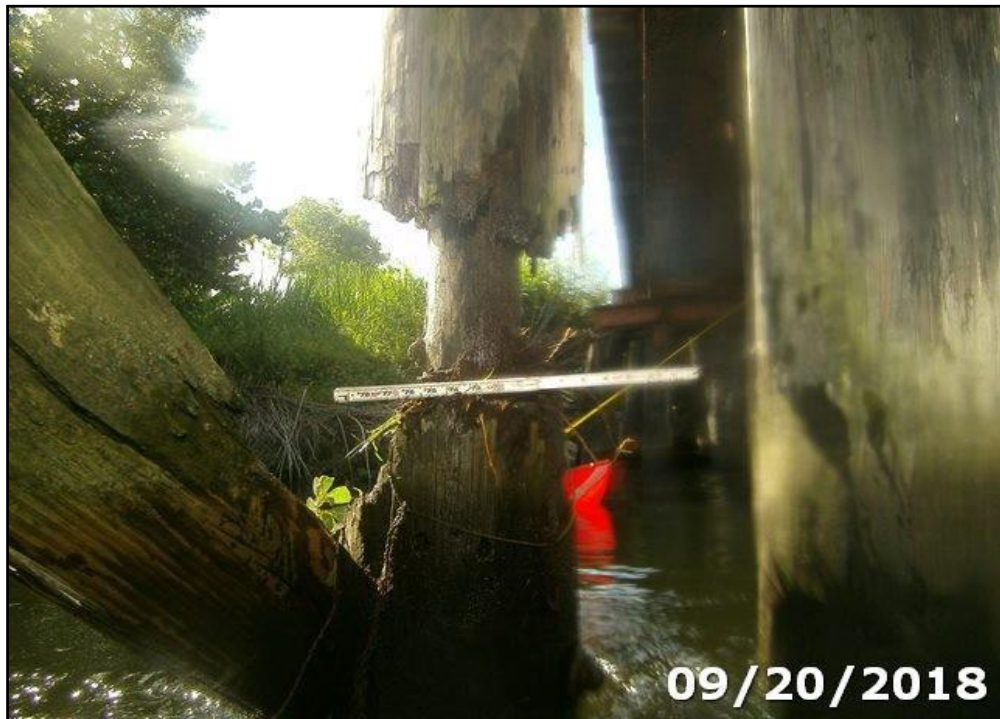
**Photo 14:** Piles 6-1, 6-3, 6-11, and 6-12 exhibit severe decay and insect activity with up to 20% section remaining. Shown Pile 6-1.

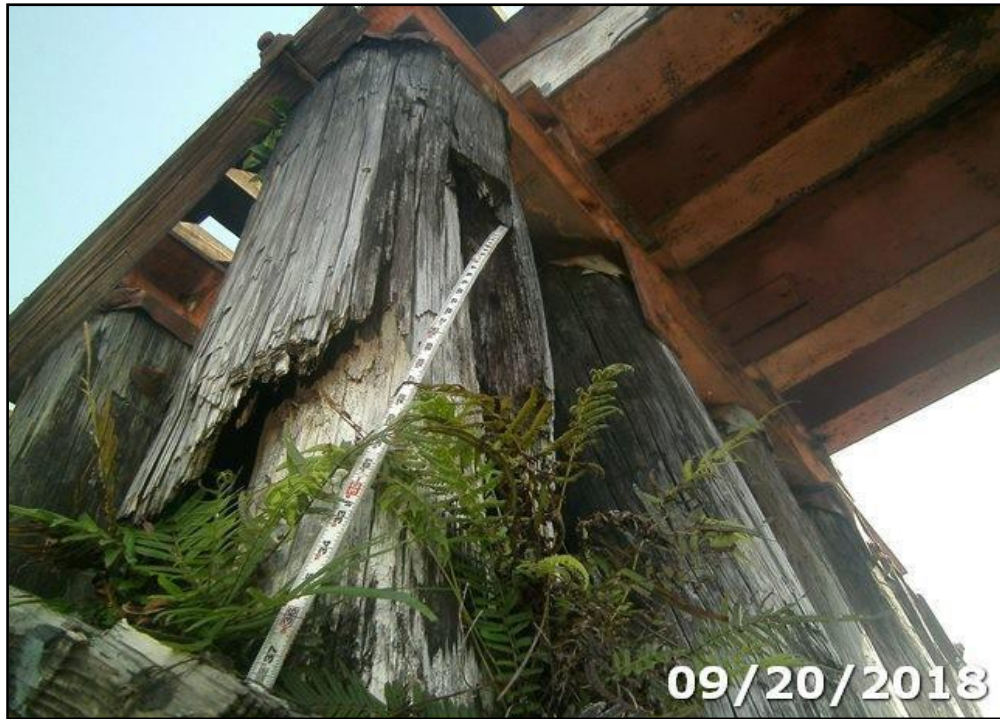
**Photo 15:** Piles 6-1, 6-3, 6-11, and 6-12 exhibit severe decay and insect activity with up to 20% section remaining. Shown Pile 6-11.

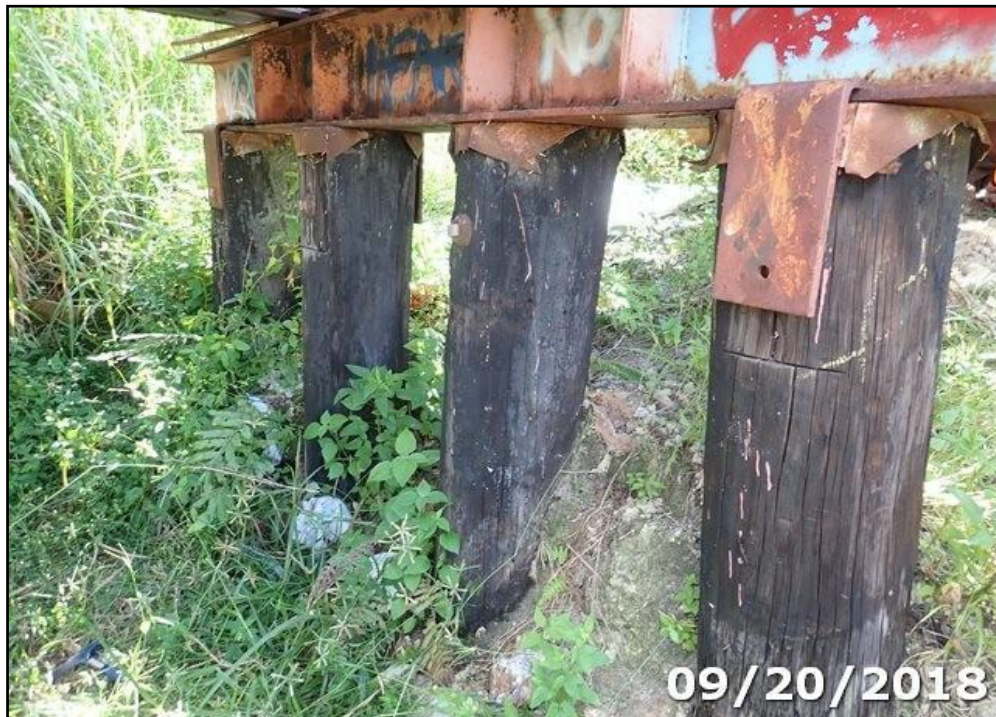
**Photo 16:** The timber piles at Bents 2 and 3 exhibit minor fire damage.

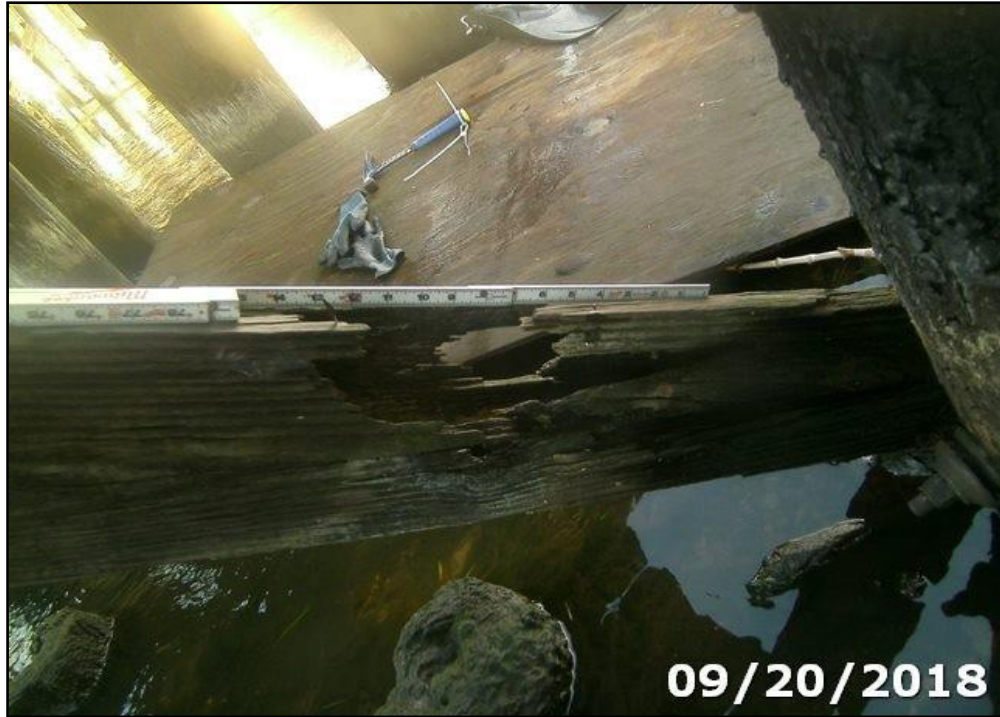
**Photo 17:** The cross bracing members exhibit areas of severe decay with up to 0% section remaining at the bottom ends.

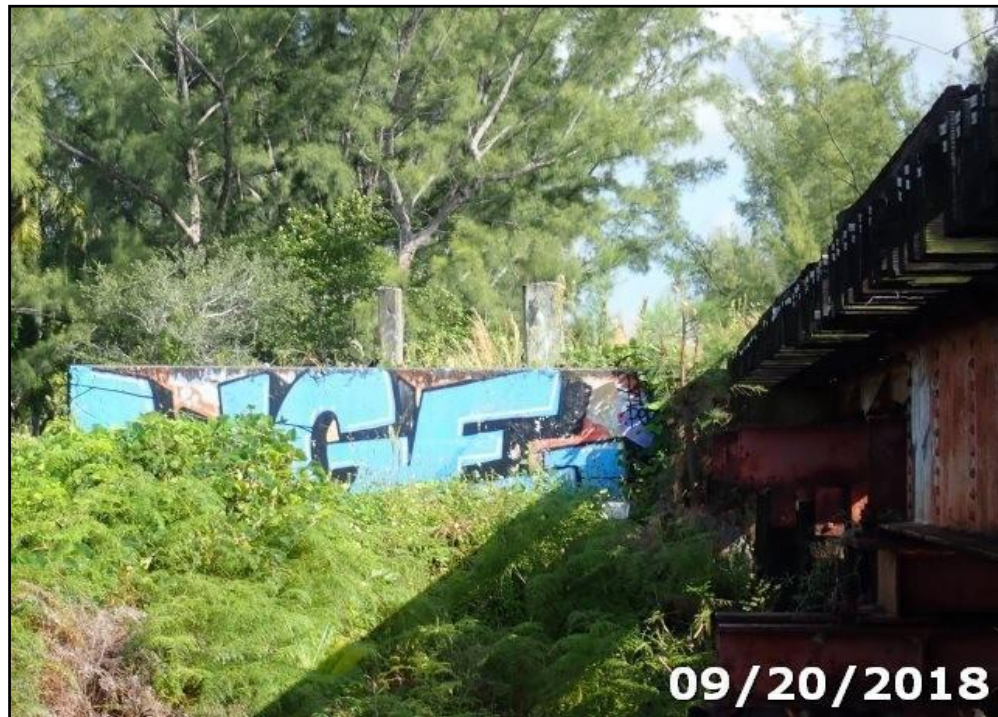
**Photo 18:** Both concrete walls exhibit graffiti throughout.

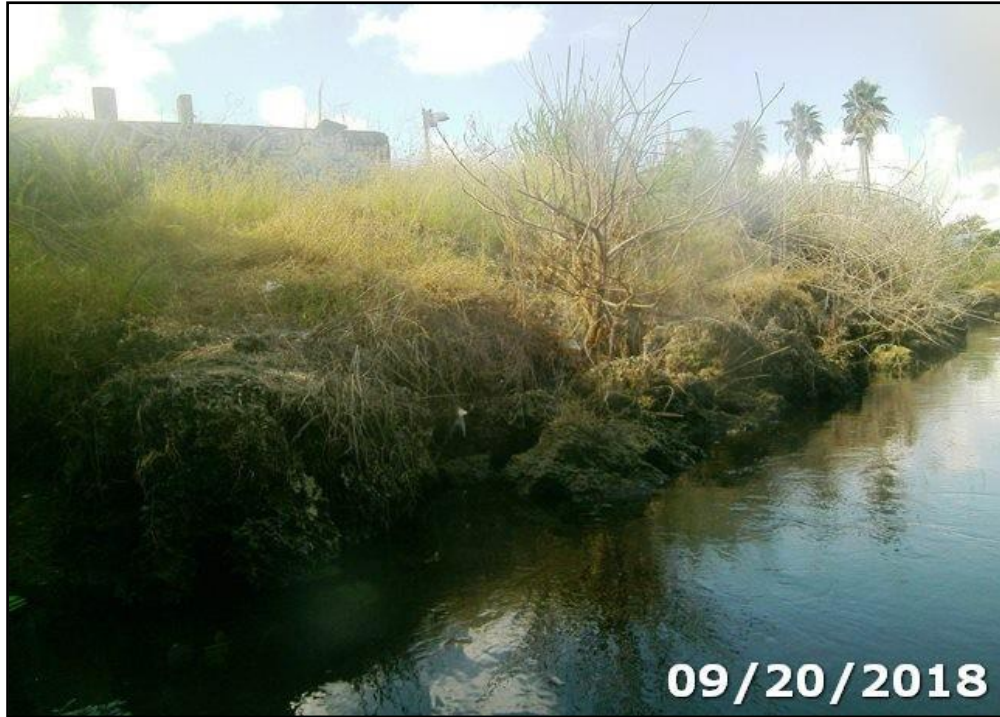
**Photo 19:** The channel embankments exhibit erosion at both sides of the bridge.

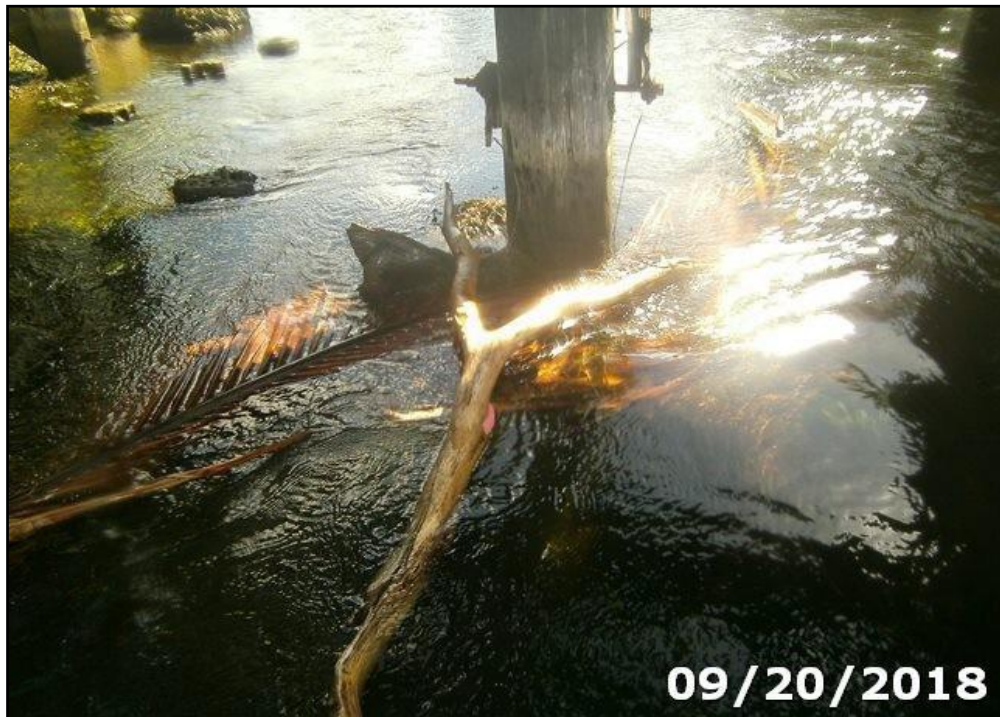
**Photo 20:** There is drift scattered throughout the channel.

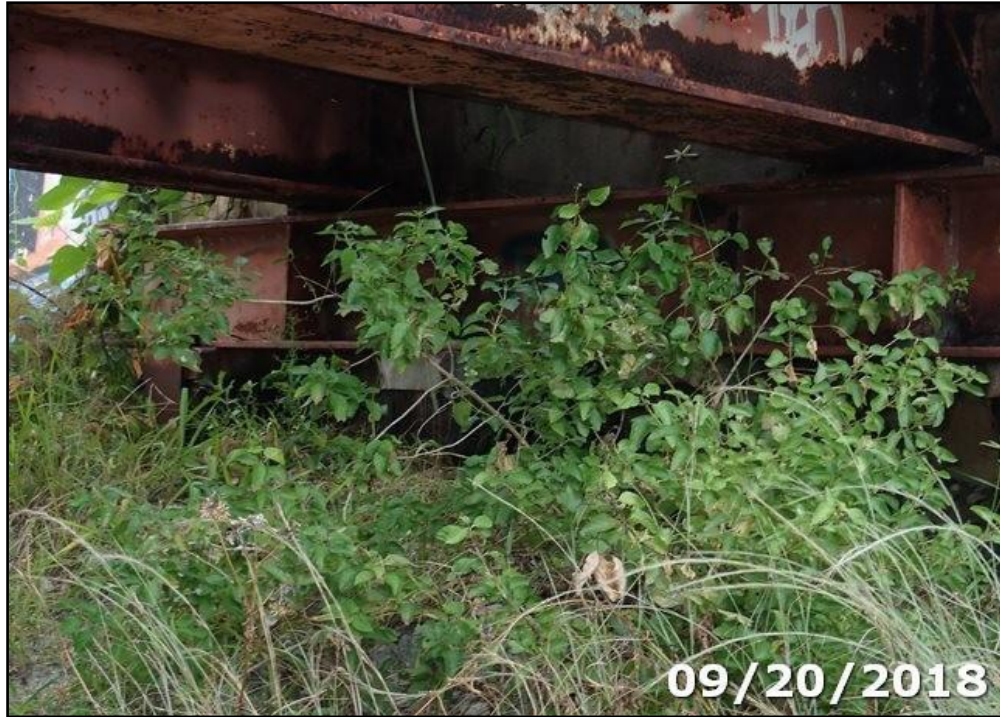
**Photo 21:** Heavy vegetation growth at both channel slopes below the structure.
