Metrobus Fleet Management Plan

Revision II :: January 2005

Miami-Dade Transit
Roosevelt Bradley, Director

MIAMI-DADE TRANSIT AGENCY METROBUS FLEET MANAGEMENT PLAN

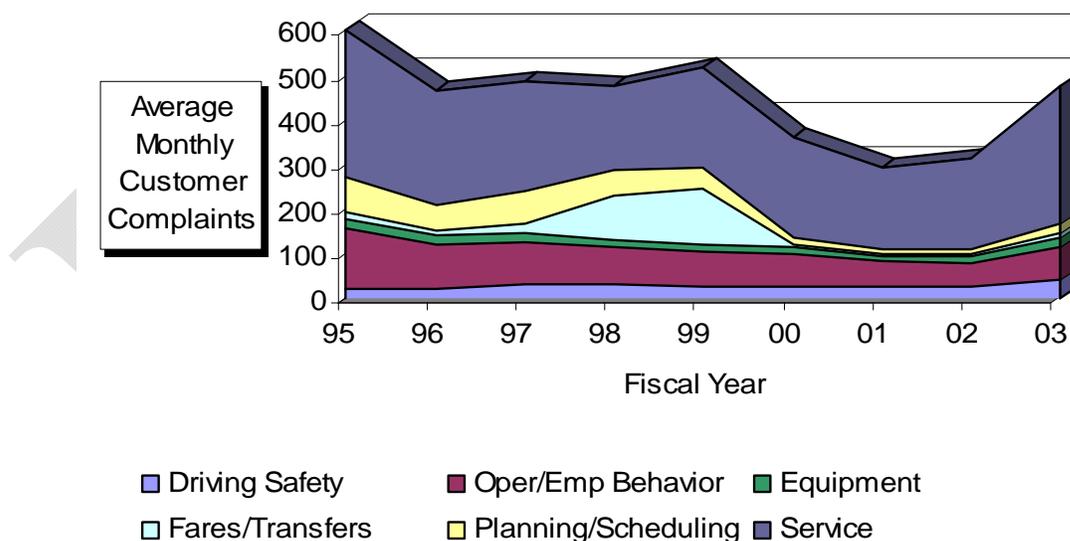
Figure 2-1: Metrobus Average Monthly Customer Complaints

A significant increase occurred in customer complaints during FY 2003 as compared to FY 2000 through FY 2002; although, complaints were actually 8% below FY 1999 levels. Service continues to be the primary customer complaint, while concerns in most other areas have shown some improvement. A graphic representation of average monthly customer complaints from FY 1995 through FY 2003 is presented in Figure 2-1.

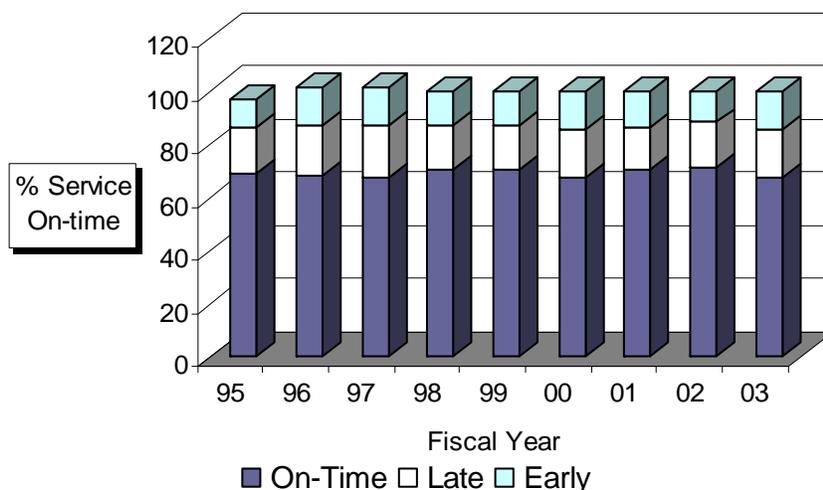
Figure 2-2: Metrobus On-time Performance

On-time performance is critical to customer satisfaction. **On-time is defined as within 0-5 minutes of schedule; late is more than 5 minutes after schedule; and, early is anything before schedule.** The goal for on-time performance for fixed routes is 70%, which Metrobus achieved during five of the last six fiscal years. Metrobus on-time performance for FY 1995 through FY 2003 is illustrated in Figure 2-2.

Metrobus average on-time performance in FY 2003 dipped to 67%, the lowest level reported since FY 2000. The percentage of late departures rose to 18% and the percentage of early departures increased to 15%, the same levels reported in FY 2000. Metrobus schedule adherence from FY 1995 through FY 2003 is presented in Table 2-2.

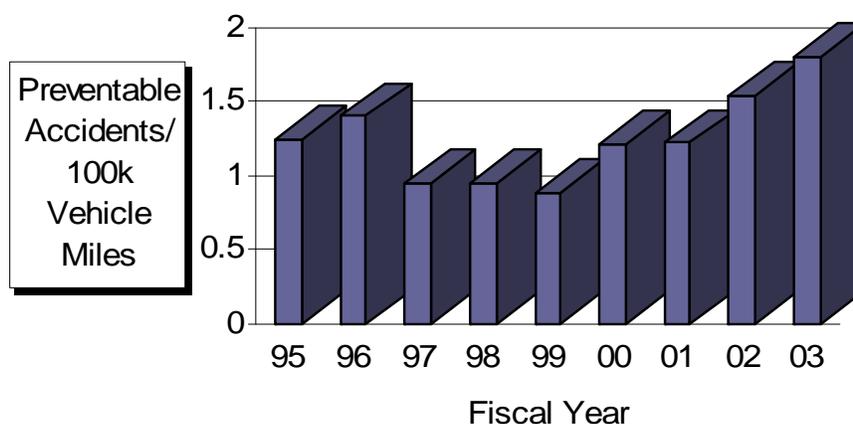
Figure 2-3: Metrobus Preventable Accidents

Figure 2-3 illustrates preventable accidents per 100,000 vehicle miles for a merger of the formerly designated “A” and “B” fleets. Prior to March 2003, separate accident data were maintained for the full-size fleet (“A”) and the minibus (“B”) fleet. The total preventable accident rate (PAR) data have been restated for January - February 2003. In-service revenue mileage was approximated using fleet fueling mileage. A comparison of the MDT preventable accident rate to a baseline average is under development. While caution must be used in interpreting the FY 2003 data, there does appear to be a gradual increase in the MDT preventable accident rate.

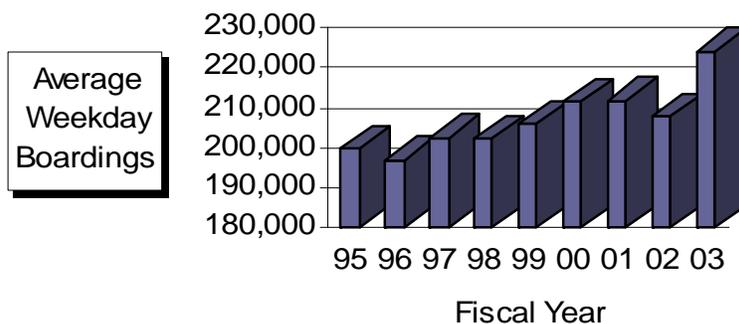
Figure 2-4: Metrobus Average Weekday Boardings

General ridership growth is evaluated using several factors. MDT examines ridership growth in terms of increase in average weekday boardings, which represents the total weekday boardings divided by the number of weekdays. Average weekday boardings from FY 1995 through FY 2003 are illustrated in Figure 2-4.

Average weekday boardings in FY 2003 show an increase in FY 2002 average weekday boardings of 7.9% and exceed the previous high of 211,863 in FY 2001 by over 12,000 or 5.8%.

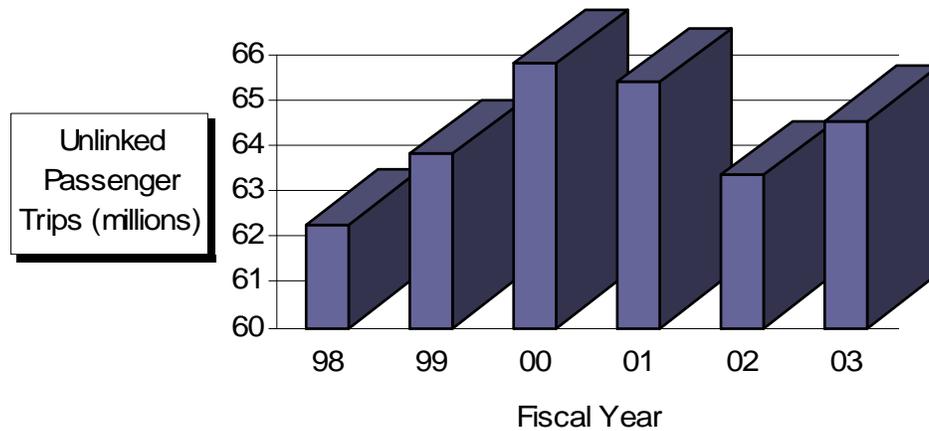
Figure 2-5: Metrobus Annual Unlinked Passenger Trips

MDT also analyzes Metrobus total annual unlinked passenger trips, which are represented in Figure 2-5. Unlinked passenger trips, which appear to have peaked at 65.8 million in FY 2000, fell to 63.4 million in FY 2002 and then rose to 64.6 million in FY 2003, an increase of 1.9%.

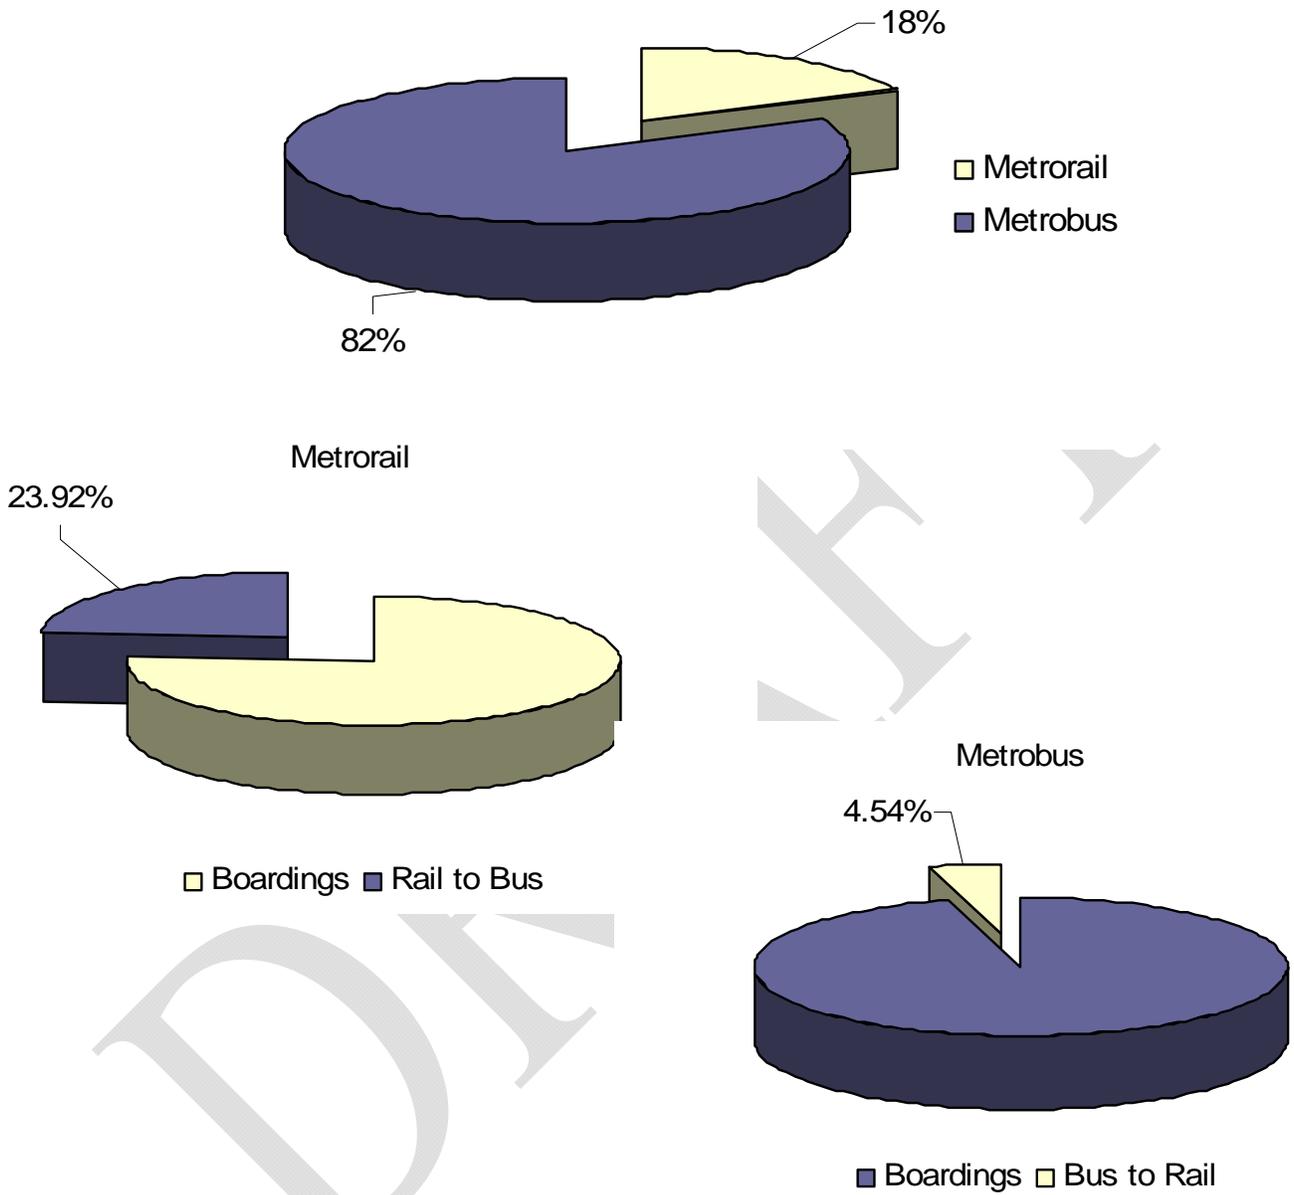
Figure 2-6: Metrobus and Metrorail Boardings & Transfers

In determining general ridership growth, MDT also examines the transfer of Metrobus passengers to and from Metrorail. FY 2003 transfer data show there were 3.4 million Metrorail transfers to Metrobus, accounting for 4.5% of Metrobus passengers, while Metrobus transfers to Metrorail equaled 2.9 million or almost 24% of Metrorail passengers. The flow of passengers to and from Metrorail and Metrobus is displayed in Figure 2-6.

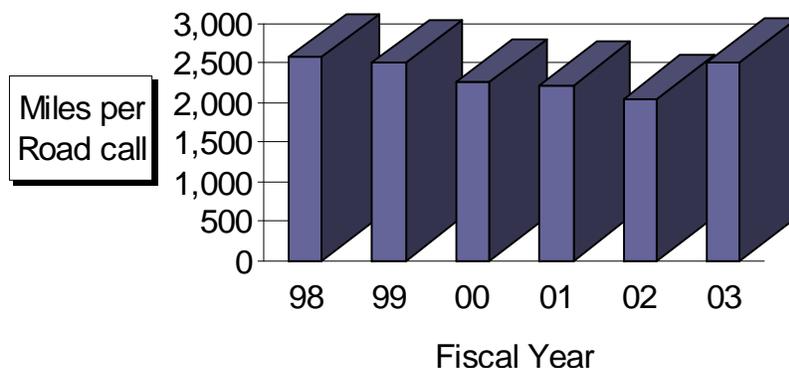
Figure 2-7: Average Miles per Mechanical Road Call

The average miles between failures for full-size buses, as illustrated in Table 2-9 and Figure 2-7, is a ratio of miles operated to the number of failures during the period and is calculated by dividing the number of mechanical roadcalls (resulting in service interruptions) by the number of bus vehicle miles. A "road call" is defined as a mechanical revenue service interruption of five (5) minutes or more. The measure is an overall indicator of the combination of failures, maintenance program, and execution.

The reliability of the full-size buses within the Metrobus fleet, as measured by the average miles per mechanical road call, is approaching the highest level for the total fleet, which was recorded in FY 1998, and appears to be driven by the positive performance of the new NABI buses. Maintenance planning for overhauling components has been implemented to improve reliability of various components and vehicles.

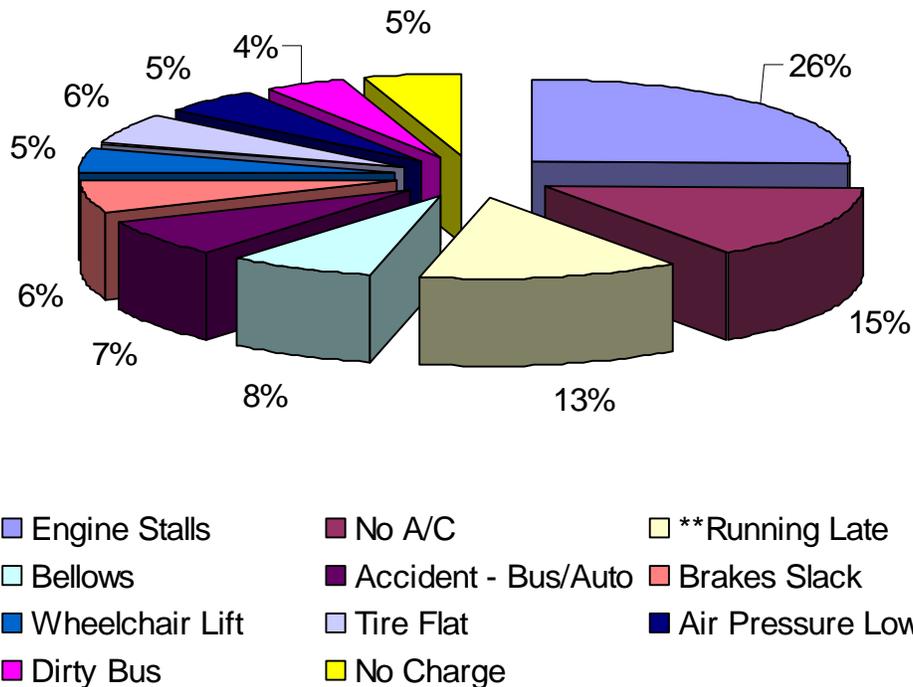
Figure 2-8: FY 2003 Service Interruption Road Calls

The extremely hot and humid weather of South Florida continues to have an adverse impact on the bus engine (26%) and A/C system (15%); nonetheless, interruptions due to buses running late (13%), accidents (7%), and flat tires (6%) appear to be on the rise as well, as can be seen in Figure 2-8. Improvements made in most equipment areas have been offset by a dramatic increase in engine stalls. This is particularly noticeable in Figure 2-9, which includes service interruption roadcalls due exclusively to equipment failures.

Road call is a mechanical revenue service interruption of 5 minutes or more

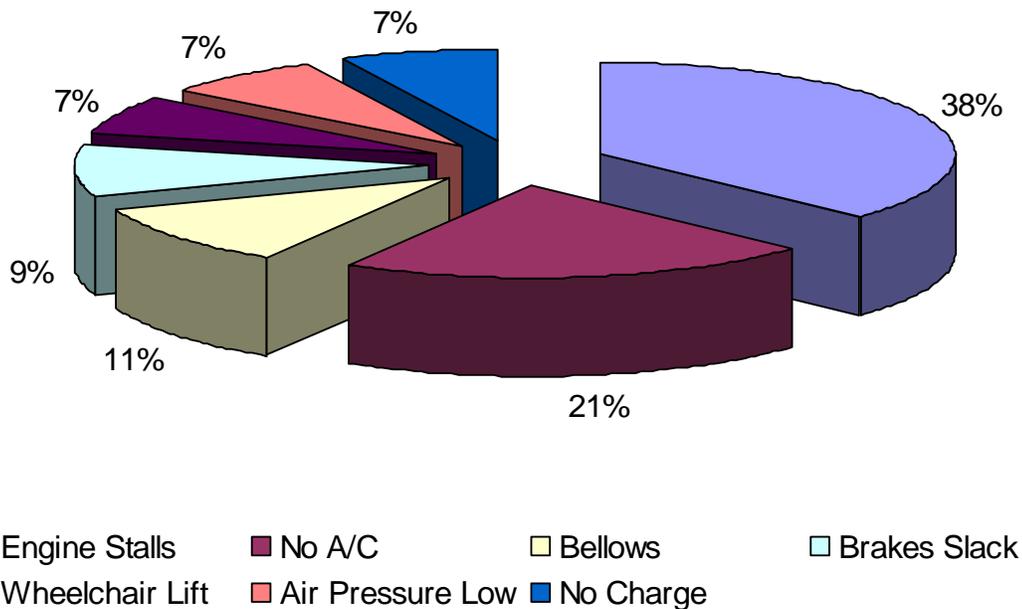
Figure 2-9: FY 2003 Service Interruption Road Calls Resulting from Failures

Road call is a mechanical revenue service interruption of 5 minutes or more
