Subject: Notice of Environmental Contamination in Commission District 5

NOTICE OF VIOLATION AND
ORDERS FOR CORRECTIVE ACTION

Facility Name: MIAMI DADE COLLEGE (FORMER DEPT OF JUSTICE)		UT#: 4657	File #: 12045
Facility Address: 35 NE 2 ND ST. MIAMI, FL	Zip Code: 33132	DEP#: Not available	
Inspector: CARLOS LINCHETA	Type of Inspection: REQ	Inspection Date: 01/14/2014

STORAGE TANKS
Facility Site Diagram

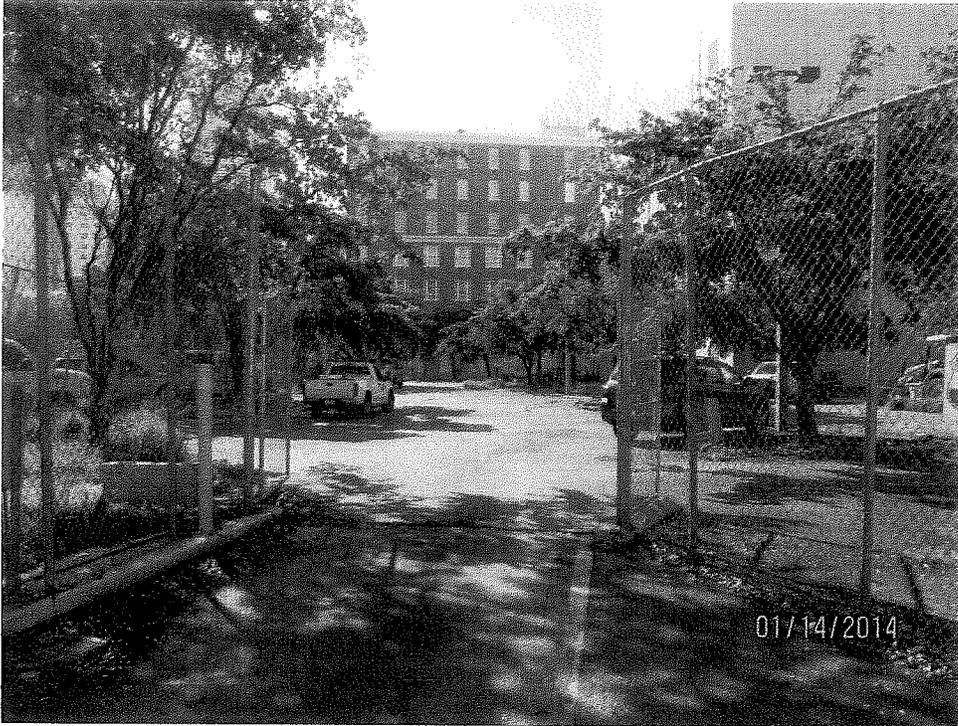
East entrance through NE 3rd ST. Picture taken facing south.

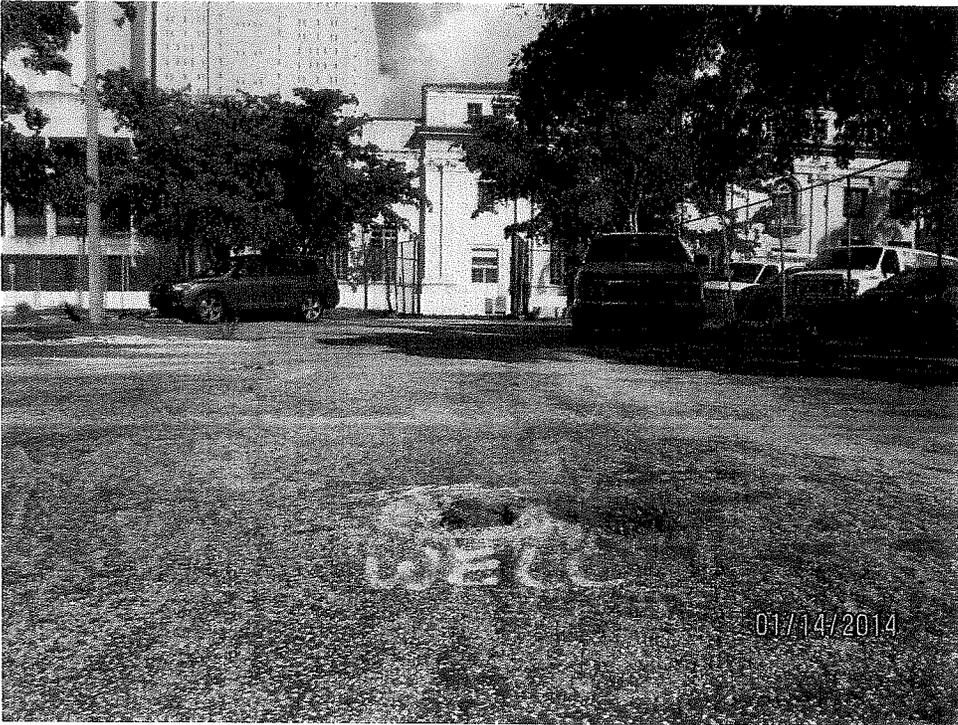
A sample was collected from a monitoring well located approximately 45 ft south of the northern property line (see site diagram). The presence of a thick petroleum base product was detected when a sample was taken from the well. Sample was collected and taken to the laboratory for analysis, blue card number is 29551.
See pictures attached.

Monitoring well is located approximately 45 ft south of entrance. Picture taken facing north.

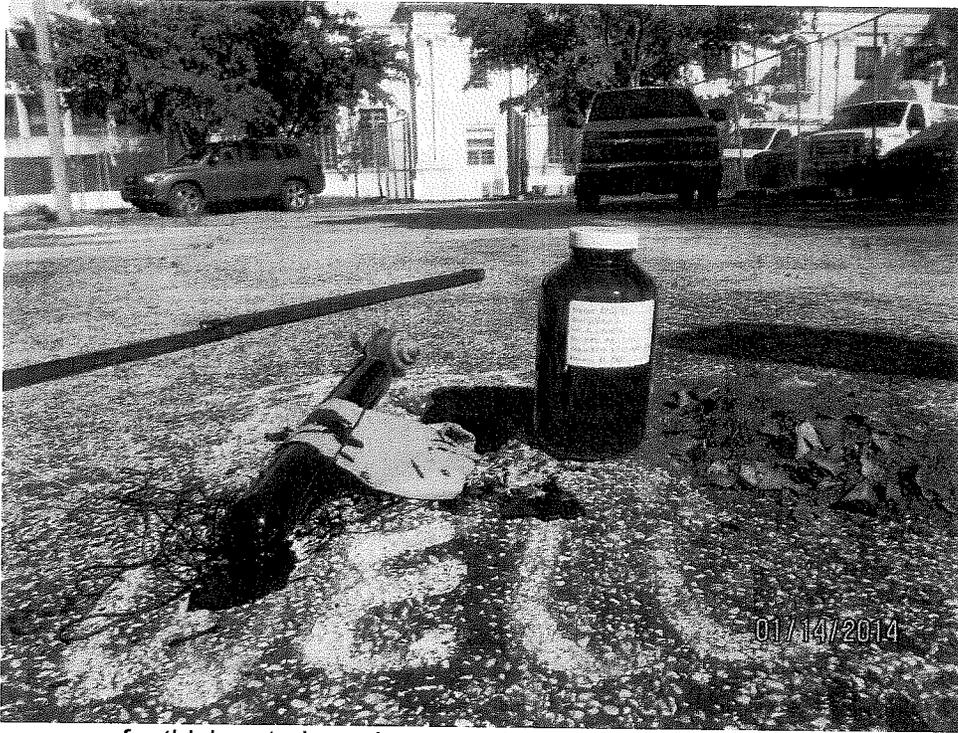
The presence of a thick petroleum base product was noted inside the monitoring well.

2. Within twenty-four (24) hours of receipt of this NOTICE, commence emergency response, including but not limited to free product removal, or interim source removal, as applicable, in accordance with Chapter 62-780.500, Florida Administrative Code (F.A.C.).

4. Within thirty (30) days of receipt of this NOTICE, conduct soil investigation, in accordance with the provisions of Chapter 62-780, F.A.C., to establish the degree and extent of contamination. Based on the current land use, assessment of open ground areas shall include an evaluation the 0-6 inch interval, separate from the remainder of the unsaturated zone. Within sixty (60) days of receipt of this NOTICE, submit two signed and sealed copies of a report including the results of the soil investigation to Wilbur Mayorga, P.E., Chief, Environmental Monitoring & Restoration Division, Miami-Dade County DERM, 701 NW 1st Ct, 4th floor, Miami, FL 33136.
