Subject: Notice of Environmental Contamination in Commission District 9

Subject: Zoo Miami (HWR#802/File-11706) facility, located at, near or in the vicinity of 12400 SW 152 St.,
(Folio # 30-5936-000-0050) Miami, Miami-Dade County, Florida.

Zoo Miami
 12400 SW 152 Street
 Inspection Date: 10-3-14
 DERM Staff: Didier Camacho / Eddie Gonzalez / Roosevelt Jean

Inspection Date: 10-9-2014

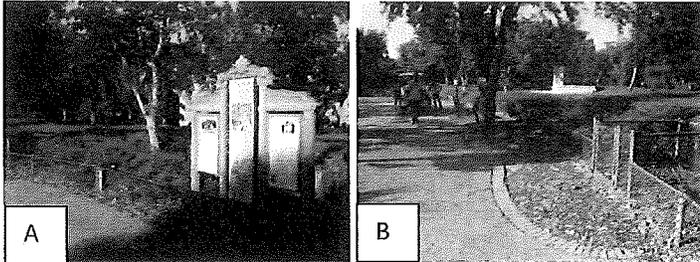
Area A – Tiger Exhibit (GPS: N25.60999 W080.39885)

Pursuant to PROS this Exhibit is popular with park patrons. Open ground areas had approximately 4 inches of mulch around the landscaping and benches. No evidence of surficial solid waste was noted.

- A. View of the Tiger Exhibit Area.
- B. View of open ground area along said exhibit.

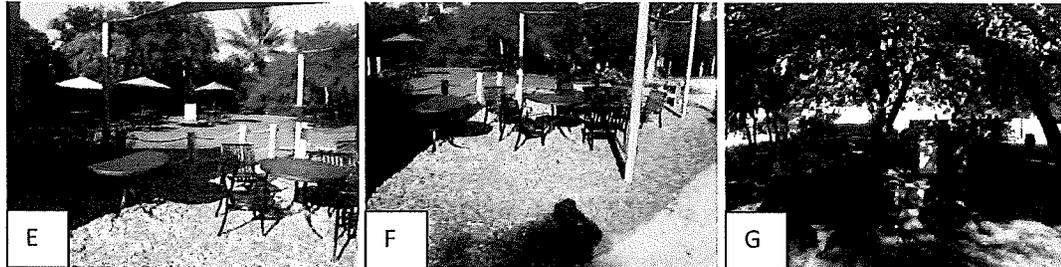
Areas C and D – Oasis Zoo Dining and Playground Areas (GPS: N25.60734 W080.39910) (GPS: N25.68707 W080.39811)

Dining area with picnic tables, benches and playground. Open ground areas had approximately 4 inches of mulch. No evidence of surficial solid waste was noted (only incidental trash apparently from park visitors).

E & F View of mulched picnic bench areas.

G. Mulched playground area in the rear of the Oasis Zoo Dining

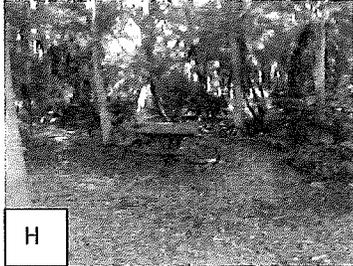
Area E – Black Rhino Exhibit Picnic Area (GPS: N25.60347 W080.40012)

Pursuant to PROS this Exhibit is popular with park patrons. Open ground areas had approximately 4 inches of mulch around the landscaping and benches. No evidence of surficial solid waste was noted.

H. Mulched picnic bench across Black Rhino Exhibit.

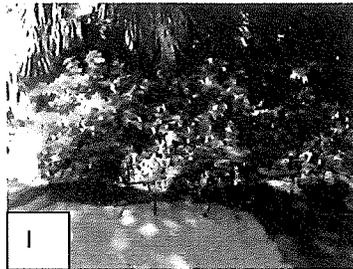
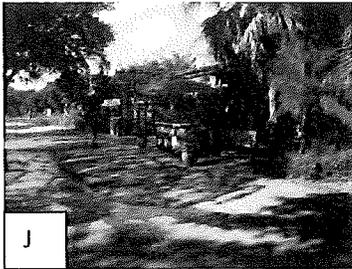
Area F – Giraffe Exhibit Picnic Area (GPS: N25.60465 W080.40167)

Pursuant to PROS this Exhibit is popular with park patrons. Area almost entirely paved. Small areas that contain open ground had no evidence of surficial solid waste.

I. Small picnic area along Giraffe Exhibit.
J. Giraffe Exhibit Area (mostly concrete).

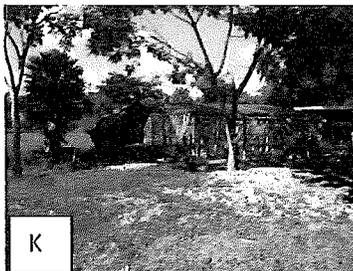
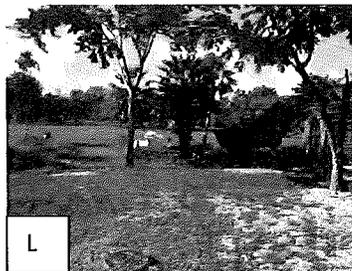
Area G – Ant Eater Holding Cage Area (GPS: N25.60405 W080.39784)

PROS indicated that further construction (expanding the cage area) of this area had taken place. Holding cages have been expanded. Surficial possible melted glass was noted in the same area documented during DERM’s August 8-22-14 inspection. PROS indicated that the park patrons do not have access to this area. DERM to delineate the extent of solid waste during subsequent inspection in this location.

K. Length of the Holding Cage expanded.
L. Open ground area in front of cage where solid waste was noted.

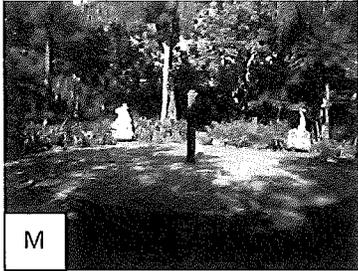
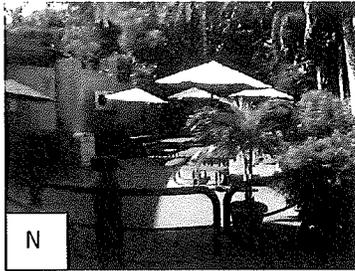
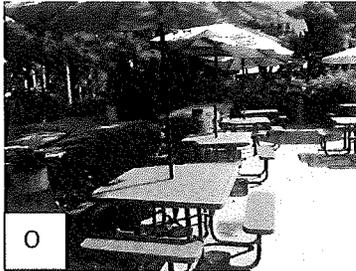
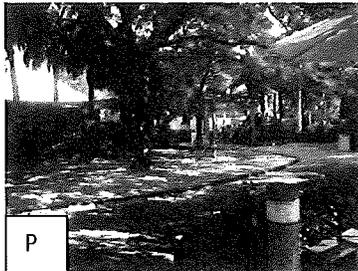
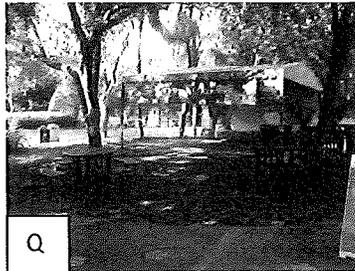
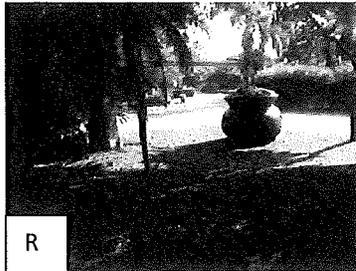
**Areas H and I – Children’s Zoo and Children’s Carousel Area (GPS: N25.61115 W080.40129)
(GPS: N25.2561166 W080.40104)**

Pursuant to PROS this Exhibit is popular with park patrons. Open ground areas had approximately 4 inches of mulch around the landscaping, benches and playground areas/carousel. No evidence of surficial solid waste was noted.

M. Playground Area.
N. Picnic Area.
O. Picnic Area.

P. Carousel playground area.
Q. Mulch playground area.
R. Mulch around golden pot area.

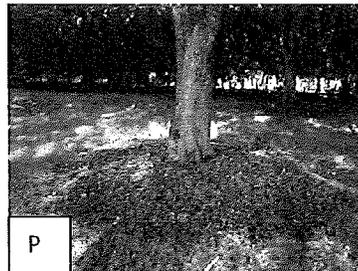
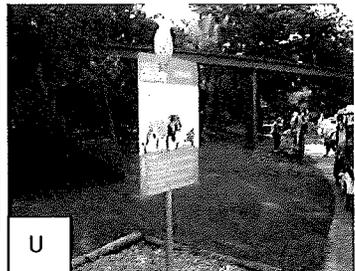
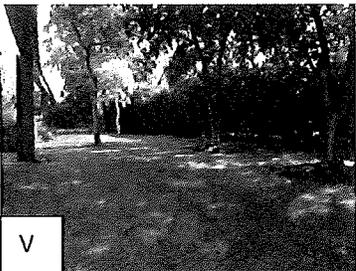
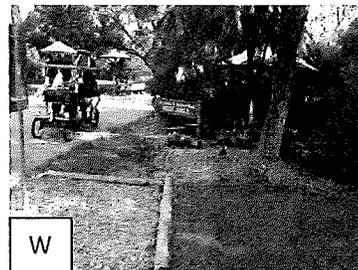
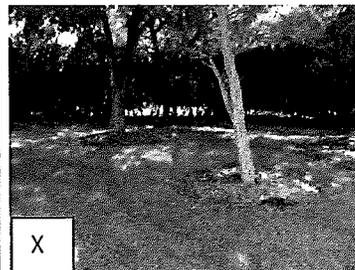
Area J – Lion Exhibit Area (GPS: N25.61087 W080.40229)

Pursuant to PROS this Exhibit is popular with park patrons. Open ground areas had approximately 4 inches of mulch around the landscaping and trees. However, one small piece (0.25 inch) of possible melted glass was noted in the open ground area along the patron walkway at the following GPS coordinate: N25.61049 W080.40296. Said piece of glass was containerized for further inspection by DERM.

P. Mulch around trees across the Lion Exhibit Area.
U. Open ground along patron walkway.
V. Open ground with trees under the monorail.
W. Mulch and open ground along patron walkway.
X. Another view of the mulched trees.

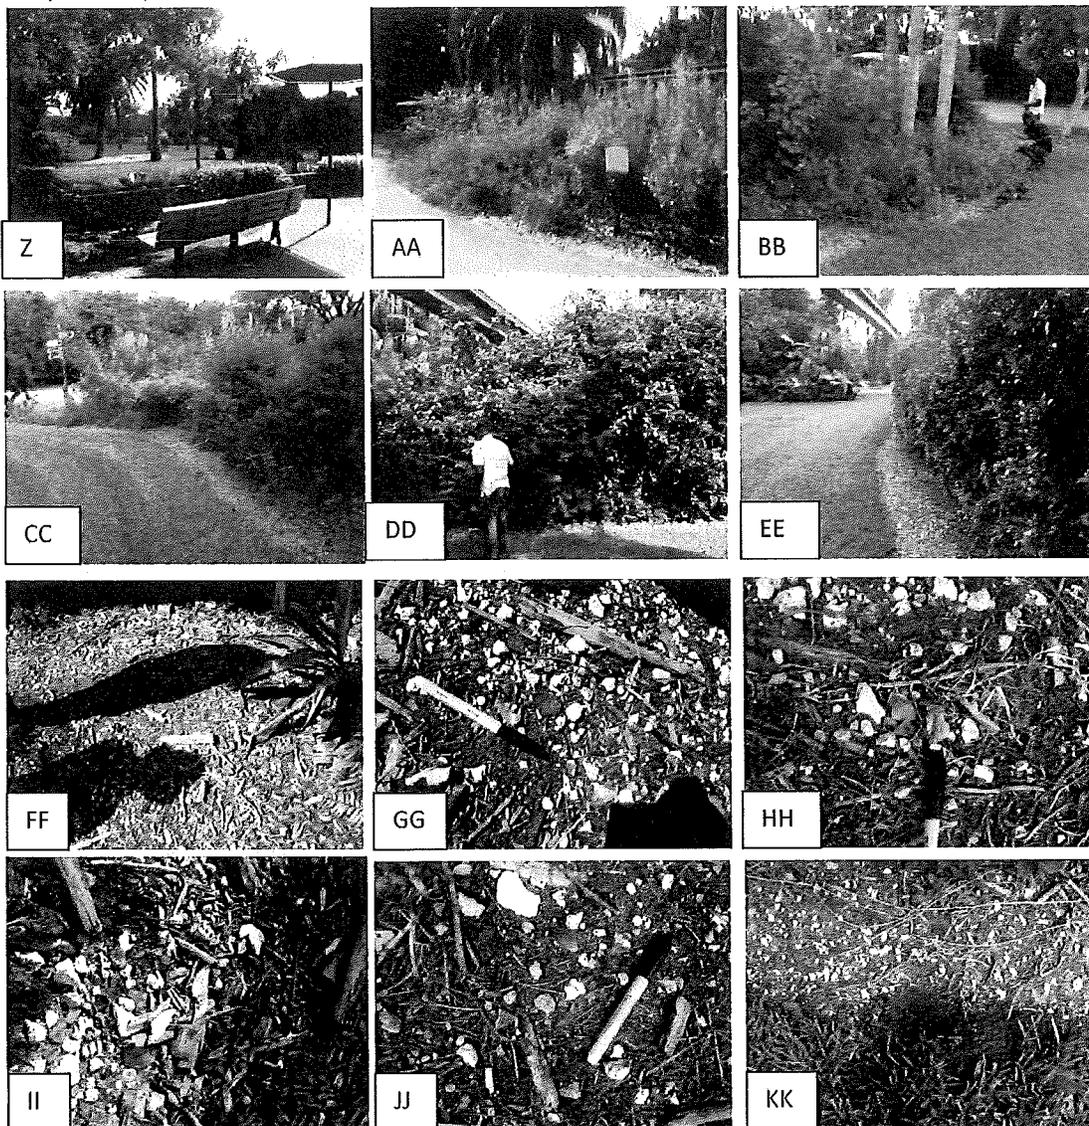
Areas K and L – Camel Exhibit Area (GPS: N25.60892 W080.40319)

Pursuant to PROS this Exhibit is popular with park patrons. Open ground area along the hedge line and bougainvillea plants had less than 0.25 inches of mulch. The landscaped area immediately along the patron walkway had no mulch. Surficial possible melted glass noted in the open ground along the edge of the walkway and along the hedge across the Camel Exhibit. Pieces of roofing shingles also noted along said hedge line.

Two surficial soil samples were collected in said areas for Metals and PAH analysis. GPS coordinates for the soil samples: N25.60887 W080.40312 (edge of walkway) and N25.60891 W080.40336 (hedge line area). Some of the solid waste pieces were containerized for further inspection by DERM.

The surficial solid waste in said area has been horizontally delineated to the following GPS coordinates (triangular shaped area): N25.60867 W080.40323, N25.60924 W080.40327, and N25.60895 W080.40320.

Z. Mulched bench area Camel Exhibit.
AA. Landscaped area along walkway.
BB-EE: Hedge line area containing solid waste.
FF-JJ: Solid waste along hedge line and walkway area
KK: Surficial sample location

To address the elevated copper concentration, DERM requires the immediate implementation of access restriction measures in the area represented by Sample #3 (e.g., construction barrier mesh with appropriately worded warning signage, etc.) to prevent exposure to the contaminated soils. Additionally, within fourteen (14) days of receipt of this correspondence, DERM requires targeted source removal in the immediate vicinity of Sample #3. Please note that to assist PROS, DERM will collect confirmation soil samples subsequent to the source removal area to determine if the impacted soil has been adequately removed. Therefore, Didier Camacho of DERM shall be contacted at 305-372-6700 (camacd@miamidade.gov) at least three (3) days before the commencement of the source removal activities to coordinate the sampling event. Please note that the manifest(s) for the disposal of excavated contaminated soil shall be provided to DERM.

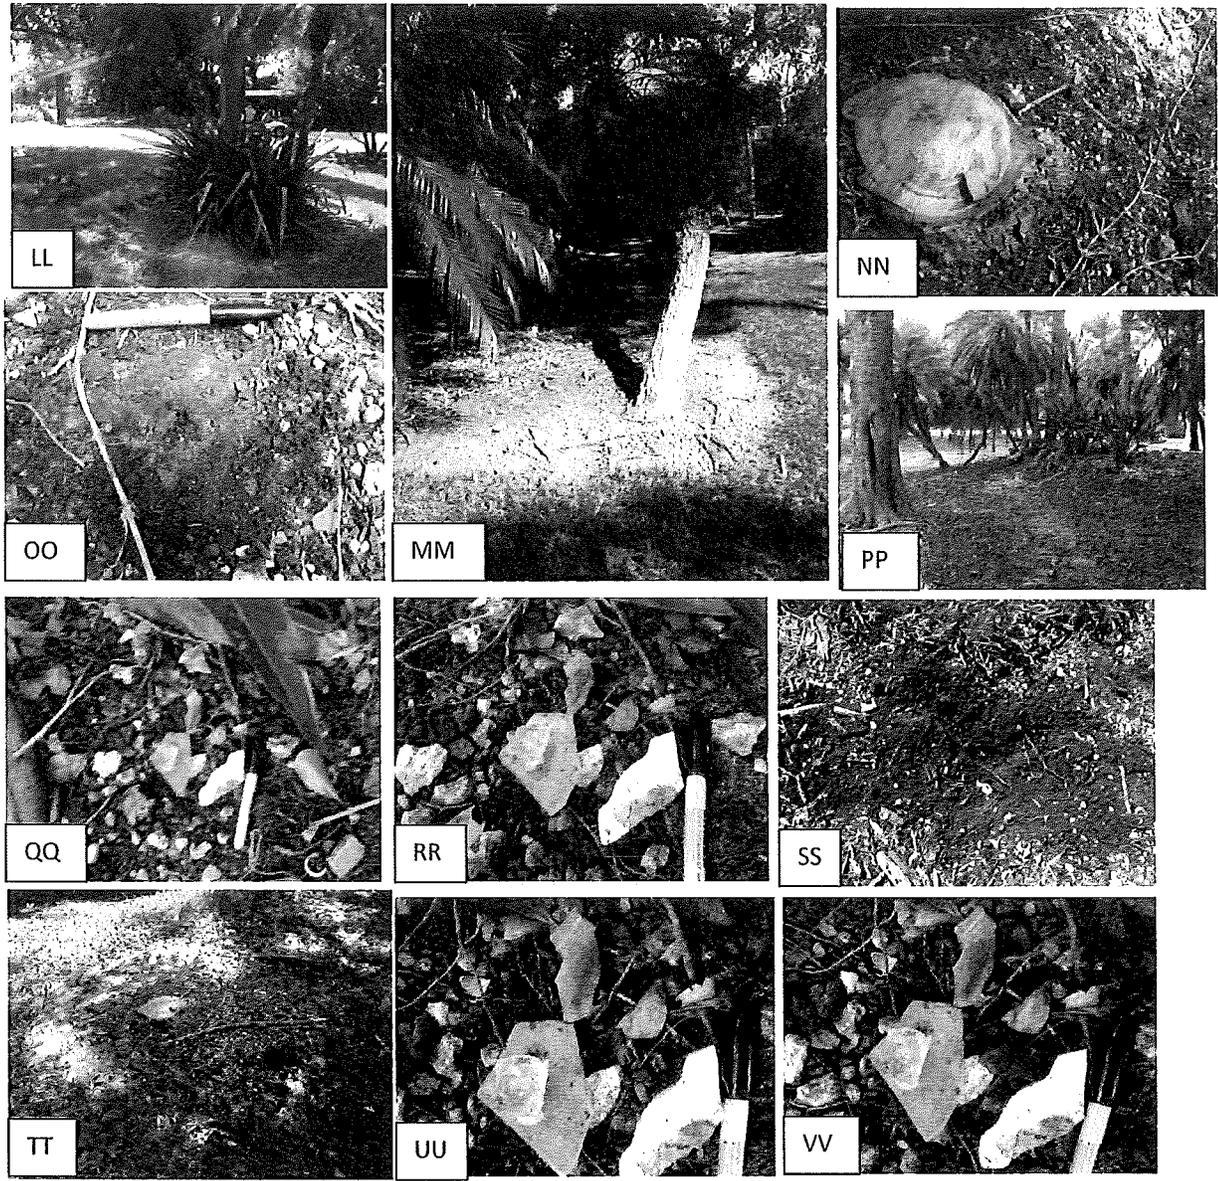
Areas M – Open ground across from Areas K and L

Since solid waste was noted in Areas K and L, DERM inspected the open ground area adjacent to the patron walkway across areas K and L. Several trees and landscaped areas have very little to no mulch. Surficial pieces of melted glass, broken tiles, and metal pieces noted around the base of trees and landscaping areas in the locations noted below.

- Plant 1: N25.608465 W080.40301 – glass around base
- Tree 2: N25.60848 W080.40289 – metal, glass and tile around base
- Tree 3: N25.60847 W080.40287 – glass around the base
- Tree 4: N25.60843 W080.40282 – glass around the base
- Tree 5: N25.60848 W080.40294 - glass around the base
- Tree 6: N25.60855 W080.40288 – glass noted around the base
- Tree 7: N25.60855 W080.40287 – glass noted around the base

LL: Tree#1, MM: Tree#2, NN: Tree#3, OO: Metal Pieces, PP: Lightly mulched area, QQ-VV: Solid Waste

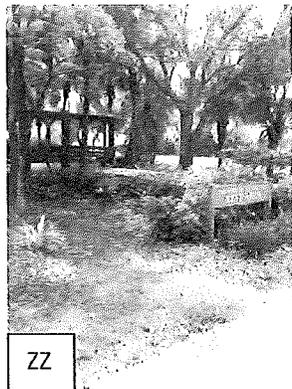
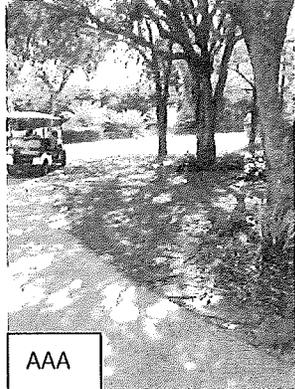
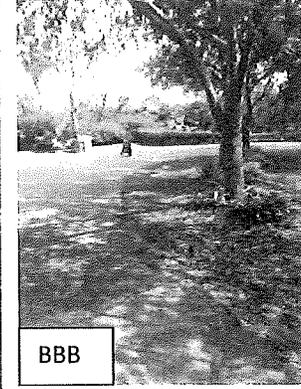
Area N – Gazebo Area across the Spotted Hyena Exhibit

Open ground area along the patron walkway that contains a small walking path leading to a Gazebo/Shelter. Surficial pieces of metal and possible melted glass was noted in the open ground area along the edge of the walkway.

The surficial solid waste in said area has been horizontally delineated to the following GPS coordinates (semi-circle shaped area): N25.60792 W080.40153, N25.60806 W080.40153, and N25.60792 W08040178.

WW-YY: Surficial solid waste
ZZ-BBB: Edge of the open ground area along the walkway where solid waste was noted.

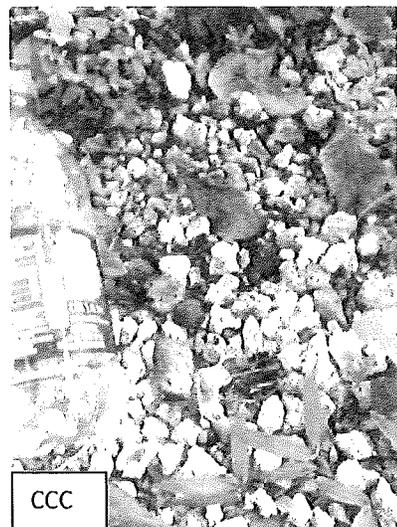
Area O – Mound Area south of Area N (GPS N25.60755 W080.40192)

Open ground area along the patron walkway. Mound containing rocks and soil had possible melted glass. Area is lightly mulched.

CCC: Surficial solid waste noted on the mound area

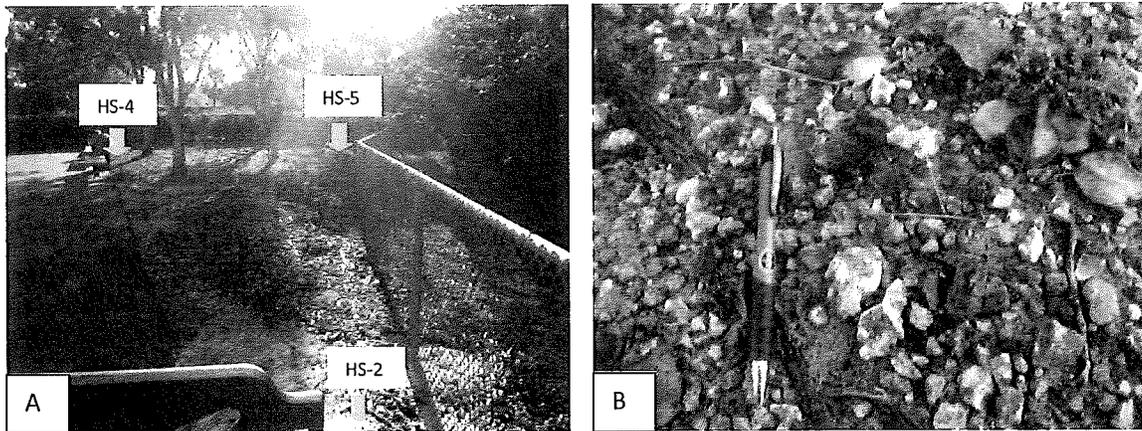
Hippo Slide Area

Surficial solid waste (glass, plastic, metal fragments, etc.) was noted throughout the open ground mulched area to the south of the slide. Said area has several trees, seating benches and is accessible to park patrons. GPS coordinates for the surficial solid waste delineation points were collected:

- A. View of the open ground area south of the Hippo Slide. Approximate locations of the surficial solid waste delineation points noted. Picture taken facing east. Note: Solid waste was discovered in this area from the 6-24" interval from two soil borings advanced during the 7-29-14 inspection. No subsurface delineation conducted.
- B. Example of the surficial solid waste noted in said area.

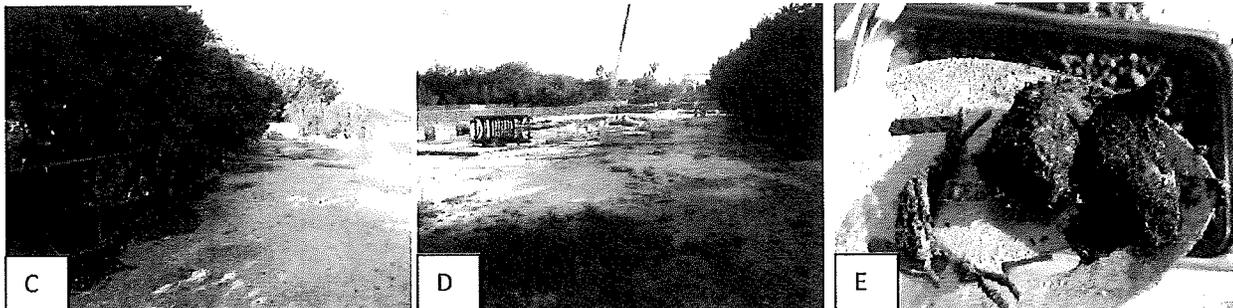
Sand has been placed beneath and around the Hippo Slide. Buried solid waste (glass, wire) was noted in two soil borings advanced in the sand area: HS Sand1(9") (N25.60821 W080.39928) and HS Sand2(1-7") (N25.60827 W080.39958). The depth of the sand at HS Sand1 was 0-5" followed by dark brown soil. The depth of the sand at HS Sand2 was 0-1" followed by black soil.

C. View of sand area facing west.

D. View of sand area facing east.

E. Buried solid waste noted in the sand area.

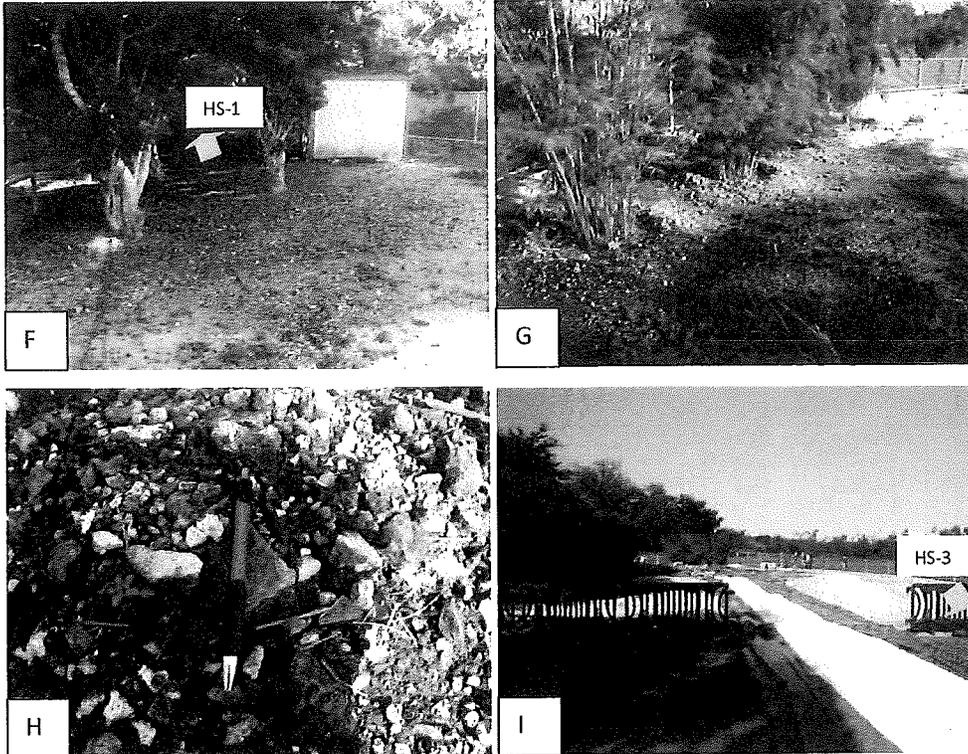
Surficial solid waste was noted in the open ground area and along the bamboo tree line to the west of the Hippo Slide's sandy area. This area appears to have denser amount of surficial solid waste (melted glass, etc.). The area appears to be accessible to park patrons. Subsurface soil borings were not advanced in this area. GPS coordinates for the surficial solid waste delineation points were collected:

- F. Area west of the sandy the Hippo Slide area. Surficial solid waste noted around the trees and wooden shed. HS-1 is located at the western most point of said area.
- G. Bamboo tree line, surficial solid waste noted.
- H. Example of solid waste noted in the areas referenced above.
- I. View of the Hippo Slide area facing west. Approximate location of HS-3 noted.

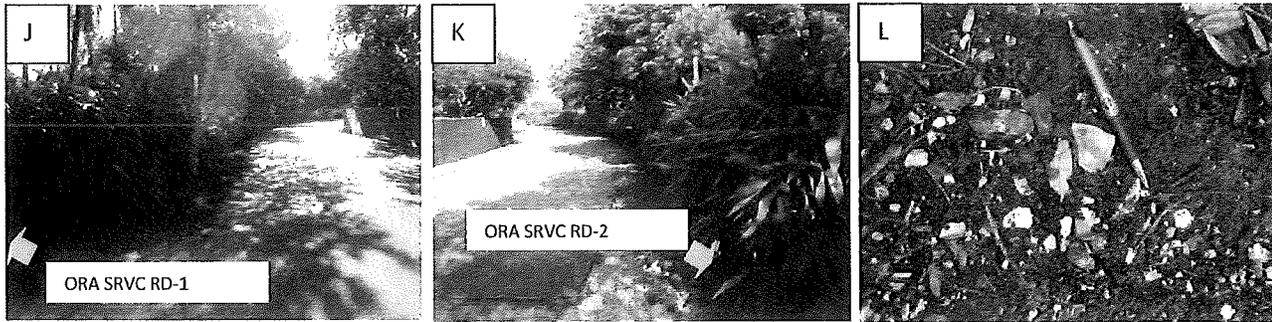
Orangutan Service Road

Surficial solid waste (glass, etc.) was noted mixed with the mulch underneath the vegetation along the service road located to the north of the Hippo Slide area. According to Zoo personnel, this road is called the Orangutan Service Road. GPS coordinates collected in the middle of the area that had the surficial solid waste: ORA SRVC RD - N25.60888 W080.39951. The surficial solid waste delineation points collected at the north and south end of the vegetation line are listed below. Subsurface soil borings were not advanced in this area.

J. View of vegetation area along the Orangutan Service Rd. facing southeast. App. location of the surficial solid waste delineating point noted in picture.

K. View of the vegetation area along the Orangutan Service Rd. facing northwest. App. location of the surficial solid waste delineating point noted in picture.

L. Surficial solid waste noted in said area.

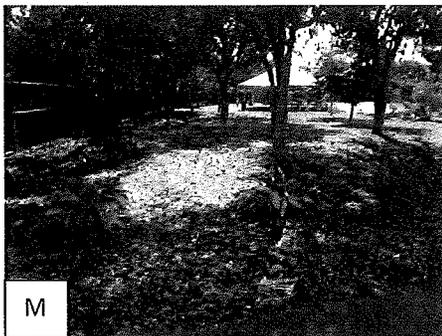
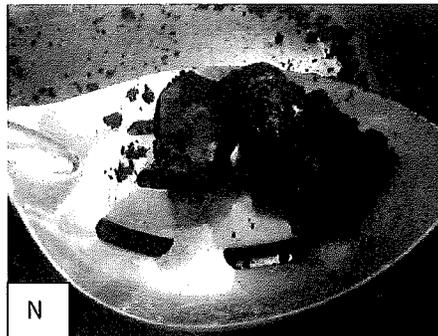
Northeast Corner Picnic Shelter Area: Open ground area is covered with app. 2-4 inches of mulch. Sporadic pieces of surficial and buried solid waste (i.e., tile, glass, plastic) were noted throughout the area and along the surface of young trees. A soil boring was advanced in location MMF-1 (N25.60878 W080.39947) and glass was discovered at the 4 to 6 inch interval bls and a rusted nail and glass was noted at 11 inches bls. Refusal encountered at 13.5 inches bls in said boring. Based on these findings GPS coordinates were collected along the edge of the mulch area to delineate the surficial solid waste.

M. View of the mulched area and picnic shelter on the northeast corner of MMF. Picture taken facing southeast.

N. Solid waste (glass) noted in said area.

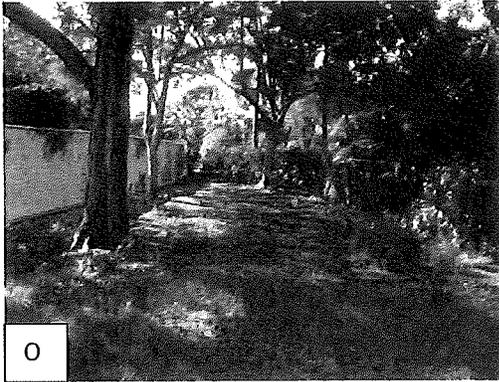
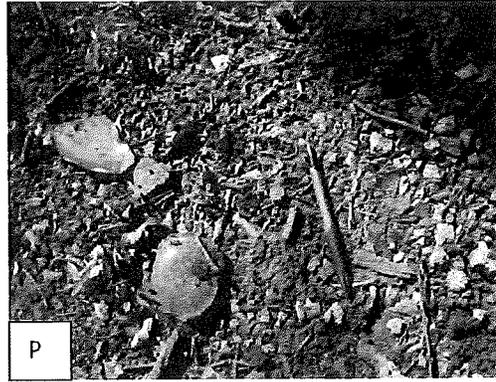
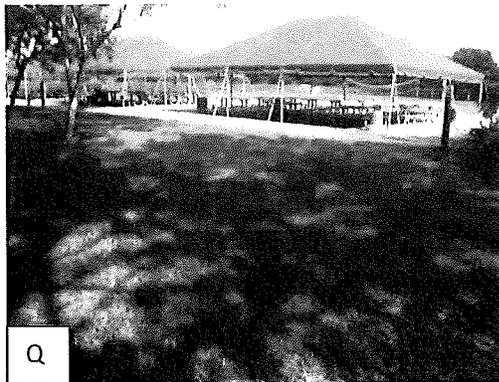
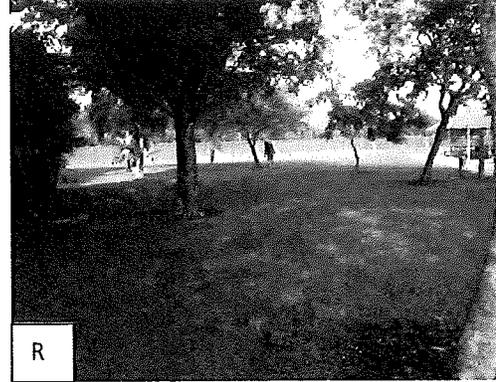
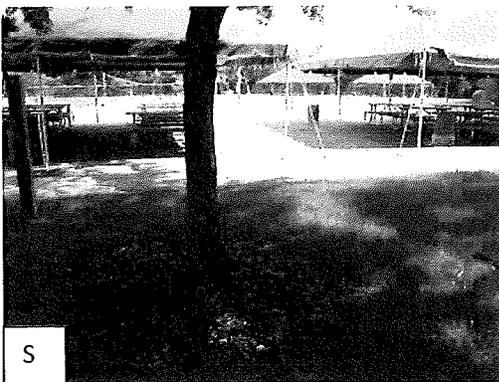
Southwest Corner Picnic Shelter Area: Area is surrounded by grass. Dense area of surficial solid waste was noted to the south of the picnic shelters underneath large mature trees with very little mulch covering. Buried solid waste was noted as six step out borings were collected from said area towards the picnic shelters; thus, subsurface delineation of the solid waste was not achieved in this area. One surficial solid waste delineation point was collected in the southern most tip of the area (adjacent to the fence). GPS coordinates were collected of the points that contained solid waste:

- O. View of area with dense surficial solid waste south of the picnic shelters. Picture taken facing south.
- P. Example of surficial solid waste noted in the area seen in picture O.
- Q. Area to the north where step-out borings were advanced in an attempt to delineate the solid waste in the direction of the picnic shelters.
- R. Tree area south of the picnic shelters.
- S. Tree #1 where solid waste was noted at the base. Picture taken facing north.

- MMF7 – Glass noted at 4'' bls. Refusal: 6'' bls. N25.60801 W080.39981
- MMF8 – Metal and Glass noted at 4-5'' bls. Refusal: 9'' bls. N25.60804 W080.39983
- MMF9 – Tile and Glass noted at 4-7 '' bls. N25.60812 W080.39986
- MMF10 – Melted Glass noted at 0-6'' bls (not surficial). N25.60814 W080.39986
- MMF14 – Melted Glass and Charcoal noted at 12'' bls. N25.60818 W080.39992
- MMF15 – Glass noted at 5'' bls. N25.60819 W080.39996
- MMF Tree1 – Glass noted around tree surface. N25.60820 W080.40002

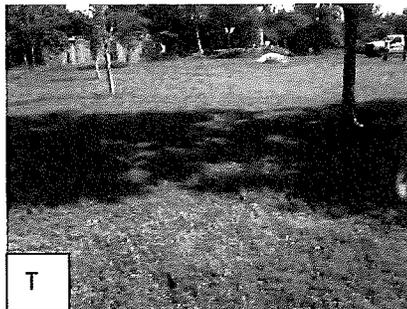
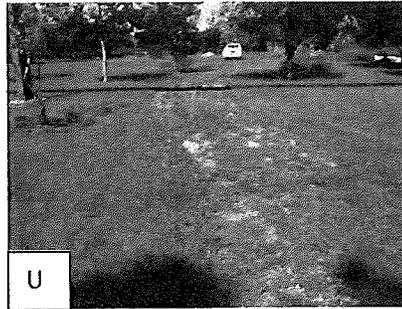
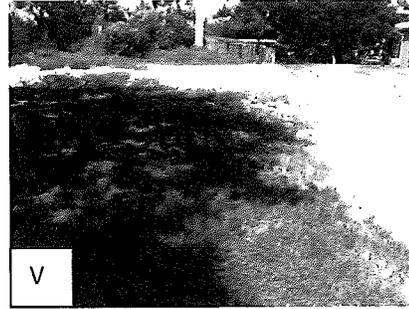
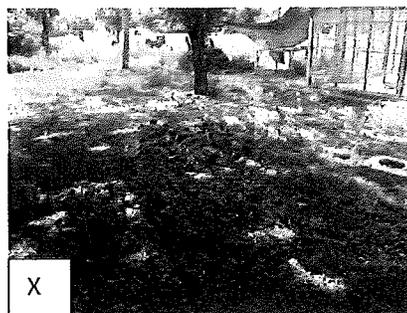
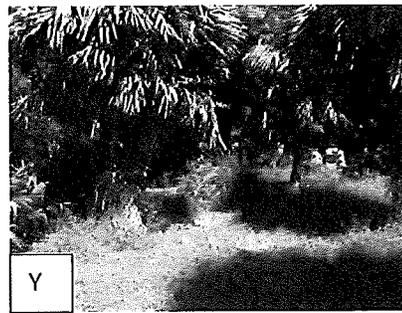
Surficial and buried solid waste was noted during DERM’s August 22, 2014 inspection of this area in soil borings SB-1A (N25.60397 W080.39796), SB-1B (N25.60404 W080.39788) and SB-Surficial (N25.60404 W080.39790). Additional soil boring (AEH 4 N25.60390 W080.39747) with buried solid waste (13 inches bls) was documented during this inspection. Step out borings were conducted to the north, south, east and west from the impacted soil borings and delineation of the solid waste material was achieved. Note that park patrons do not have access to this area of the site (only Zoo staff has access). GPS coordinates for the delineating locations are noted below

- T. View of the delineated Ant Eater Holding Area facing northeast.
- U. View of the delineated Ant Eater Holding Area facing northwest.
- V. View of the AEH 5 boring location facing northwest.
- X. View of the Ant Eater Holding Area facing southwest.
- Y. View of the AEH 7 boring location facing north.

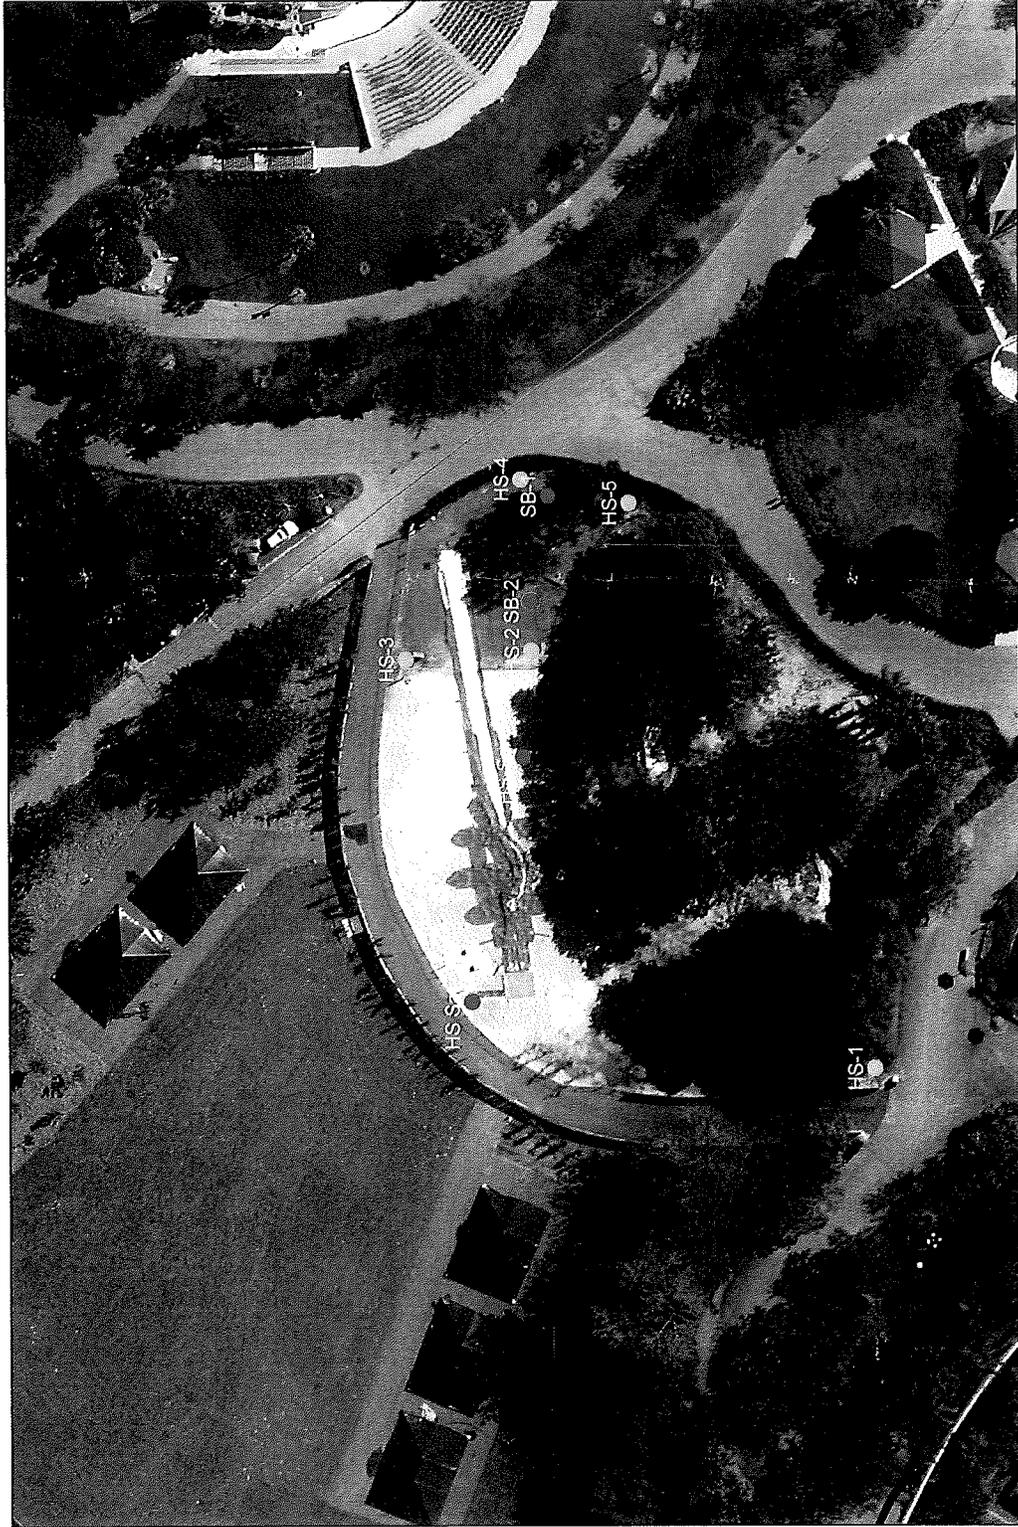
Zoo Miami Hippo Slide Area Incidental Solid Waste Findings

Hand Sand 1 sampling interval from 0-9 inches BLS. Solid waste noted at 9 inches BLS.

Hand Sand 2 sampling interval from 0-7 inches BLS. Solids waste noted from 1-7 inches BLS.

SB-1 and SB-2: Solid waste noted in the 0-6" and 6-24 inches BLS intervals.

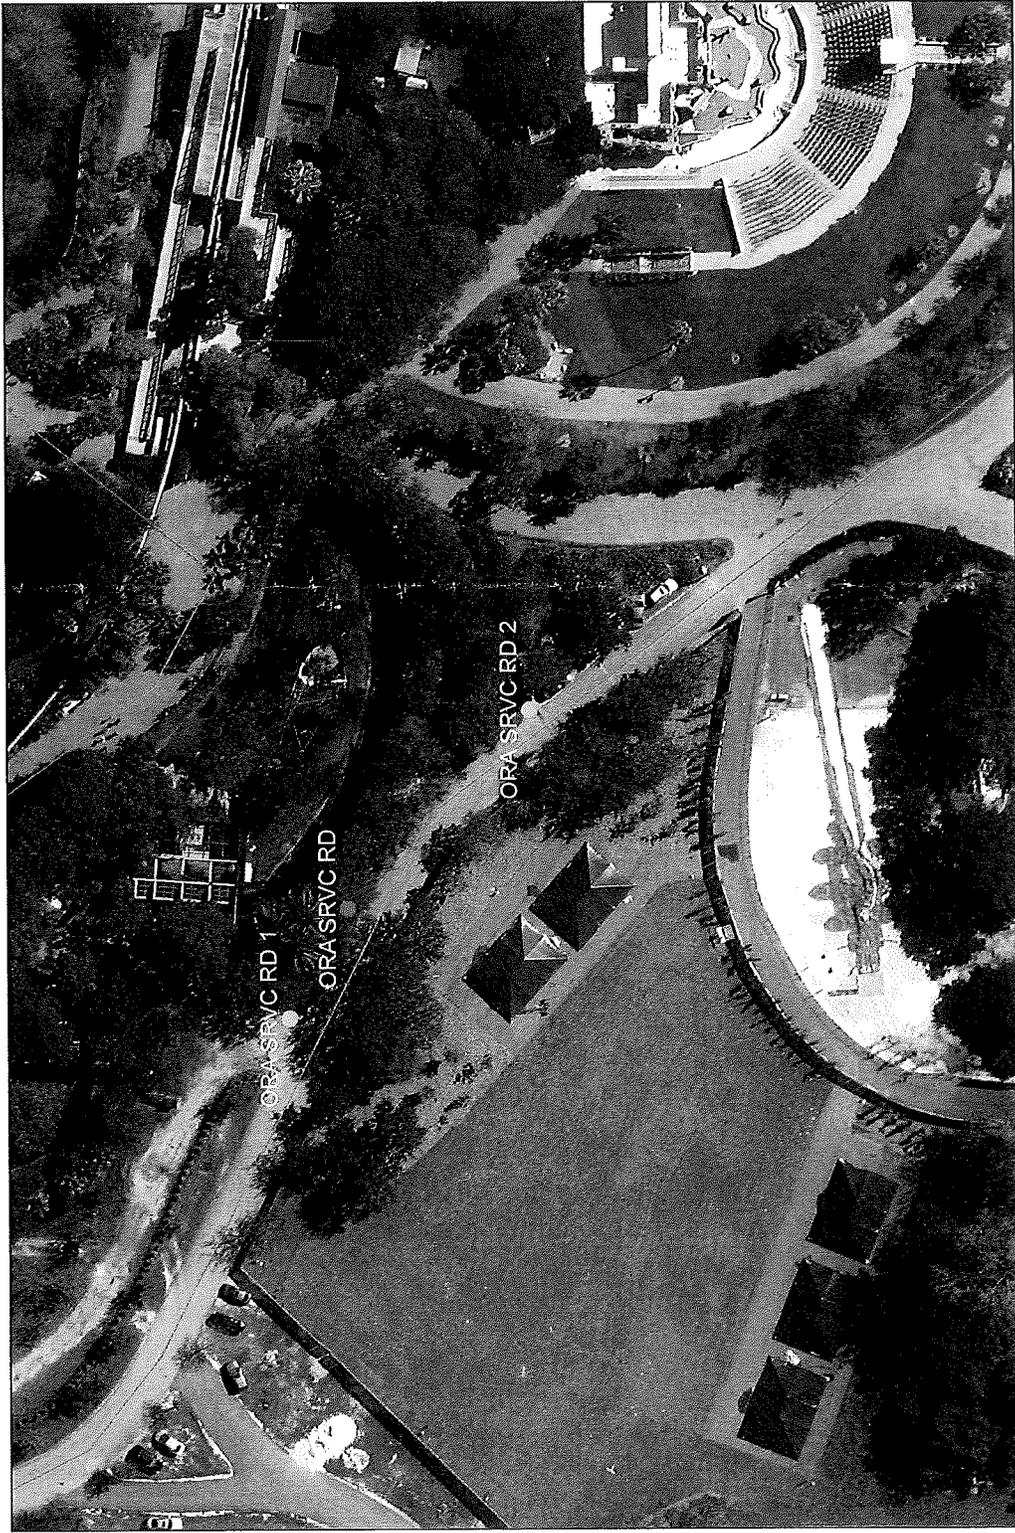
Zoo Miami Orangutan Service Road Incidental Solid Waste Findings Map

- Surficial Delineation Points
 - Incidental Solid Waste
- Note:
ORA SRVC RD sampling interval from 0-7 inches BLS.
Glass noted at the surface underneath vegetation between the two delineating points.

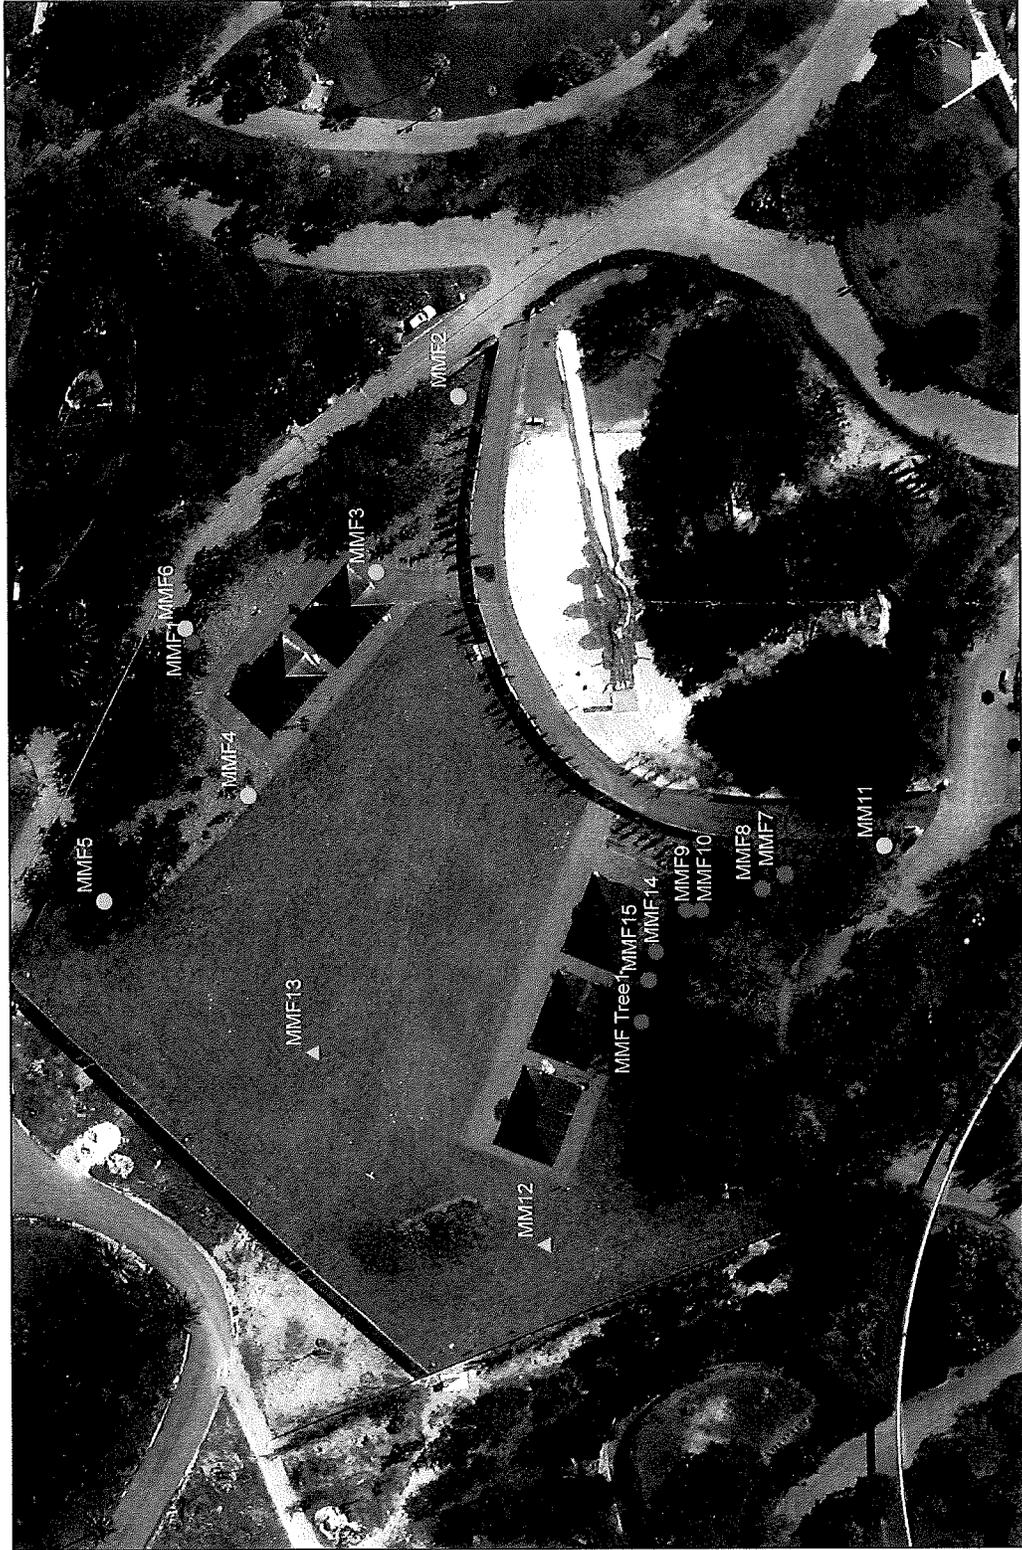
Zoo Miami Monkey Meadow Field Incidental Solid Waste Findings Map

Note:
MMF1 to MMF5: Surficial solid waste noted throughout mulch area and around the trees. Solid waste was noted at interval 4-6 inches BLS and at 11 inches BLS.

The following observations of solid waste were noted:
MMF7 at 4 inches BLS
MMF8 at 4-5 inches BLS
MMF9 at 4-7 inches BLS
MMF10 at 0-6 inches BLS
MMF Tree 1 observed solid waste around base of tree
MMF14 at 12 inches BLS
MMF15 at 5 inches BLS

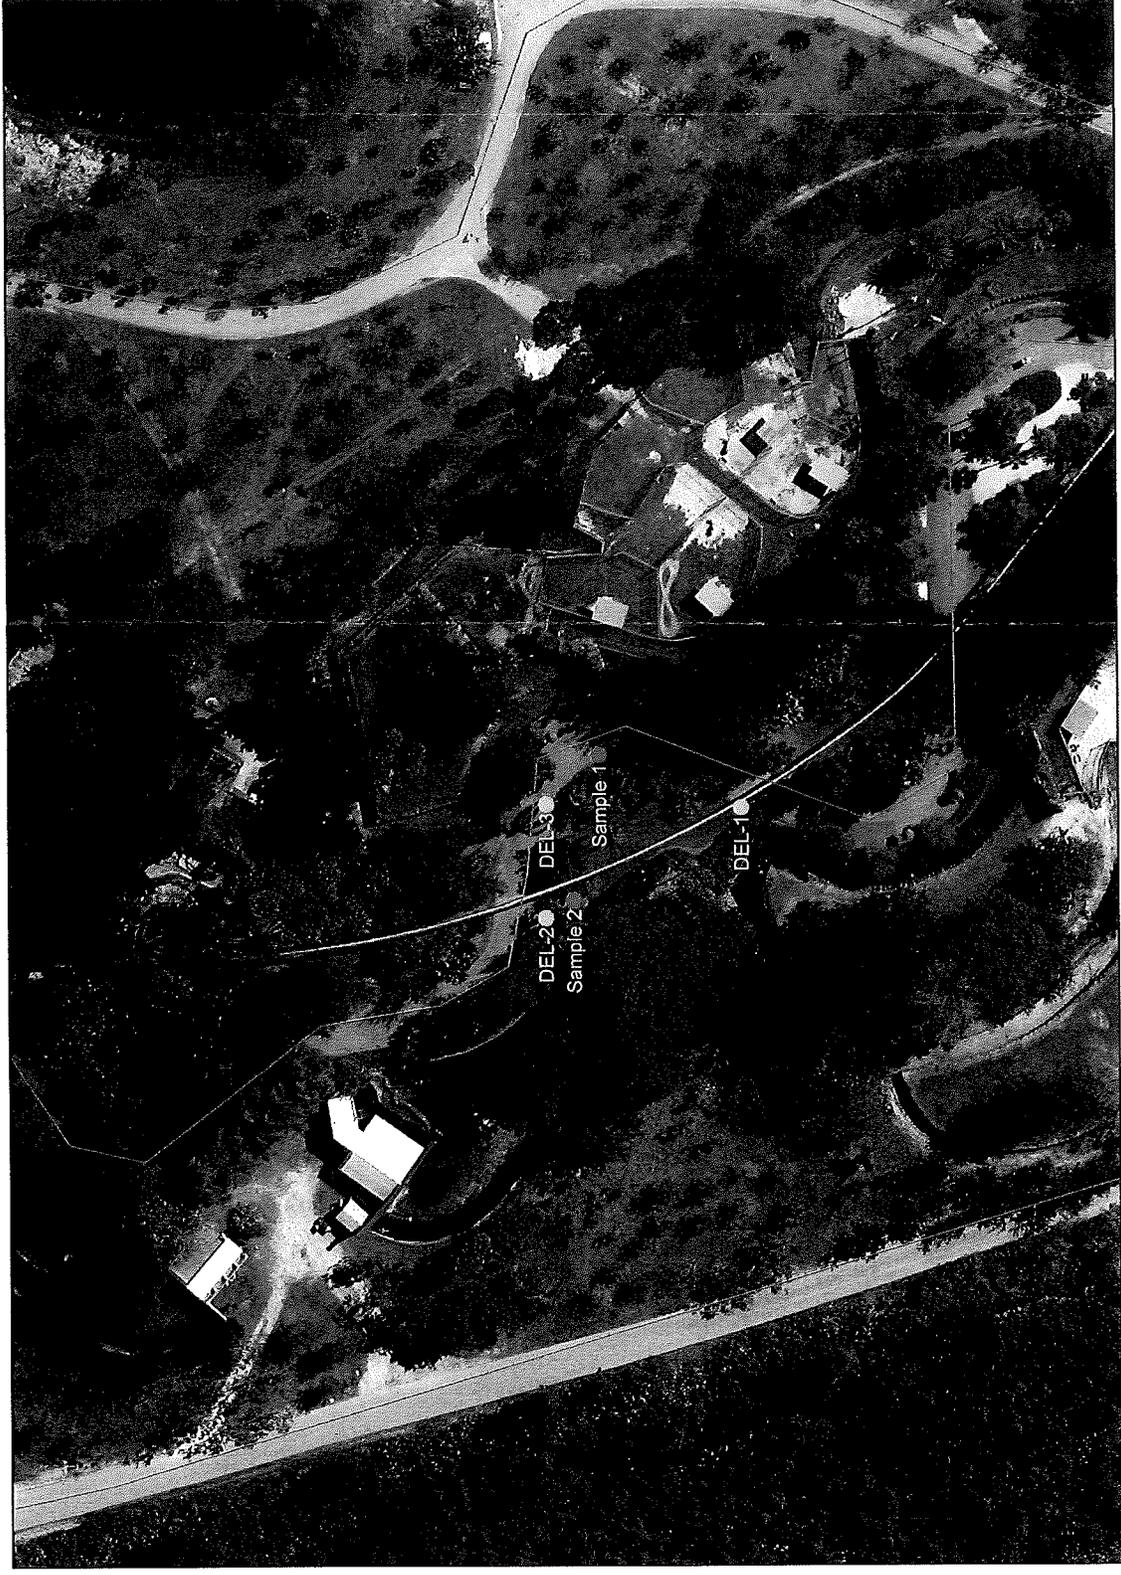
Zoo Miami Area L Incidental Solid Waste Findings Map

Note:
At sample points Sample 1 and Sample 2 melted glass was observed on ground surface. A surficial sample was collected.
At sample points DEL-1 through DEL-3, only a surficial inspection was conducted. No samples were collected.
DEL-1 and DEL-2 locations are approximated.

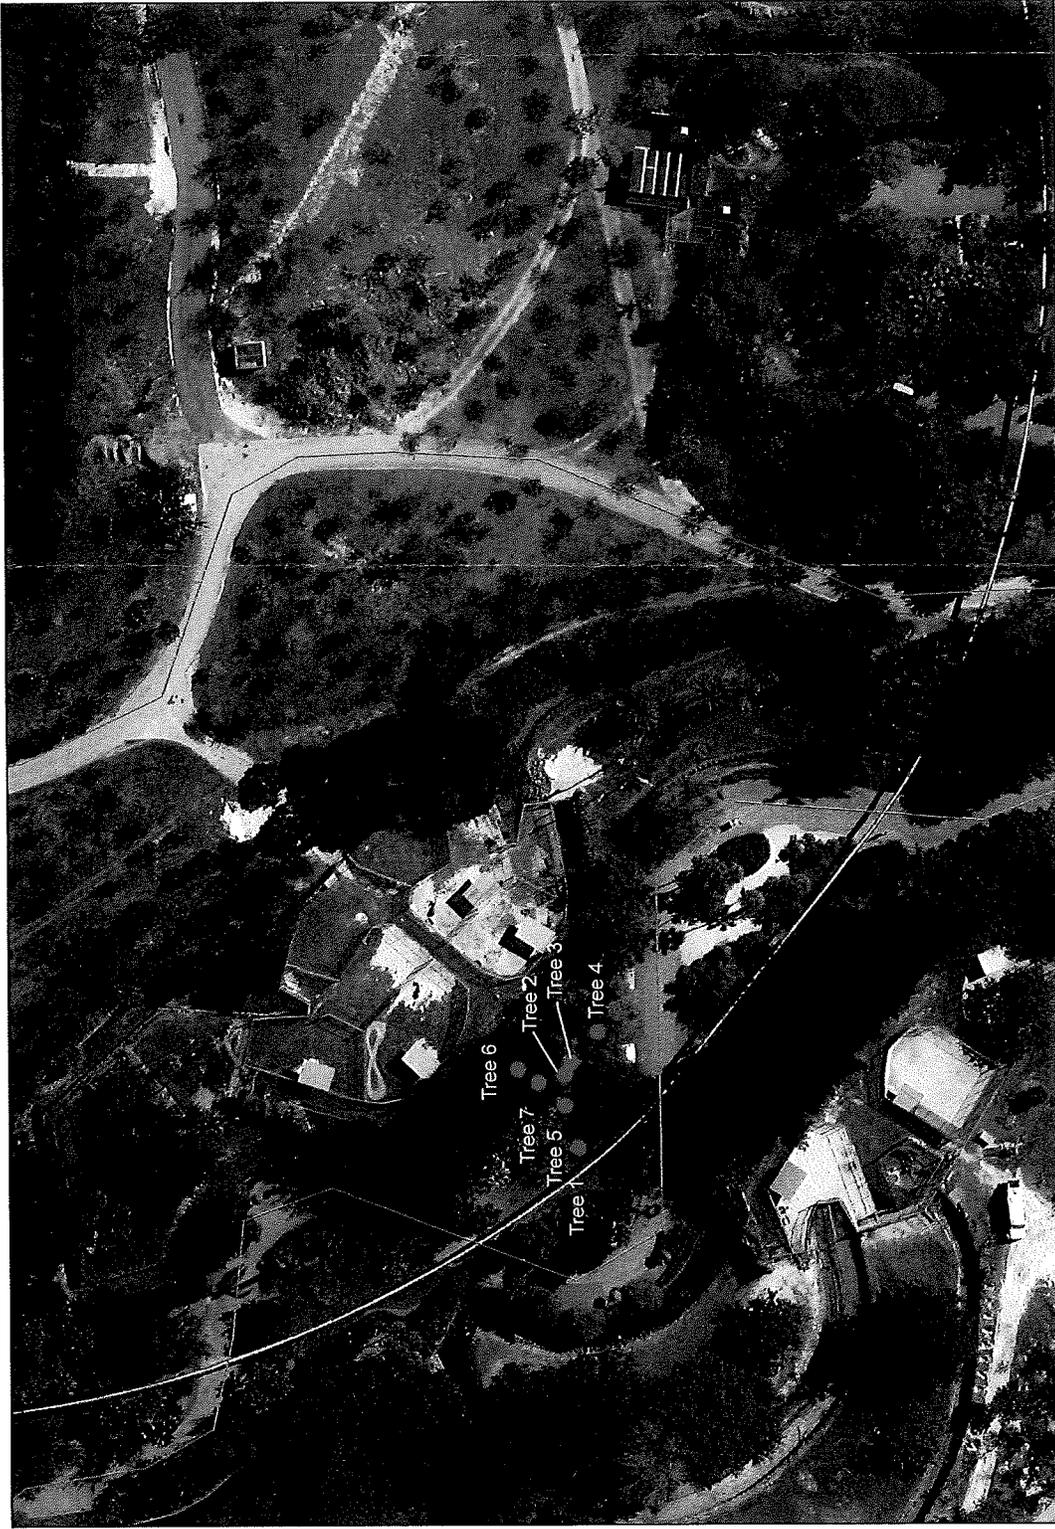
Zoo Miami Area M Incidental Solid Waste Findings Map

Note:
Surficial solid waste was noted around base of trees.
No samples were collected.
