Subject: Notice of Environmental Contamination in Commission District 9

Subject: Zoo Miami (HWR#802/File-11706) facility, located at, near or in the vicinity of 12400 SW 152 St.,
(Folio # 30-5936-000-0050) Miami, Miami-Dade County, Florida.

Zoo Miami
 12400 SW 152 Street
 Inspection Date: 10-3-14
 DERM Staff: Didier Camacho / Eddie Gonzalez / Roosevelt Jean

Inspection Date: 10-9-2014

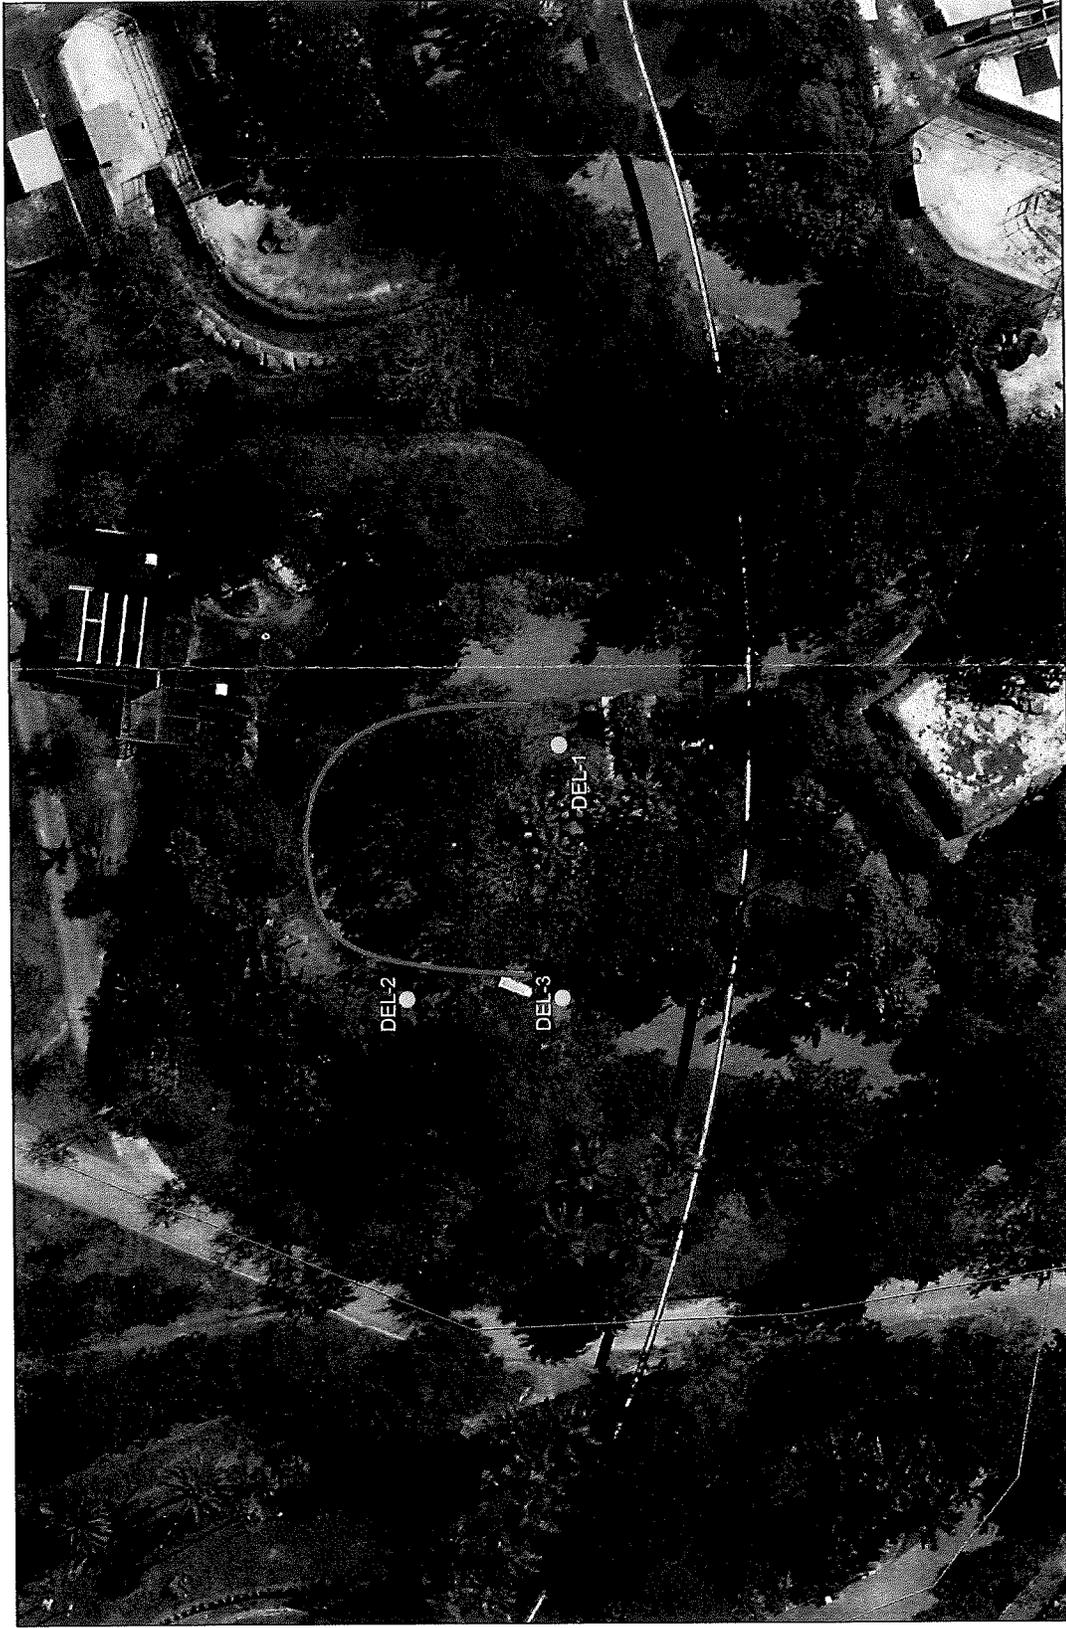
Zoo Mimai Area N Incidental Solid Waste Findings Map

Area outlined in red indicates approximate area where surficial solid waste was observed.
