**POST
HURRICANE WILMA
PROGRESS ASSESSMENT**

**BUILDING CODE COMPLIANCE
OFFICE**

April 2006

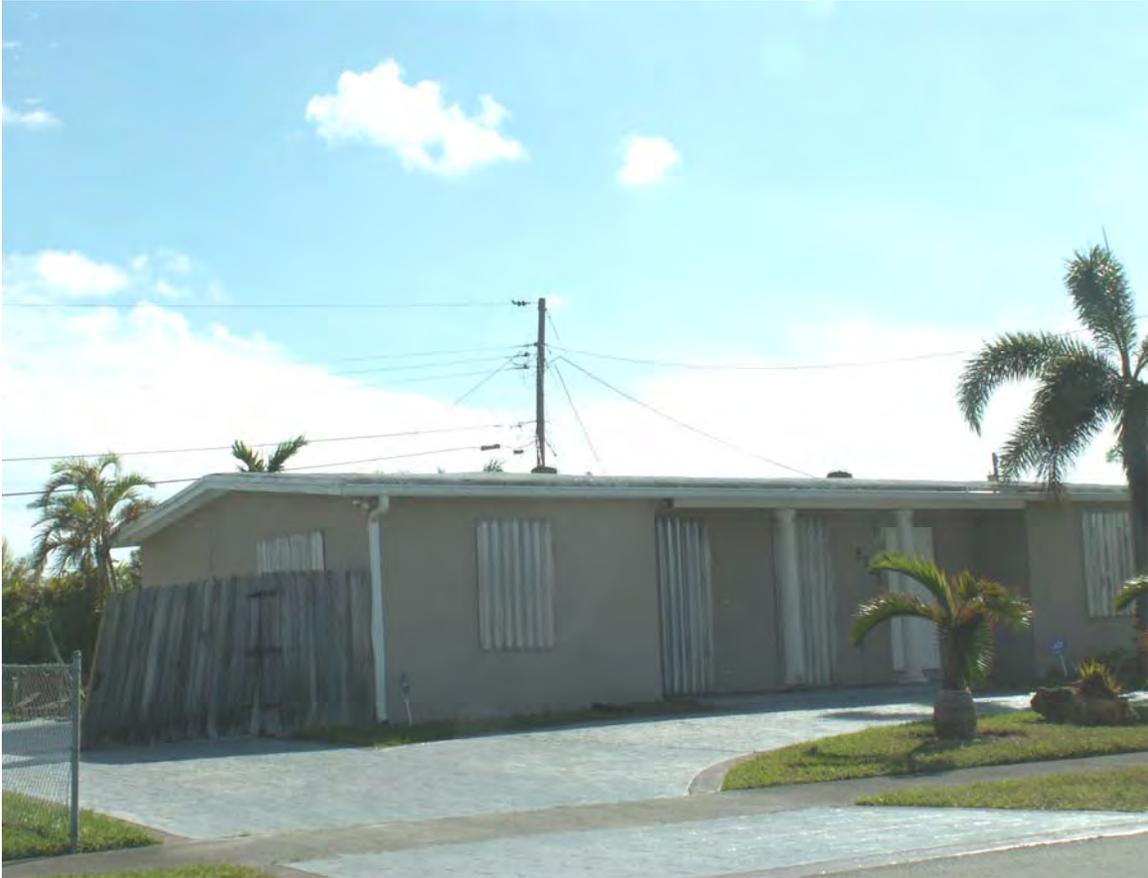
View of well prepared home which suffered no hurricane damage.

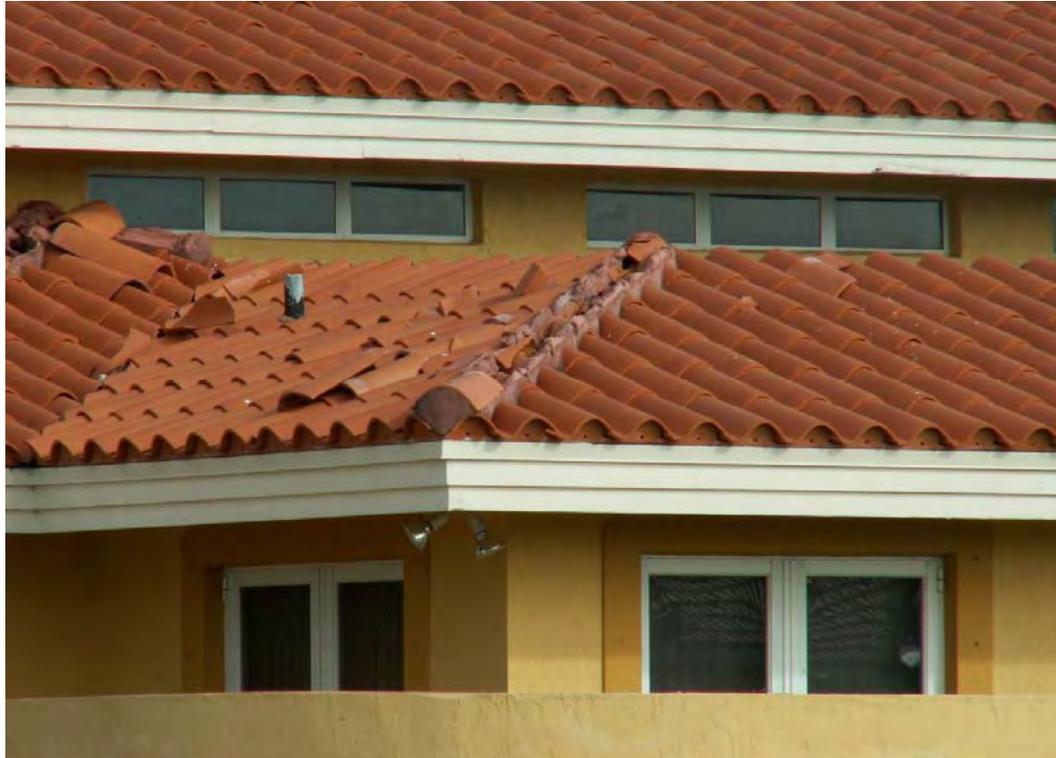
The hip and ridge caps on both concrete and clay roof tile installations suffered wind loss damage. Hip and ridge caps installed with mortar performed poorly with clay tile being the most affected. Hip and ridge caps installed using one of the five enhanced methods prescribed in the code for mechanically attached tile performed very well except in cases where lack of adequate workmanship was evident. In these cases, observations were made of metal channel/adhesive configurations where the foam did not rise to make contact with the hip and ridge tile component. It seems that either channels not match to the tile configuration were used or the adhesive did not rise sufficiently to make contact. Ultimately, in both cases the hip and ridge tiles were not secured to the roof, with only the cosmetic closure mortar offering any adhesion.

Typical view of hip cap wind loss on a clay tile system.

The empirical evidence regarding the weakness of mortar set hip and ridge attachment and the loss of the first course of tile on mechanically attached tile systems provided clear evidence that remedial action was necessary. Hurricane Wilma occurred while the Florida Building Code was in a code modification cycle. As a result, BCCO submitted code modifications which would eliminate the mortar set option for hip and ridge tile. Additionally, a code modification was submitted to require specific post installation testing of hip and ridge cap installation by third party testing agencies. The issue regarding the loss of the first course of tile was also addressed with a code modification which would require that a tile clip be installed along with the other required tile fasteners on each tile along the first course for mechanically attached roof tile systems.

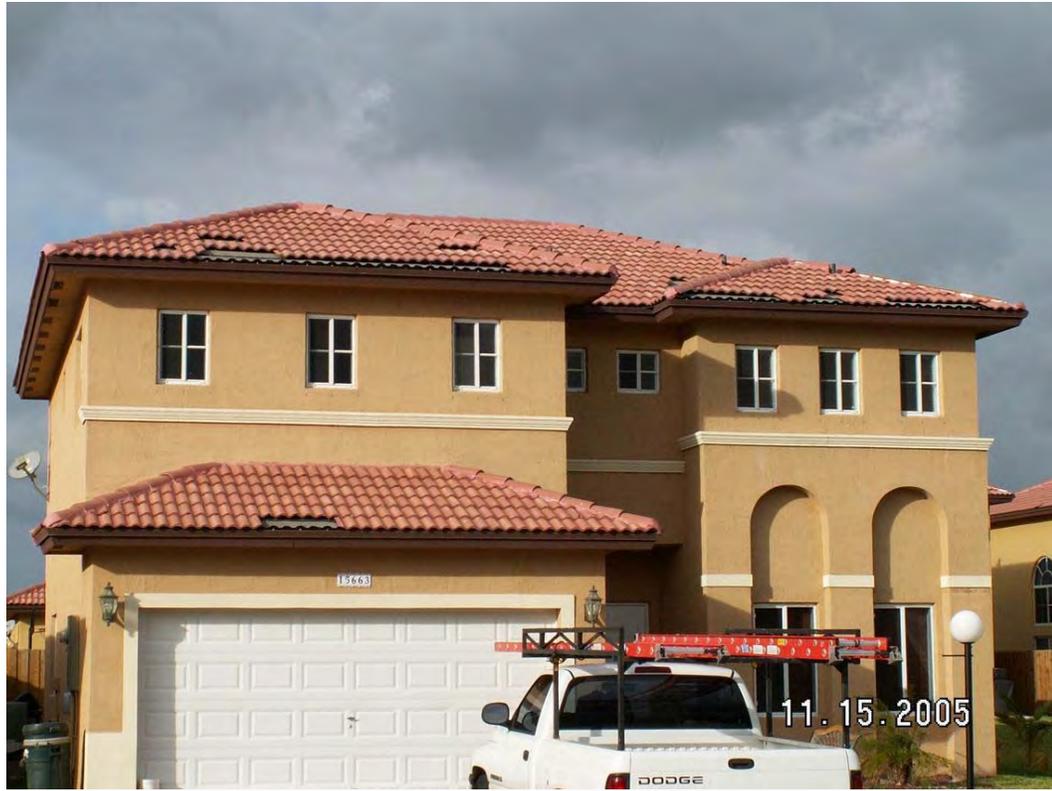
Mechanically attached tile roof systems suffered the loss of the first course of tile, in many cases. This phenomenon was not observed in either mortar set or adhesive set tile installations. In some cases the lifting of the first course of tile resulted in progressive but diminishing loss of roof tile in the second and third courses. The first course of tile is installed with a typical two inch overhang beyond the eave of the roof. This seems to expose the first course of tile to greater wind induced uplift. With the tile fastener near the top edge of the roof tile, the wind was observed, to rotate the lower edge of the tile upward. Once lifted the tile becomes increasing vulnerable to wind loss, with the possibility of large missile debris being generated.

Typical view of first tile course wind loss.

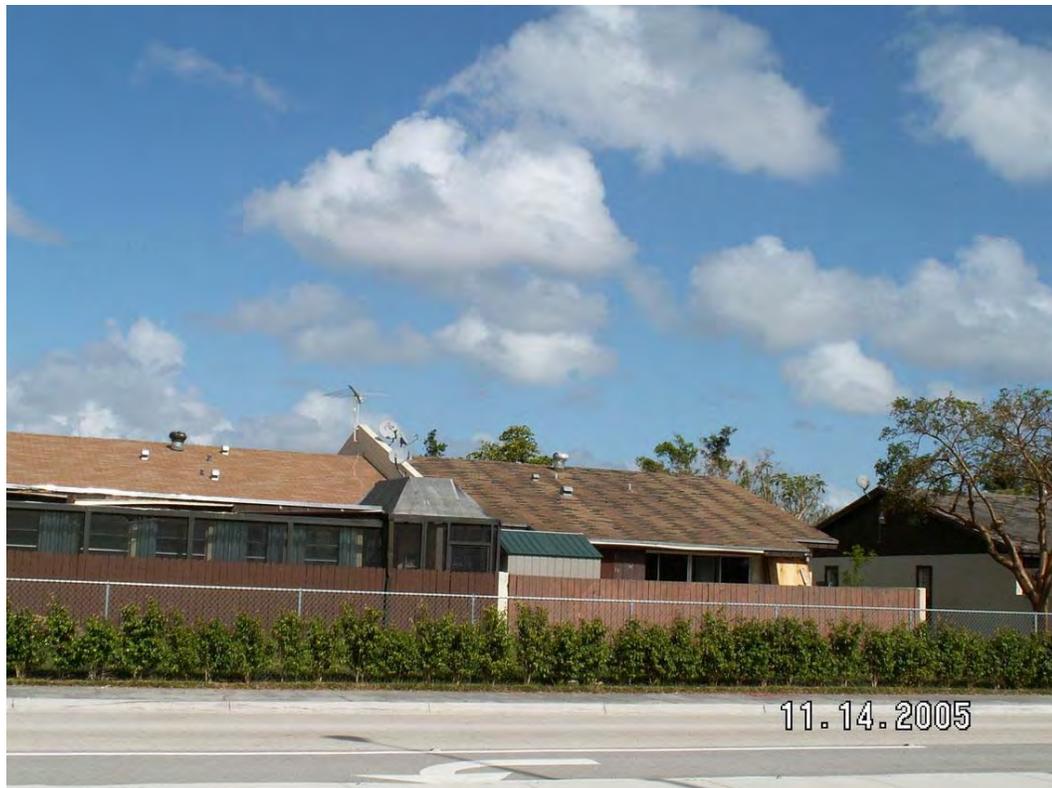
The effects of hurricane force winds were most evident and widespread with regard to asphalt shingle installations. Nonetheless, there was a clear and direct correlation to the age of the shingles and the amount of damage sustained. Shingle roof systems five years and less in age encountered little to no damage, while shingle roof systems dating from post hurricane Andrew or older saw, in some cases, significant shingle tab losses. Loss of entire shingles was more the exception than the rule. Discussions with shingle manufacturers reveal that the shingle tab sealant, used to seal down the shingle tabs, has been modified in recent years to create a more rigid seal that will also allow for thermal movement of the shingles. It was observed that the level of wind encountered did not cause shingle fastener pullout or shingle pullover except in isolated instances, even though shingle tab adhesion failed. The code since 1994 regarding shingle attachment stipulates a minimum of six ring shank roofing nails per shingle. With the underlayment and significant portions of the roof shingles remaining in place, coupled with the onset of, post hurricane, drier weather conditions, resulting water intrusion damage remains minimal. As the rainy season approaches, those unrepaired roofs may begin to experience water intrusion problems.

Side by side view, undamaged new shingle on the left. Damaged older shingle roof on the right.

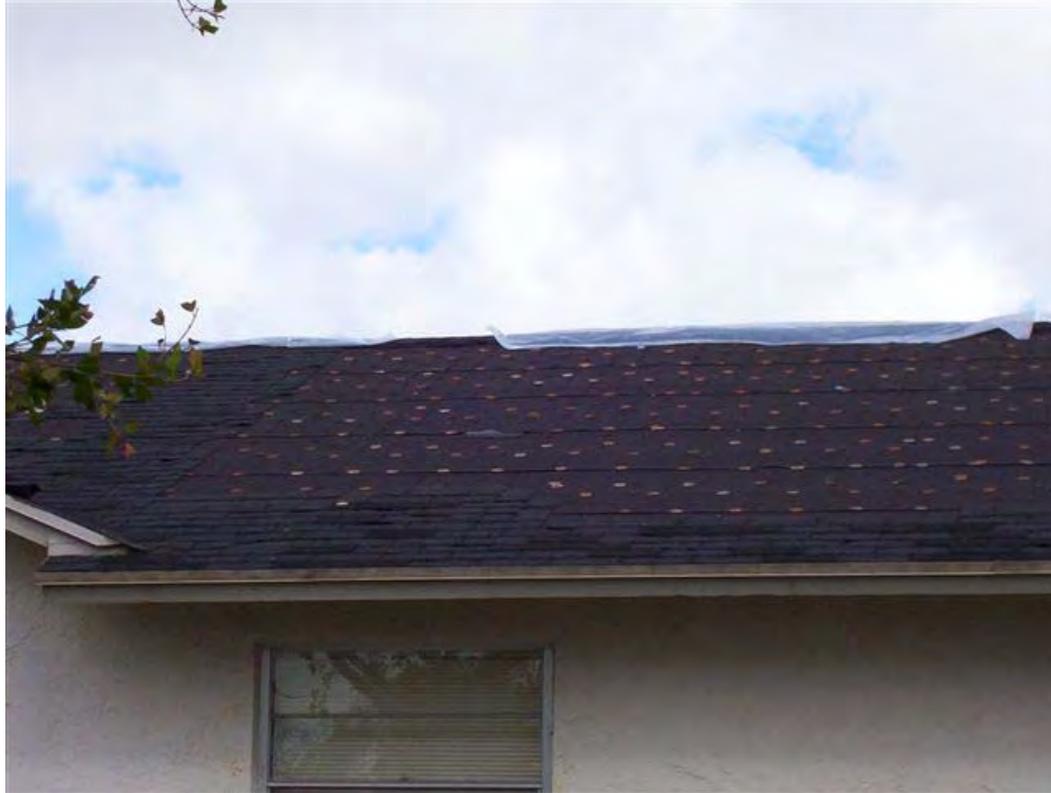
Enhanced underlayment attachment for steep roofing systems was implemented in 1994. It was contemplated that if damage to the prepared roof covering occurred the underlayment would stay in place to provide redundancy in minimizing water intrusion damage, with a resultant overall mitigation of property loss. This concept proved to be a success. Where shingle losses occurred, the underlayment remained in place contributing to the water shedding capabilities of the roof system. Dozens of buildings, either being constructed or in the process of being reroofed were assessed; these buildings were at the dry-in stage with only the underlayment and edge metal installed. It was observed that the benefit achieved as a result of this requirement clearly reinforced the value of enhanced underlayment attachment.

View of roof with shingle loss, with underlayment still in place.

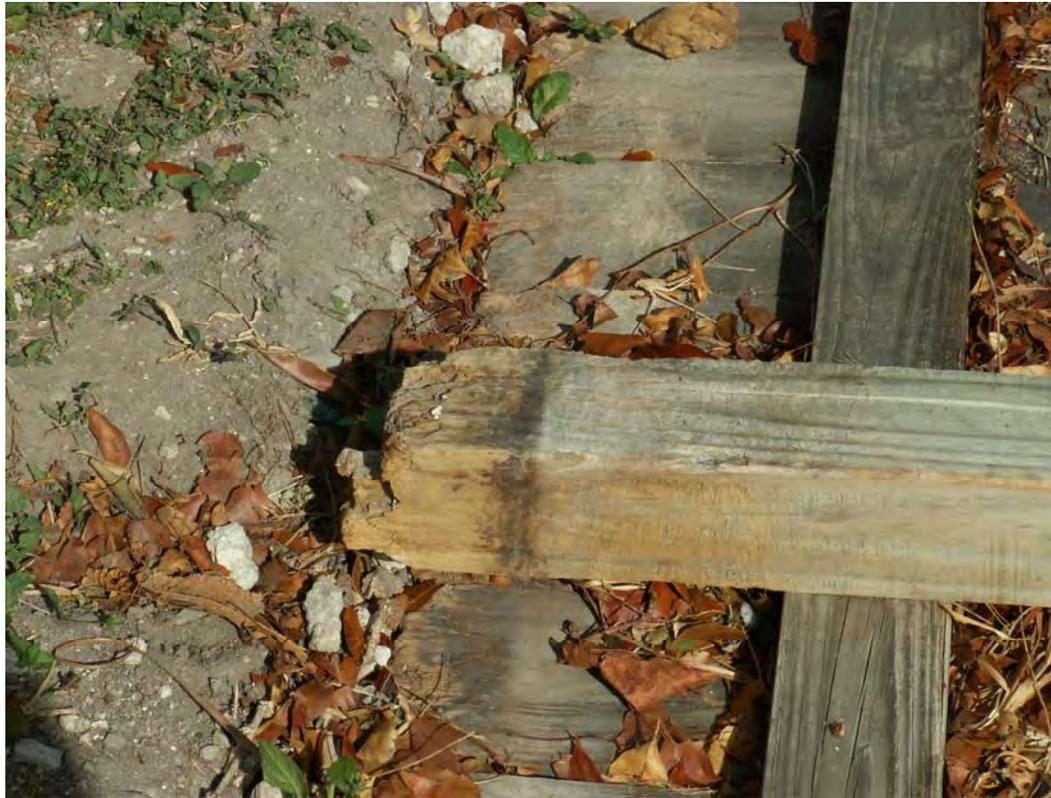
Poorly maintained and obsolescent wood fences were observed to be the most vulnerable to wind loss damage.

View of wood fence damage caused by obsolescence.

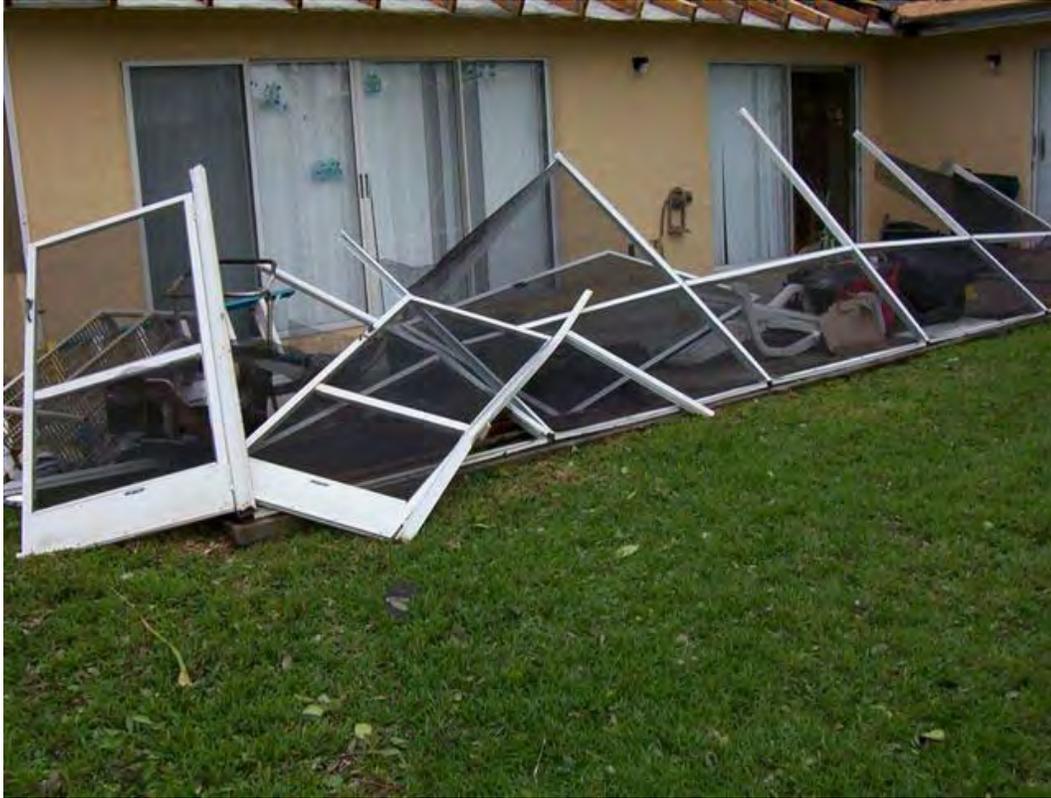
Impact of debris and installation deficiencies was observed to be the primary cause of damage.

View of screen enclosure damage caused when screen panels did not break away.

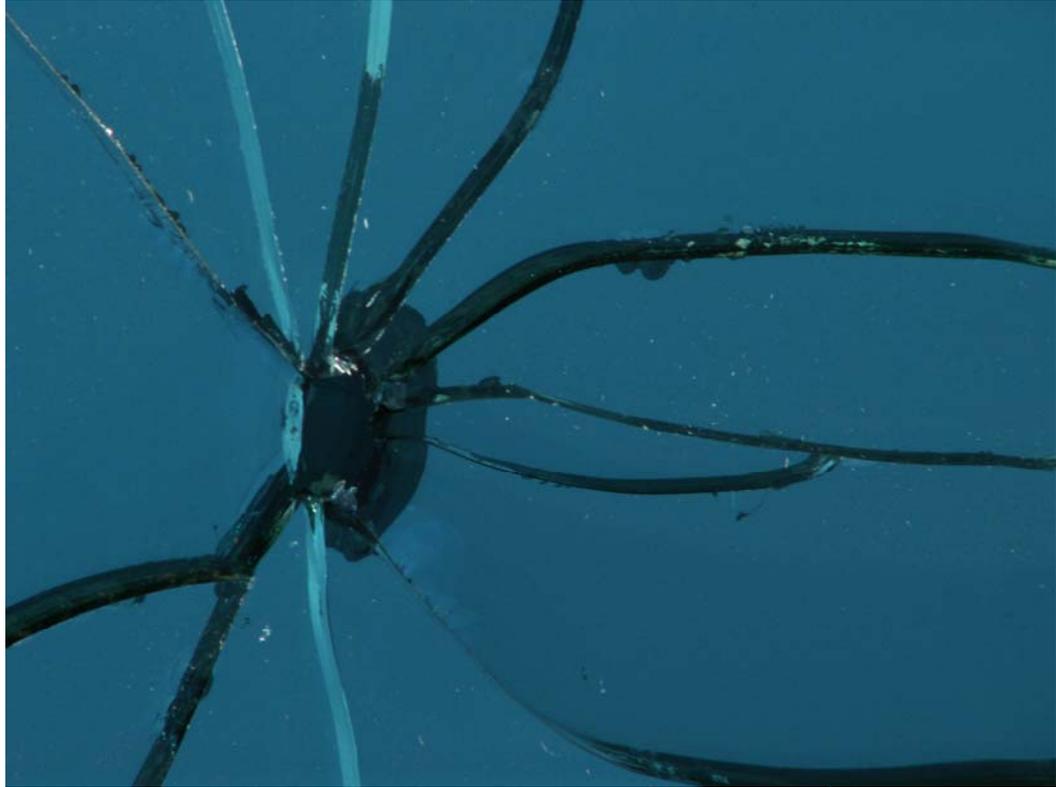
High rise buildings in isolated areas of the county were affected. Loss of glazing in balcony railings, sliding glass doors, curtain walls and windows did occur. However, none of the damage was observed in buildings constructed under the most recent building code. In those isolated cases where the building envelope was breached, interior damage due to water intrusion and internal pressurization occurred, causing collateral damage. Glazing above 30' is currently required to meet the small missile impact test consisting of 2 gram steel balls projected at a test sample in groups of ten at a velocity of 130' per second.

View of large missile debris impact above the 30th floor.

- ✚ Large missile impact debris above 30'.
- ✚ Gravel from adjacent roofs causing impact damage.
- ✚ Fully adhered roof system recovers over existing gravel roof systems.
- ✚ Impact damage to glazed balcony railing systems.

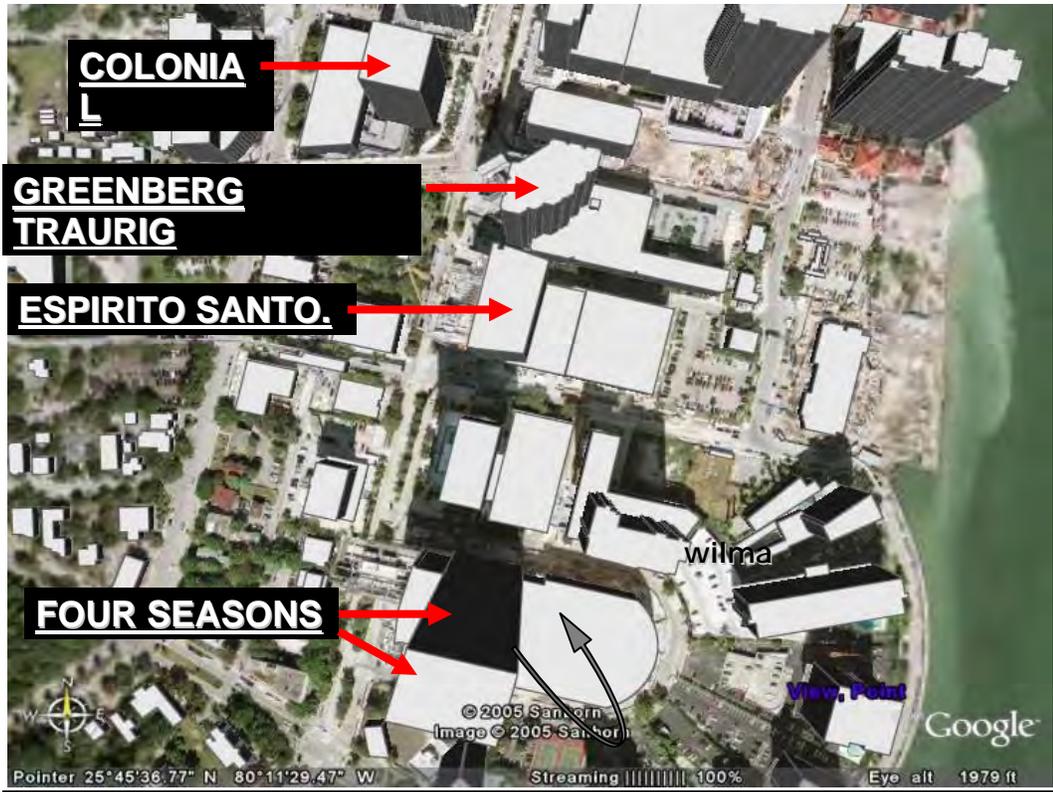
Glazing damage in the Brickell area was primarily limited to four buildings. However, and surprisingly, many nearby high rise buildings suffered little or no glazing damage. There seemed to be a channeling effect of the wind which created an isolated path of damage.

View of damaged buildings in the Brickell area.

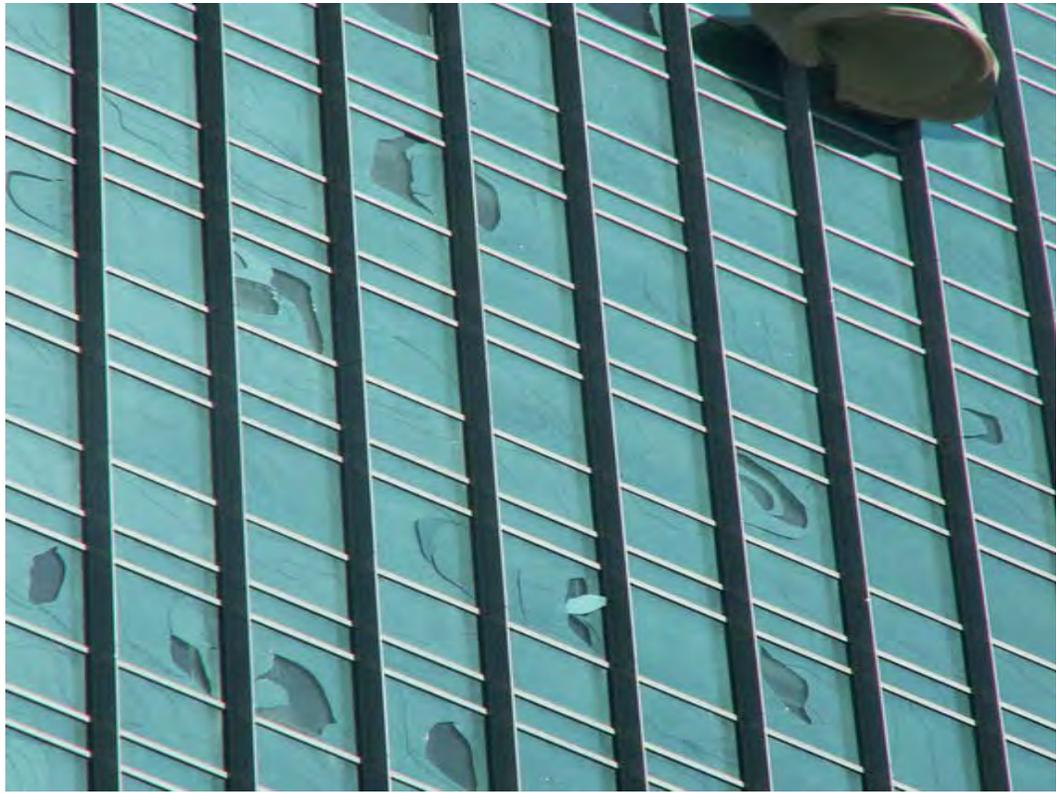
View of glazing damage in the Brickell area.

Currently delays are being experienced in acquiring replacement glazing for high rise repairs. In most cases special order replacement glass is necessary, in order to match existing tints and styles. In the mean time, plywood has been installed where the glazing has been broken in order that the buildings may be safely occupied. For the most part permits have been issued and repairs are proceeding as the glass becomes available.
