# RICHMOND HEIGHTS POTENTIAL CRA FINDING OF NECESSITY NOVEMBER 2015

### SECTION 1 INTRODUCTION

#### 1.1 HISTORY AND PURPOSE

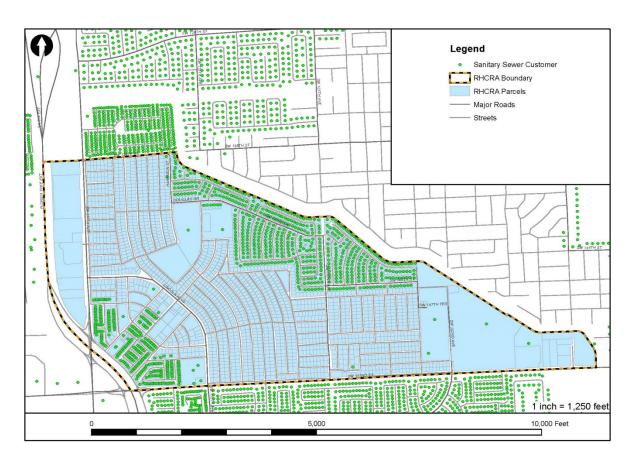
EXHIBIT 2-1 SANITARY SEWER CUSTOMERS

In addition, Exhibit 2-1, on the next page, shows the sanitary sewer customers in the proposed CRA. The map shows that more than one-half of the proposed CRA does not have sewer service. The preponderance of septic tanks in the CRA poses health and sanitation risks for the area.

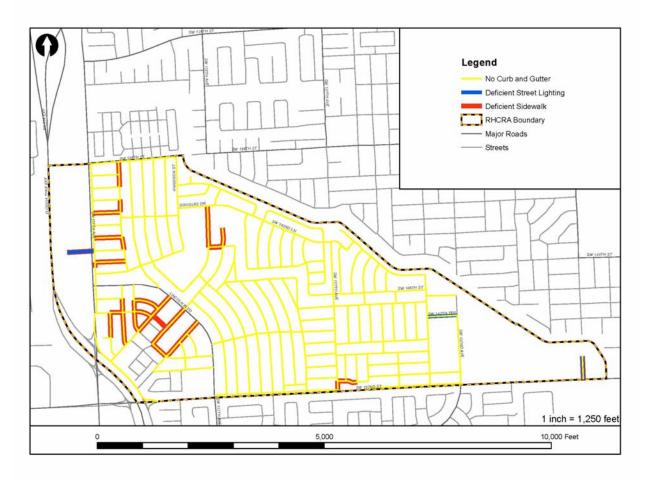
EXHIBIT 3-1 ROADWAY DEFICIENCIES

The designation of deteriorated structures is not limited to buildings. Structures also include infrastructure elements such as roadways, sidewalks, drainage canals, fences, driveways and drainage aprons. An examination by Florida Technical Consultants, Inc. was undertaken as a part of this analysis. The examination considered the existence of deteriorated or substandard facilities as illustrated by the previous photographs. In addition, the examination also identified where these infrastructure facilities were absentl. The following table represents the determination of the inadequate or missing structures in the proposed CRA area and possible costs associated with the improvements.

Exhibit 3-1 shows a map of the roadway deficiencies in the Proposed CRA. This highlights the areas where the improvements detailed in Table 3-1 should be concentrated. The maps on the following pages show the existing drainage structures in the proposed CRA (Exhibit 3-2) and the existing water customers in the proposed CRA (Exhibit 3-3).

ltem	Quantity	Unit	Cost	Total	
Install Sidewalk	30567	SY	55	\$	1,681,167
Install Curb and Gutter	312954	LF	35	\$	10,953,390
Install Drainage	94734	LF	75	\$	7,105,050
Structures	1080	EA	5000	\$	5,400,000
Install Sanitary Sewer	114932	LF	85	\$	9,769,220
Install Sanitary Sewer Structures	400	EA	4000	\$	1,600,000
Install Sanitary Sewer Features	3	EA	300000	\$	900,000
Install Lighting	57	EA	10000	\$	570,000
Roadway Restoration	389140	SY	60	\$	23,348,400
Design and Contingency 30%				\$	18,398,168
TOTAL IMPROVEMENTS				\$	79,725,395

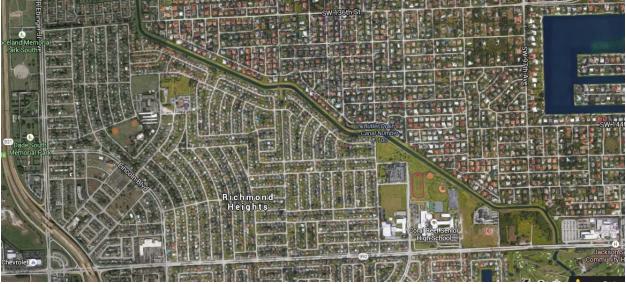
EXHIBIT 3-4 AERIAL PHOTOGRAPH OF STREET LAYOUT

For economic purposes, the street layout should enable customers to reach businesses easily and for trade among business to be conducted directly and efficiently. Most of the commercial property in the proposed CRA is on major roadways and easily accessible. The street pattern of the proposed CRA is not detrimental to development of commercial property.

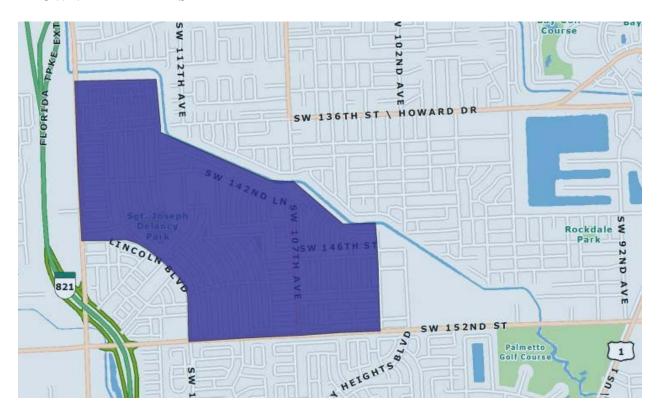
EXHIBIT 3-5 BROWNFIELD AREAS

Ground contamination is a very serious issue throughout the potential area and much of the Richmond Heights community has been designated as a Brownfield site. Brownfield status is a condition, within certain legal exclusions and additions, of real property, the redevelopment or reuse of which may be complicated by the presence or potential presence of a hazardous substance, pollutant or contaminant, which may include petroleum hydrocarbon releases. Brownfield status generally means there are use or development restrictions on the site.

Over one-half of the Richmond Heights area is within the Richmond Heights Brownfields area (as seen in dark blue in Exhibit 3-5).

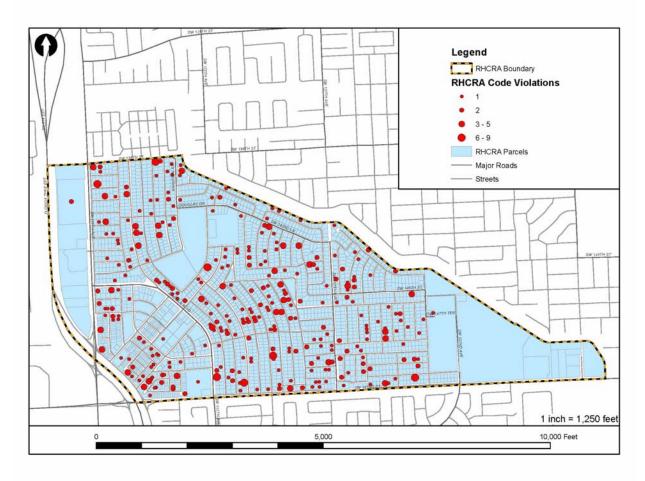
EXHIBIT 3-7 CODE VIOLATIONS BY LOCATION

Table 3-5 lists the figures and analysis for the Code violations in the area. Exhibit 3-7 is a graphic representation of the number of violations in the area.

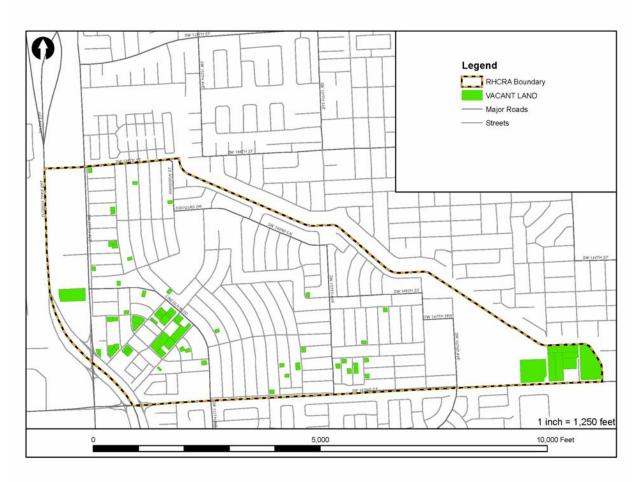
### EXHIBIT 3-8 VACANT PROPERTY

Another factor in assessing the amount of vacant property is the diversity of the ownership. The best chance for development or redevelopment is if much of the area has common ownership. In several cases multiple ownership exists. Bethel Baptist Church and Martin Memorial African M E Church Inc. each own multiple properties in the Southwest corner of the proposed CRA, and Village at Coral Reef LLC owns the six vacant parcels in the Southeast corner of the proposed CRA.

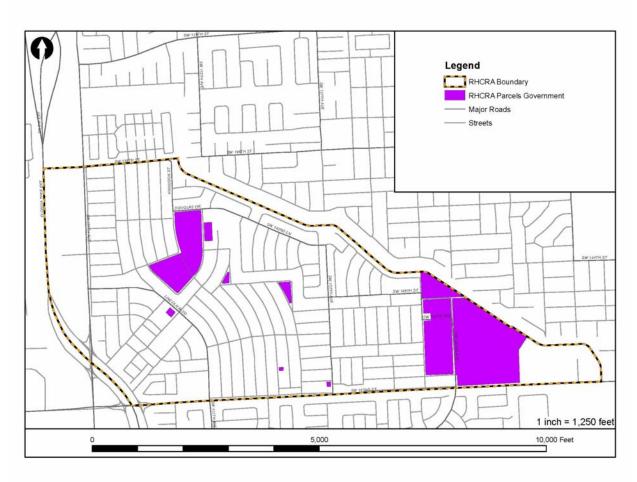
EXHIBIT 3-9 GOVERNMENT OWNED PROPERTY

A visual representation of government owned land is shown in Exhibit 3-9 on the following page. There is only a small amount of property in government ownership in the potential area. Therefore the amount of land that is held by the government because it has environmental concerns is limited. However, Exhibit 3-5 identifies that much of the potential area is within the Brownfields designation. This designation provides an environmental issue for the area.
