# *Appendix D*

Baseline Assessment and Monitoring Program

**TECHNICAL MEMORANDUM**  
**COASTAL WETLANDS REUSE REHYDRATION DEMONSTRATION PROJECT**  
**MONITORING PROGRAM BASELINE ASSESSMENT**

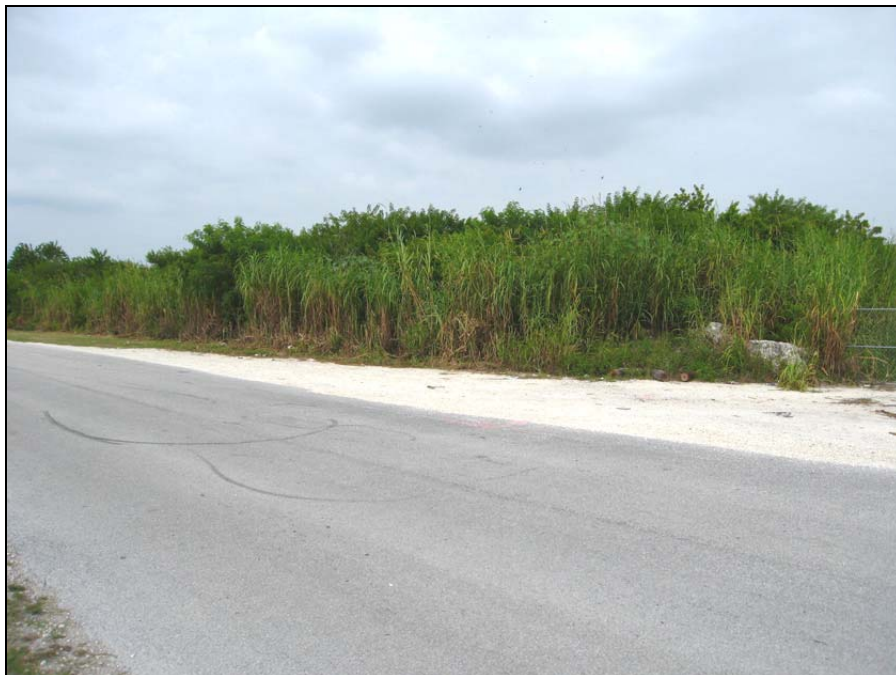
South side of the 60-Acre area (facing west)

Currently, the test area contains large stands of maiden cane (*Panicum hemitomon*) and is predominantly overgrown with Brazilian pepper (*Schinus terebinthifolius*), vines (*Ipomoea* spp., and *Dioscorea alata*), and castor bean (*Ricinus* spp.). There were a few hardwoods, silk trees (*Albizia julibrissin*) and Australian pine (*Casuarina equisetifolia* L.), observed on the edge of the property. However, hardwoods within the interior were not readily identifiable, as the interior of the test area was not readily accessible by foot. Following are picture is representative of the vegetation at the site.

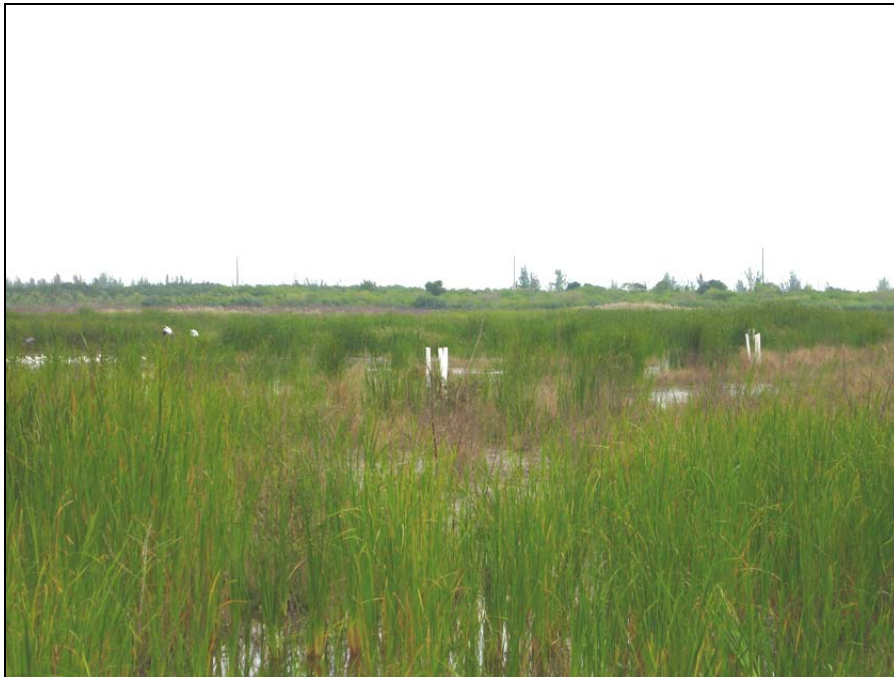
Only cursory observations were made for the vegetation within the 160-acre mitigation area constructed immediately to the north and west of the test site. However, the mitigation and monitoring plan developed for this area indicates that 138.08 acres of the area are shallow, freshwater marsh, 15.67 acres of deep water habitat, and 6.58 acres of upland buffer (Ford Engineers, 2003). A baseline report was generated for this area in 2004, and a one-year monitoring report was generated in 2005. Today, this constructed wetland contains mostly cattail (*Typha* spp.) and other low lying aquatic vegetation. The following picture is typical of the interior of the Lennar development mitigation area.

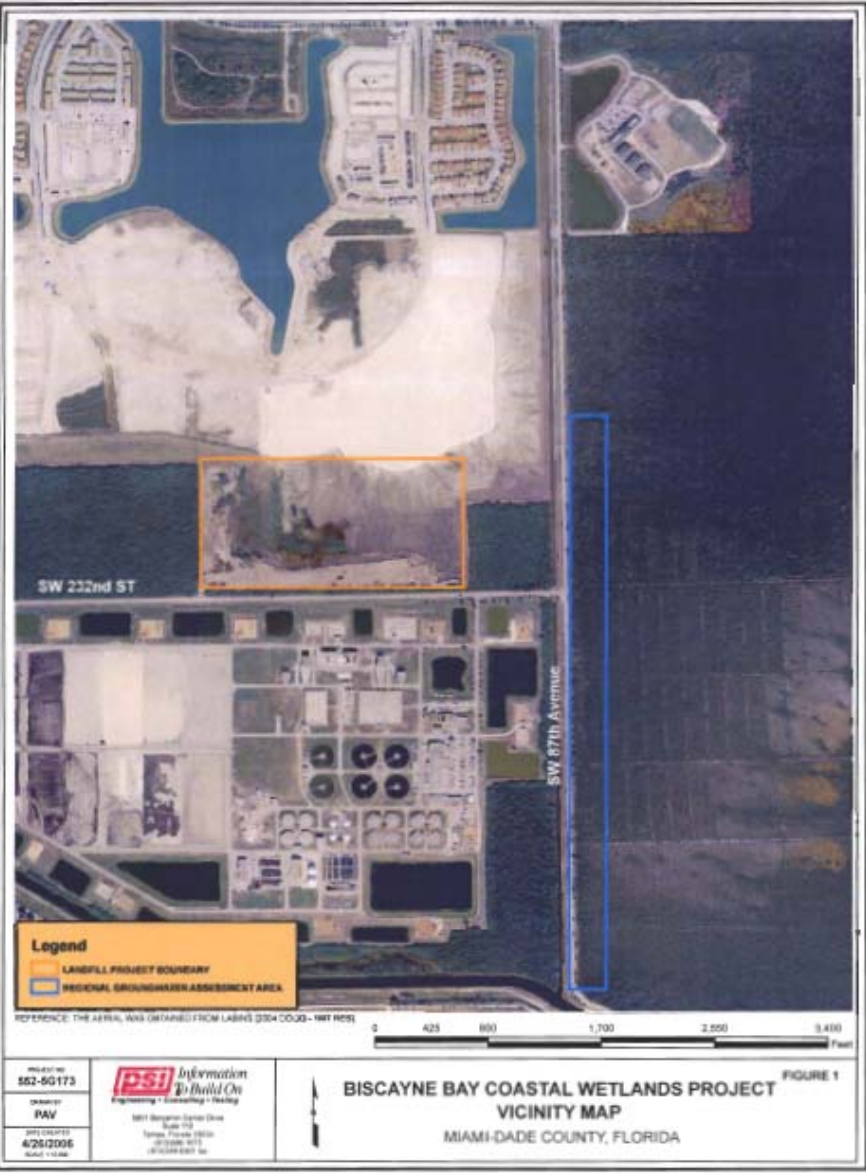
**FIGURE 2**

PSI collected twenty surficial soil samples (SB-10 through SB-29) within the landfill, with each boring representing approximately 1 acre. The soil boring locations were established after first considering the previous PSI sample locations in an effort to provide relatively complete coverage of the former landfill area. The soil boring locations are shown on Figure 2.

Groundwater samples were also collected by PSI from three existing shallow monitoring wells (MW-1 through MW-3) which were previously installed by Hydrologic Associates on behalf of Lennar. A fourth well installed by Lennar (MW-4) and five wells installed by PSI during the previous Phase II activities (TMW-1 through TMW-5) were also to be sampled, however, none of these wells could be located and appear to have been destroyed by landfill reclamation and construction activities in the area. The monitor well locations are shown on Figure 2.
