Miami Dade Water and Sewer Department

2011 Annual Water Loss Reduction Plan Implementation Status Report

March 2012

Condition Assessment of Prestressed Concrete Cylinder Pipe

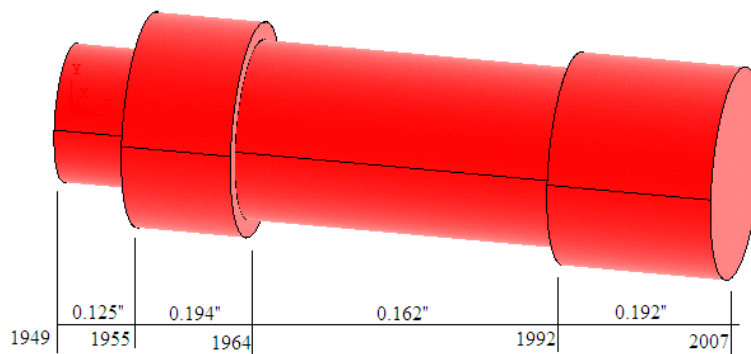
Figure 2.4. Minimum required size of prestressing wires [1].

The most influential changes in standards affecting the performance of PCCP are those related to the prestressing wires. Changes in PCCP design with respect to the prestressing wire were primarily based on updates to the American Society for Testing and Materials. (ASTM) *A227/A668 Standard Specifications for Hard-Drawn Steel Spring Wire/Standard Specification for Steel Wire, Hard Drawn for Prestressing Concrete Pipe (Current Standard – 2004)*[5]. Previous ASTM standards significantly changed the composition of the steel in the wire in order to increase the tensile strength of the prestressing wire; reducing the amount of material necessary in its manufacturing. Tensile strength is defined as the amount of stress (i.e. internal pipe pressure) the wires are able to withstand before either permanent deformation and/or failure occurs. Increasing the material strength by modifying the composition of the steel and its manufacture allowed for the reduction in the overall amount of steel necessary to achieve the minimum tensile strength for the pipe design. This allowed for a cost reduction to the pipe manufacturer and provided a cost advantage for the pipe owner. Due to the competitive cost of PCCP related to other pipe materials, its popularity grew significantly with water/wastewater utilities in the US for their large diameter pressure pipelines built in the 1950s, 1960s and 1970s.

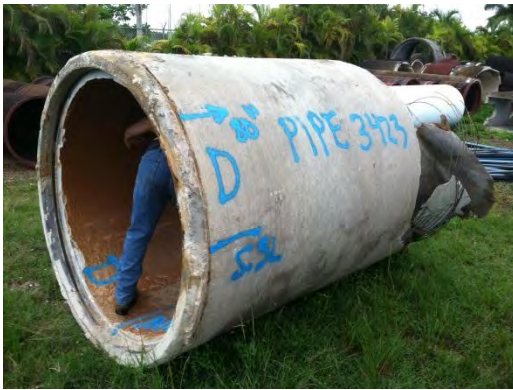
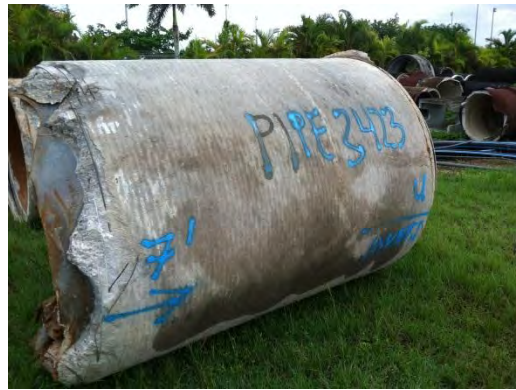
In addition to the carbon fiber reinforcement of Pipe 4213 and 4210, WASD removed and replaced Pipe 3423. Pure Technologies mobilized to the project site August 26, 2011 to perform an external forensic evaluation of Pipe 3423. Following the removal, two pieces of Pipe 3423 remained – approximately seven linear feet of each of the upstream and downstream ends. Figures 3.1 and 3.2 show the remaining portions of Pipe 3423.

Figure 3.1 Downstream bell end of Pipe 3423. Figure 3.2 Upstream spigot end of Pipe 3423.

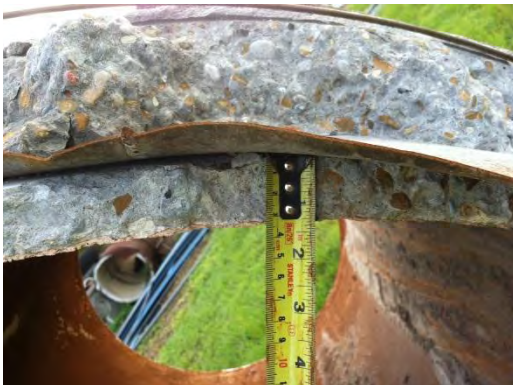
Pure Technologies performed a visual and sounding inspection of the exterior and interior of the pipe, followed by destructive techniques to dissect the composite layers of the 60-inch PCCP. No cracking, spalling, or delaminations were observed within the inner concrete core and outer mortar coating. The remaining components appeared to be intact and well consolidated. Following the dissection, the components of the pipe were inspected, measured, and compared to the provided manufacturer's specifications. (Figures 3.3 and 3.4)

Figure 3.3 Inner concrete core measurement.

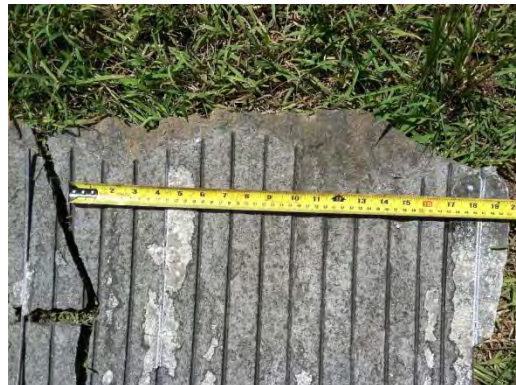
Figure 3.4 Wire spacing measurement.

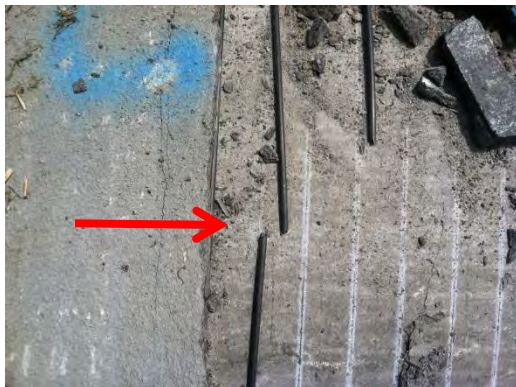
Prestressing wire breaks were quantified, located and compared to the electromagnetic distress estimates. Twenty-one (21) broken wire wraps were identified on the upstream portion of the pipe, correlating well with the location of the 25 estimated from the electromagnetic survey. The wire breaks were inspected and found to be brittle in nature. Typically, brittle wire fractures, as those observed on Pipe 3423, are a result of a moderate to severe degree of hydrogen embrittlement. Hydrogen embrittlement is typically attributed to the poor techniques utilized by Interpace Corporation in the manufacturing of high strength Class IV wire. However, hydrogen embrittlement has been observed within manufactured Class III prestressing wires – as in Pipe 3423. Figures 3.5 and 3.6 show the observed brittle wire fractures.

Figure 3.5 Brittle wire fracture observed following the removal of the mortar coating.

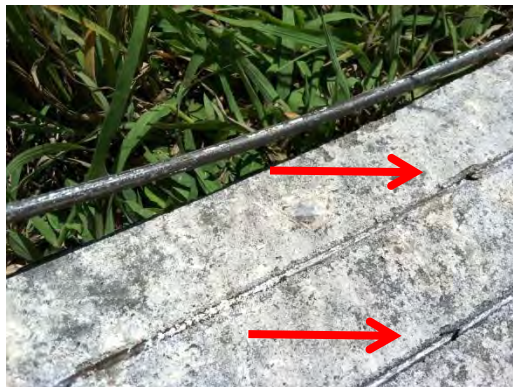
Figure 3.6 Brittle wire fractures observed embedded in a sample of the mortar coating.

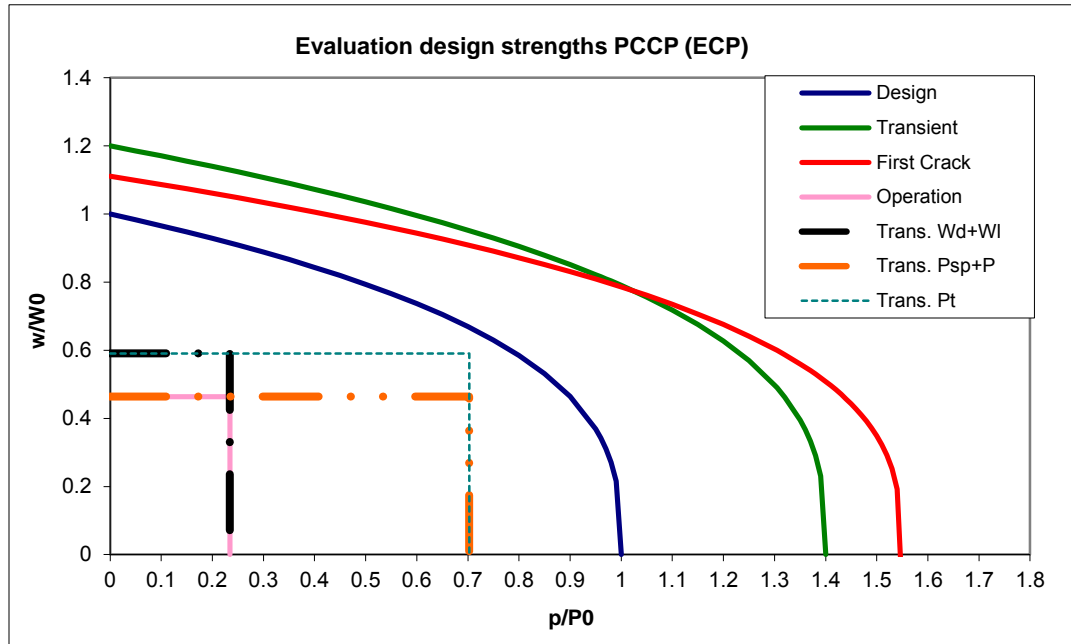
Figure 4.2. AWA C301 Appendix A design curve for 60-inch embedded cylinder PCCP.

The AWWA C301 Appendix A design curve for the 60-inch SW Well Field Supply Main is shown in Figure 4.2. The blue line indicates the design curve and the green line represents the transient curve. Using the AWWA C301 Appendix A “Cubic Parabola Method”, the design for the 60-inch pipe would be satisfied under the actual loading conditions. AWWA C301, the design standard in place at the time of manufacturing, analyses concluded that each of the three mains was operating within their design limits. All structural C301 plots are contained in Appendix F, one for each of the pipe designs within the three subject transmission mains.
