ENVIRONMENTAL IMPACTS OF THE  
1990 BAL HARBOR BEACH  
RENOURISHMENT PROJECT:  
Mechanical and Sedimentation Impact on  
Hard-Bottom Areas Adjacent to the  
Borrow Area

December 1990

Metro Dade Derm Technical Report 90-15

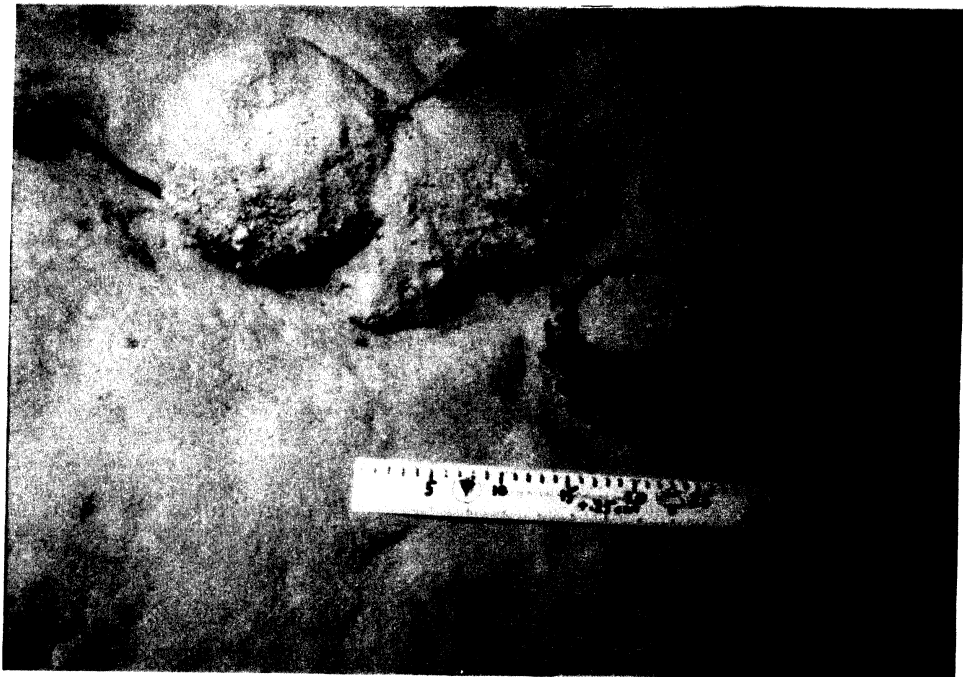
Figure 7. Sediment accumulation in a barrel sponge (Xestospongia muta) on the DLS site.
