Subject: Resolution Approving a Two-Year Extension to Contract E9668-0/13 with Slider Engineering Group, Inc. for Coordination, Construction Oversight, and Litigation Services Related to Water Damage at the Adrienne Arsht Center for the Performing Arts of Miami-Dade County

Storm Water System Failure Engineering Evaluation

Storm Water System Failure
Adrienne Arsht Center for the Performing Arts of Miami-Dade County
Miami, Florida

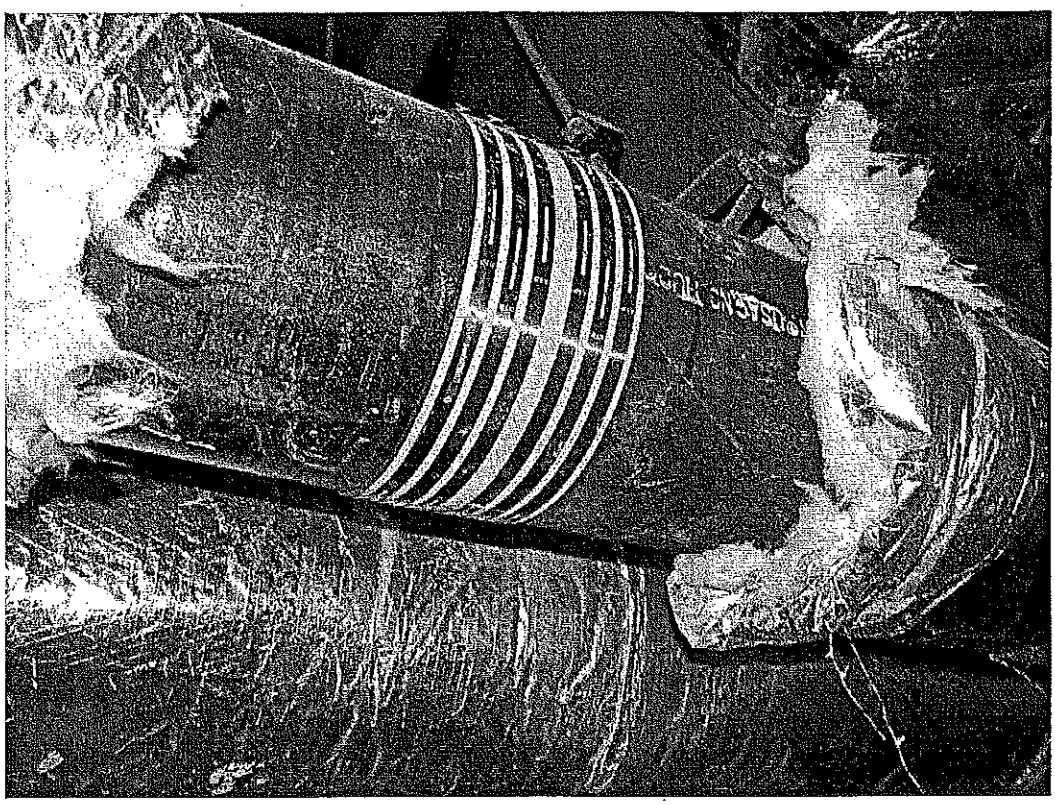
Photo 1: Typical Hubless Coupling with Stainless Steel Bands Securing an Elastomeric Sleeve

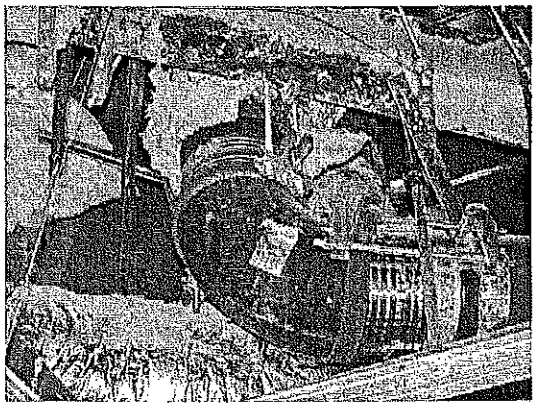
Photo 3: Post Failure Temporary Repairs at Point of Failure Illustrating New Code Compliant Joint Restraints and Couplings (Noted by Arrows

It was reported that PAC Management directed the temporary repairs of the area on the night of the incident. These repairs included re-assembling the failed pipe joint with a new no-hub coupling, the installation of temporary joint reinforcement at both ends of the elbow fitting, and the installation of a new pipe support hanger (see Photo 3).

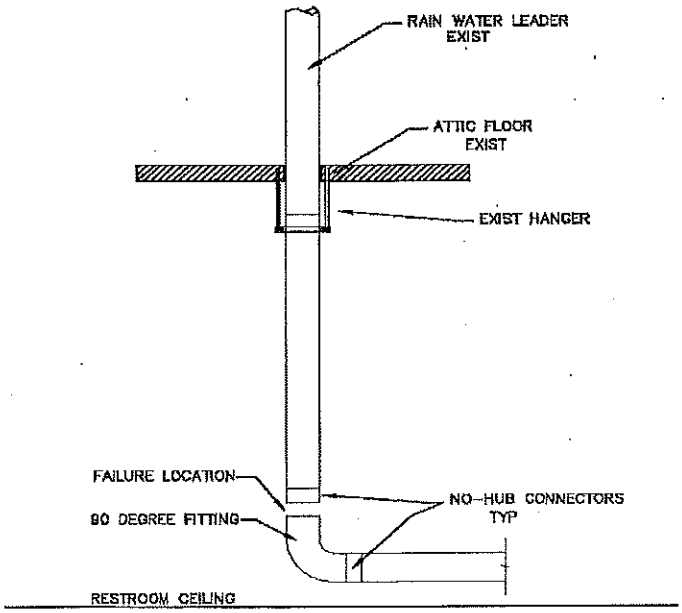
On May 20, 2012, a 12" diameter RWL above the east restroom ceiling on the 4th Tier of the ZBOH failed during a rain event. The point of failure was a no-hub coupling used to connect a 90 degree elbow fitting at a transition from a vertical (down flow) pipe to a horizontal pipe. The fitting reportedly became disengaged from the coupling during the rain storm leading to separation of the piping assembly at the joint (see Photo 2) causing storm water to flood the facility. Photo 3 is the point of failure, post temporary repair.

Figure 2: Failure location

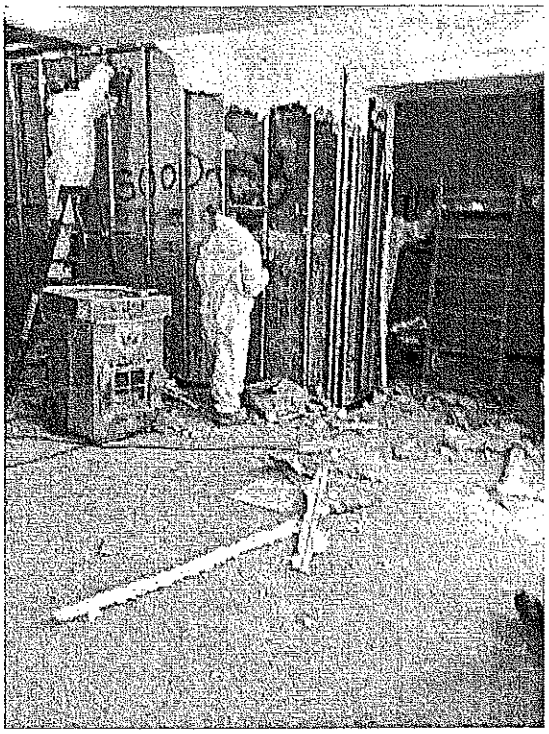
This failure of the storm water drainage system resulted in considerable damage to the interior finishes of the ZBOH building (See Appendix "C" for damage summary). Because the point of failure was located above the 4th tier of the ZBOH, the areas of water damage extended to the 4th tier, 3rd Tier, 2nd tier, Ballet Box Tier, Intermediate Level and Orchestra Level (see Photos 4 thru 7).

Photo 4: Damage to Interior Finishes

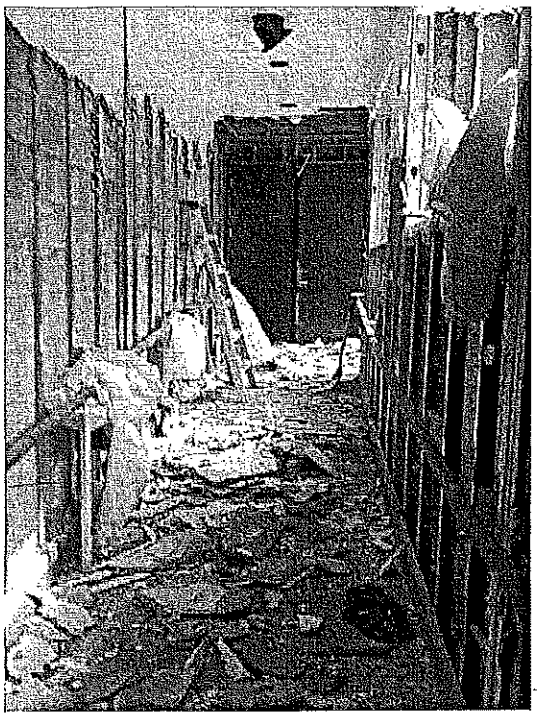
Photo 5: Damage to Interior Finishes

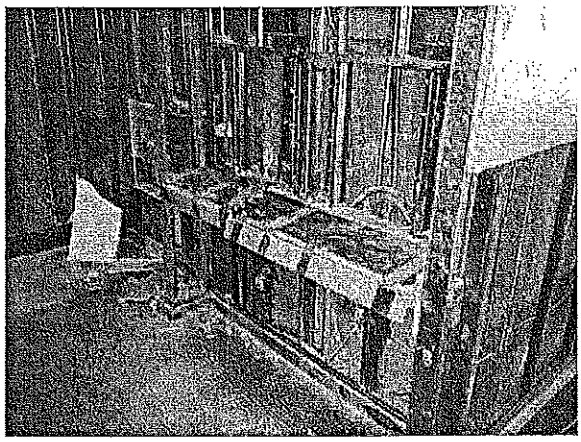
Photo 7: Damage to Interior Finishes

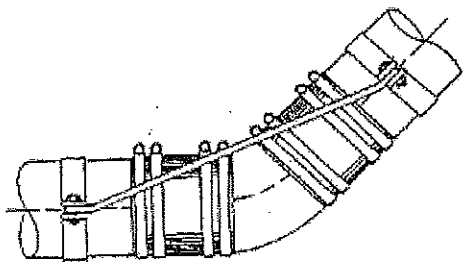
Figure 3: Typical Joint Reinforcement for Large Diameter Pipe (CISPI)

Suitable bracing at joint locations, as required by CISPI, is achieved through the installation of a bolted-on joint reinforcement bracket. Figure 3 illustrates typical joint reinforcement as recommended by CISPI.

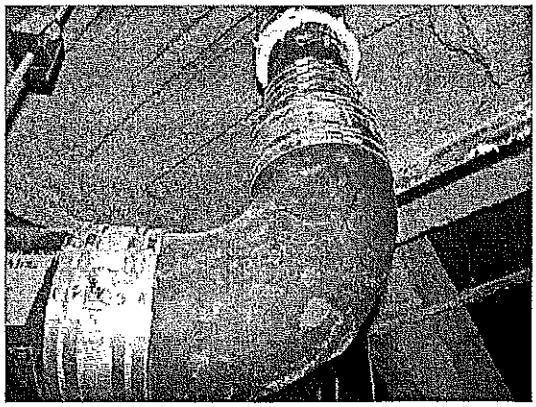
Photo 8: 90 degree Fitting missing Joint Reinforcement

During our review it was observed that no joint reinforcement was installed throughout the storm water drainage system. Photo 8 is a typical example of a 90 degree pipe fitting connected with no-hub couplings, but is lacking the joint reinforcement specified in the contract documents.

It is my professional opinion that the original pipe installer's failure to install joint reinforcement on both ends of the subject elbow was the primary cause of the failure.

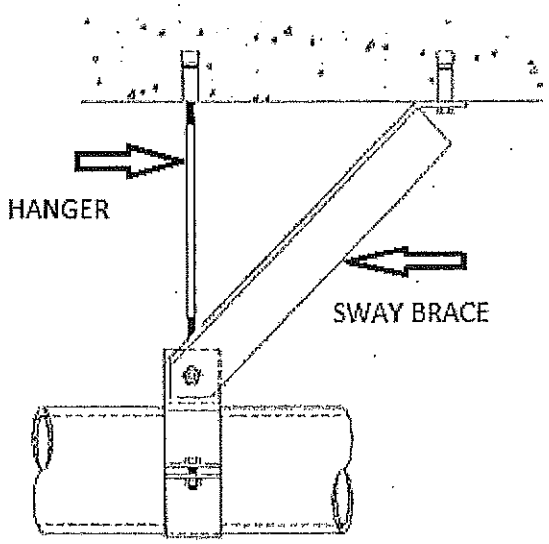
Figure 4: Example of Typical Sway Bracing (CISPI)

> *"Horizontal pipe and fittings five inches and larger must be suitably braced to prevent horizontal movement."*

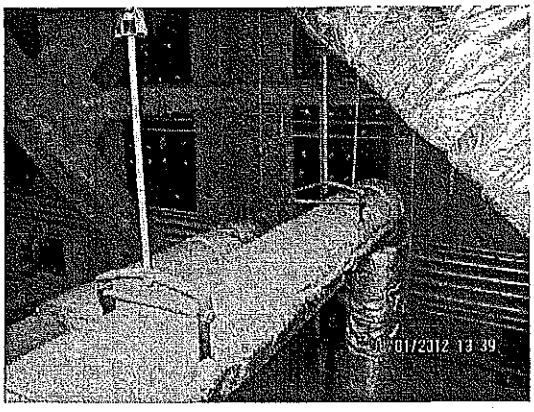
Photo 9: Pipe Installation with no Sway Bracing

During the survey of the pipe installation SEG observed that the piping is primarily suspended from single, threaded rod hangers with no "sway bracing" installed (see Photo 9). Single point rod hangers, incorporating rubber sound isolators, are considered "non rigid" hangers and were observed installed with an un-braced length of up to 20 feet. The installed configuration provides no restraint of horizontal sway motion. Figure 3 above shows an example of typical sway brace as detailed by CISPI.

It is my professional opinion that the original pipe installer's failure to include sway bracing on the storm water drainage system pipe was a significant contributor to the failure.

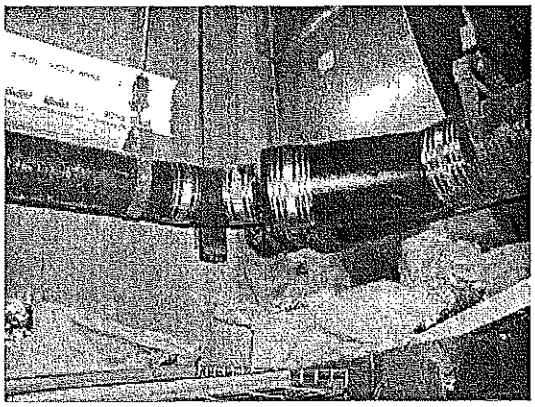
Photo 10: Pipe Installation missing Hangers

At various points throughout the system, pipe components were observed that were not supported at every joint as required per Contract Documents. Photos 10 thru 12 illustrate examples of these deviations from specifications.

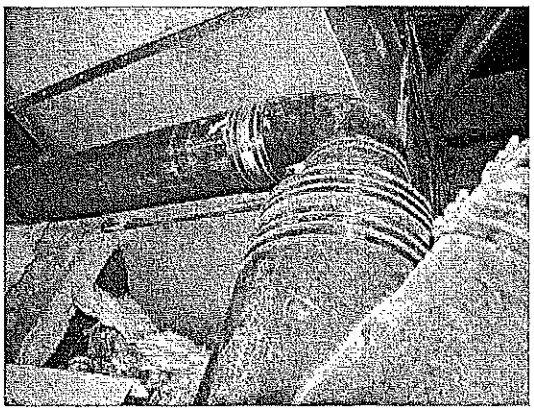
Photo 12: Piping Installation missing Hangers

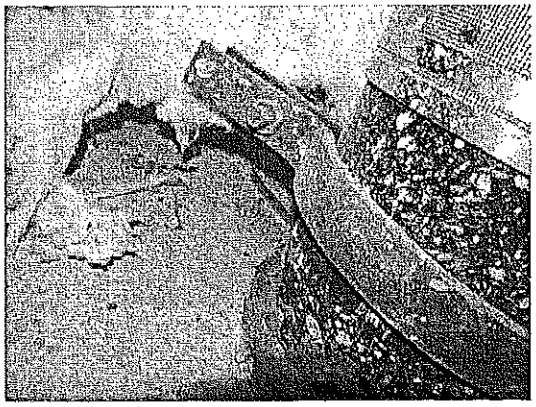
Photo 14: Improperly installed Riser Clamp

Riser clamps were observed to be missing on several of the vertical risers (see Photo 13). In other locations the riser clamps were improperly installed. Photo 14 shows a riser clamp that is not in contact with the floor and is therefore not supporting the weight of the pipe riser.

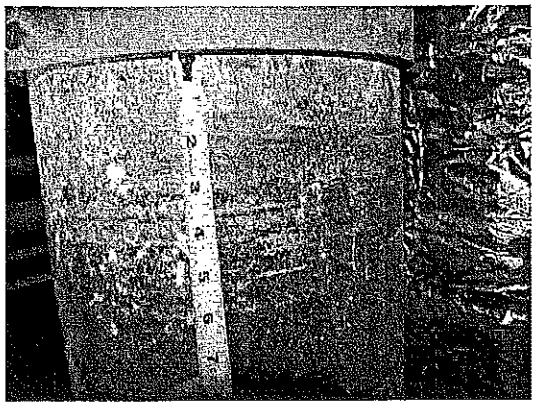
Photo 15: Evidence of Pipe Slippage above Point of Failure

Improper vertical support was further evidenced at the piping section directly above the point of failure. Photo 15 shows that the pipe had slipped downwards in the pipe clamp at this location. These observed configurations impose weight on the elastomeric rubber connections of the pipe system. As an additional note, the riser clamps should incorporate sound isolation pads.

This riser section, just above the attic floor, is directly above the failure point of the 90 degree elbow in the 4th tier restroom. The slippage of the pipe is indicative of the downwards force imposed by the storm water pulsing through the inadequately restrained and/or braced piping system impacting on the elbow below. The force of the falling storm water caused a downward load to impact on the fitting, which disengaged the fitting from the coupling. Additionally, the force of the water changing direction in the fitting will generate sway movement of the inadequately restrained piping system.

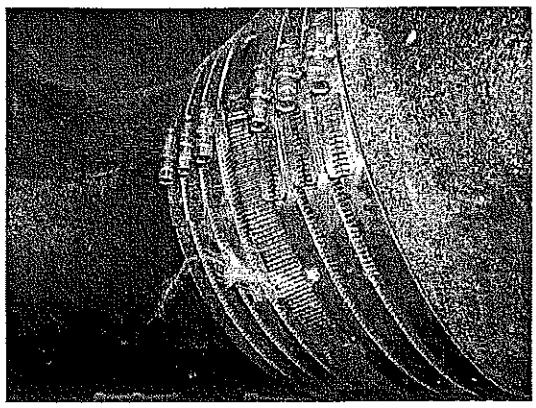
The no-hub fittings incorporate either 4 or 6 hose clamp bands which secure the elastomeric rubber sleeve to the pipes (see Photo 16).

Photo 16: No-Hub Coupling with 6 Hose Clamps

The manufacturer (ANACO) of the couplings specifies that these bands be tightened using a torque wrench to a torque value of 80

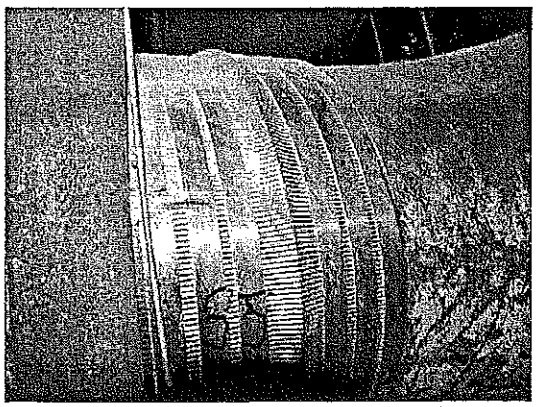
Several of the couplings reviewed exhibited a deformation of the metal shield as shown in Photo 17. Deformation of the shield metal indicates that the coupling has been displaced from its original installation configuration. This deformation is indicative of excessive movement of the piping system due to inadequate sway bracing.

Photo 17: Example of a Coupling with a Deformed Shield
