APPENDIX "F" TO SPECIAL PROVISIONS
STRUCTURES LOAD RATING CALCULATIONS

PW Project No. 20200315, EDP-MT-20200315

**Matheson Hammock Park Road (Bridge No.874294) over
Matheson Hammock Canal**

DEPARTMENT OF TRANSPORTATION AND PUBLIC WORKS

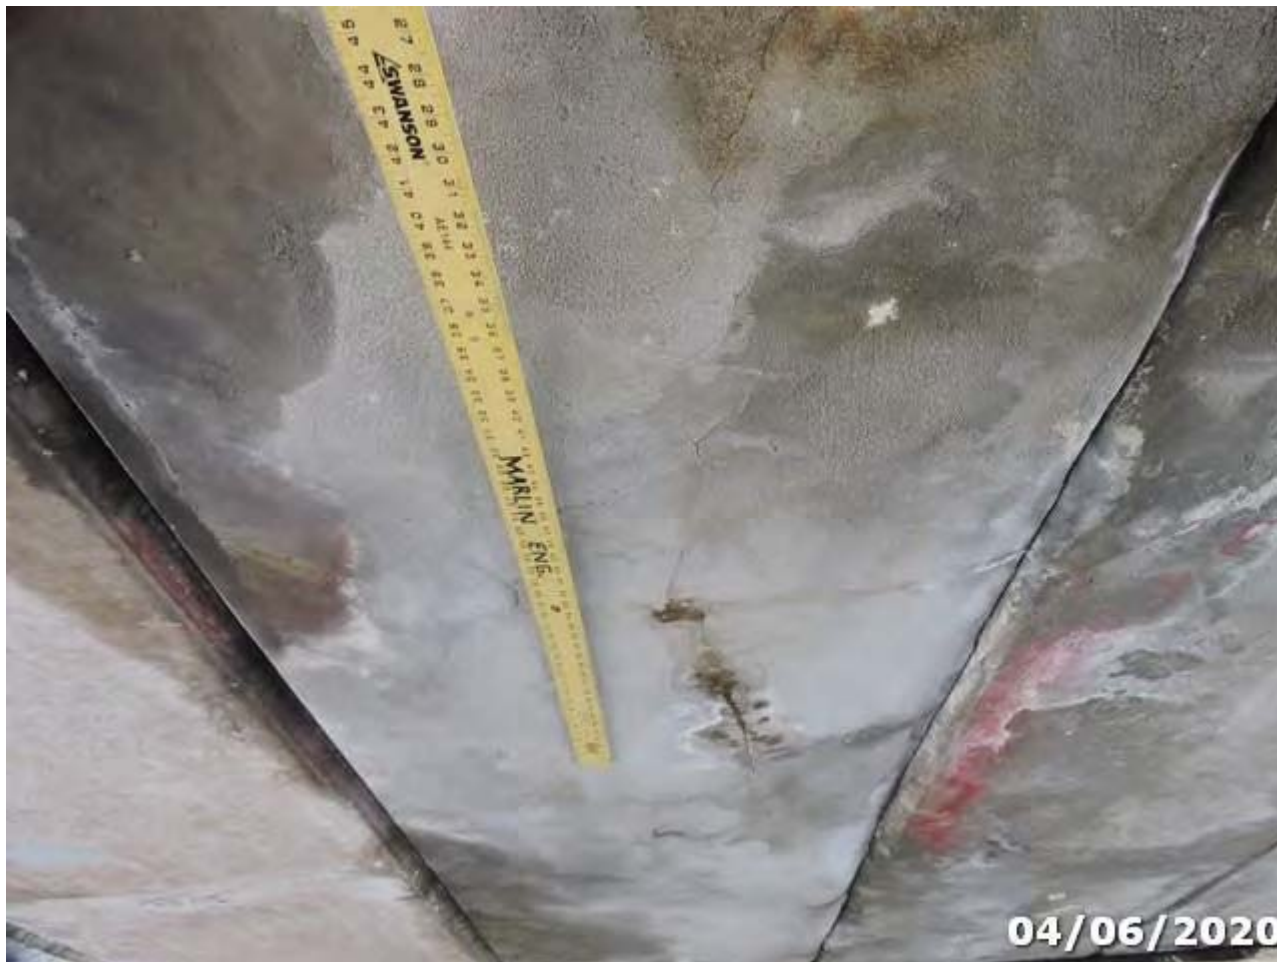
Photo 05 Element/Env 8099/3: PS Conc Slab (Sonovoid)

Slab Unit 3-7 has an unsound repaired area 11ft. L x 2ft. W starting from Abutment 4 with hollow sounding throughout and associated cracks up to 1/16in. W with efflorescence and corrosion bleed-out.

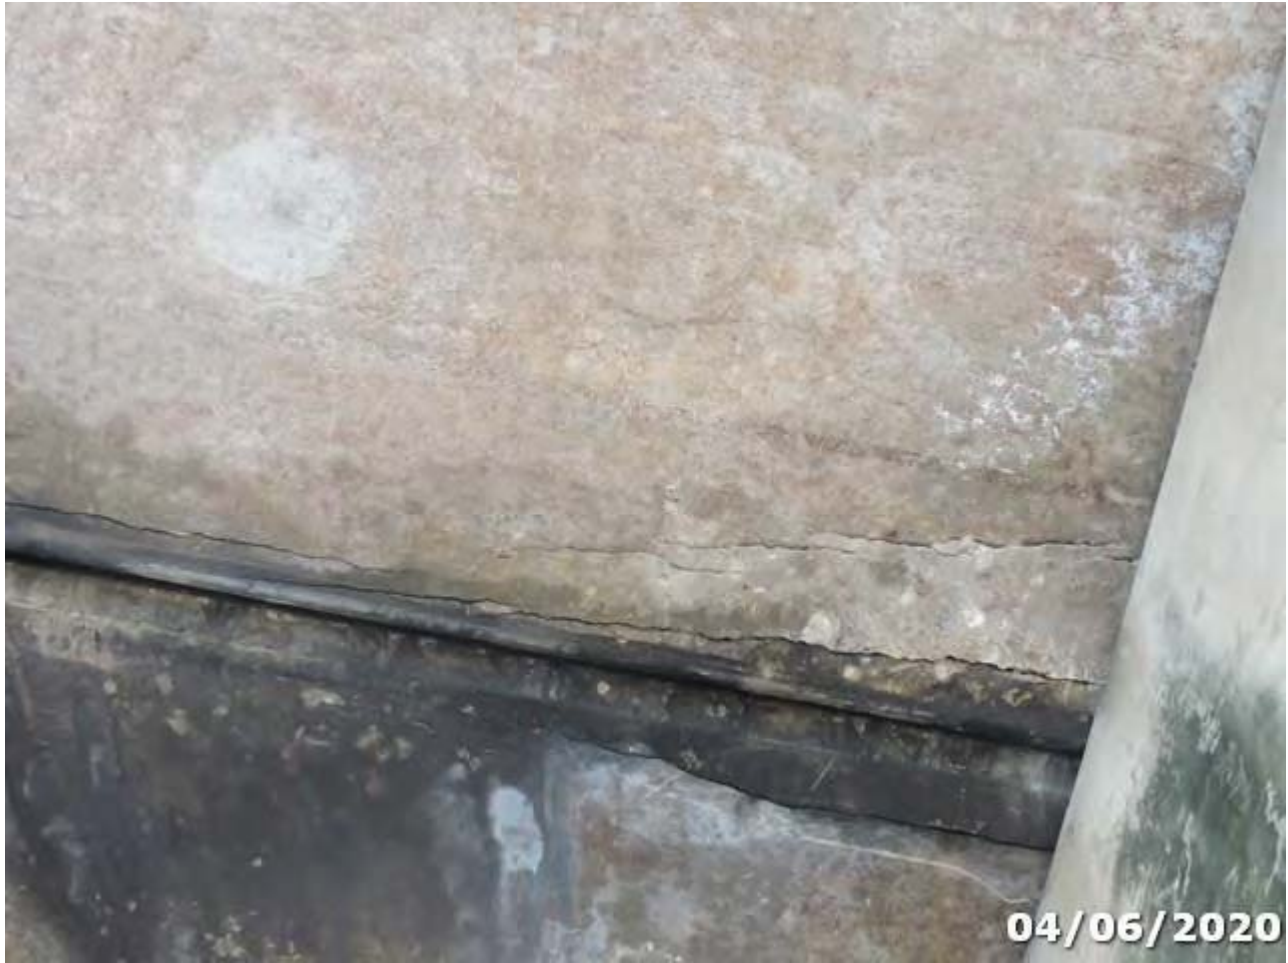
Photo 07 Element/Env 8099/3: PS Conc Slab (Sonovoid)

_Slab Unit 2-6, east edge has a delamination 30in. L x 4in. W starting at Pier 2 cap. (Total 3 SF). Refer to Photo 07. NO CHANGE.

_Slab Unit 2-7, west edge has a delamination up to 24in. L x 4in. W starting at Pier 2 cap. (Total 2 SF) Refer to Photo 07. NO CHANGE.

Slab Units 2-6 and 2-7, east and west edges have delaminations up to 30in. L x 4in. W, starting at Pier 2 cap.

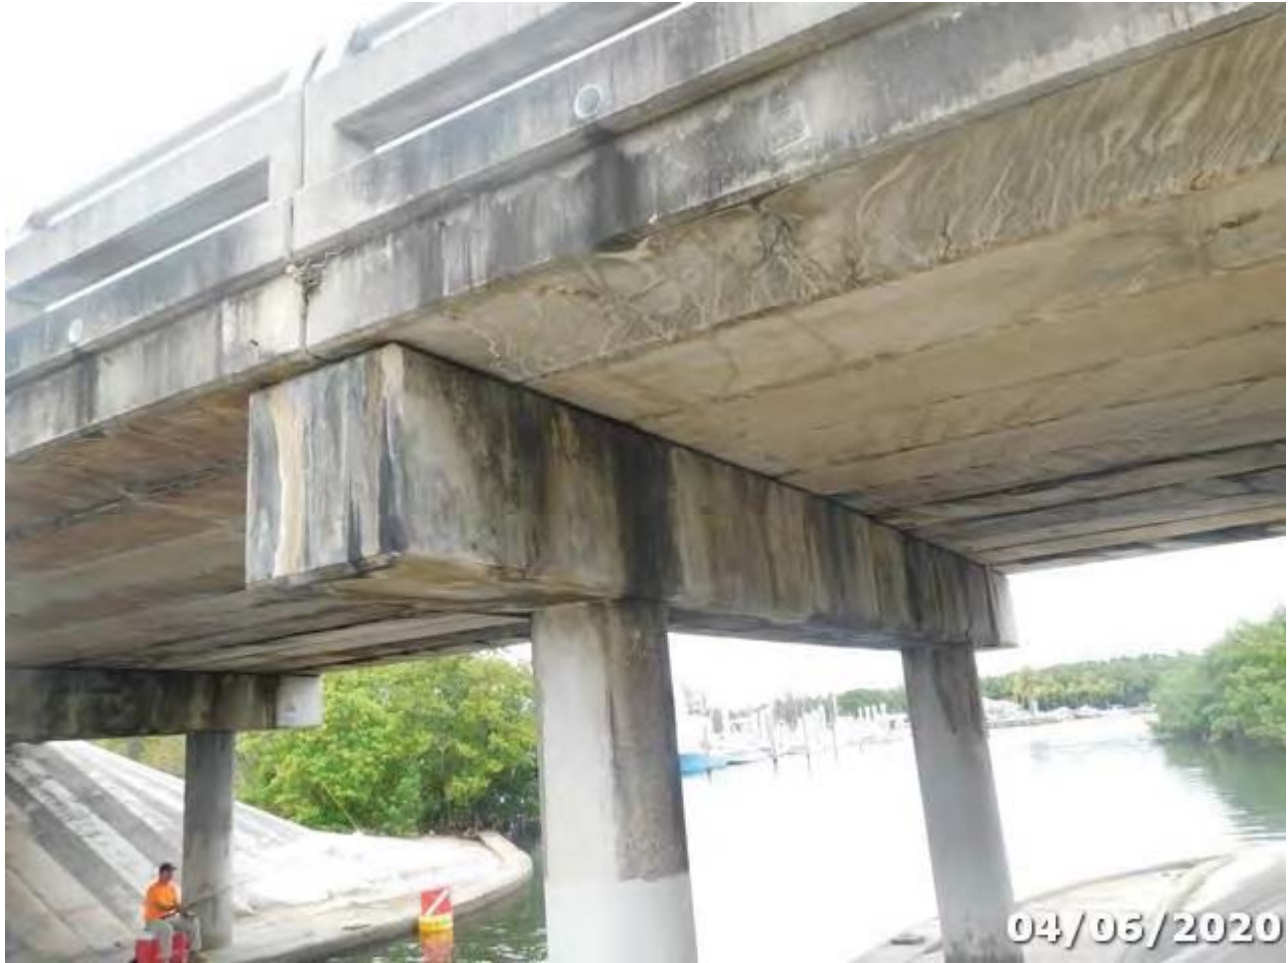
Photo 14 Element/Env 301/3: Pourable Joint Seal

2310/3 CS-3:
_There is evidence of moderate to heavy water seepage through the expansion joints on bents and abutment caps. (Total 104 LF) Refer to Photo 14. NO CHANGE. NCAR.

There is evidence of moderate to heavy water seepage through the expansion joints on bents and abutment caps.

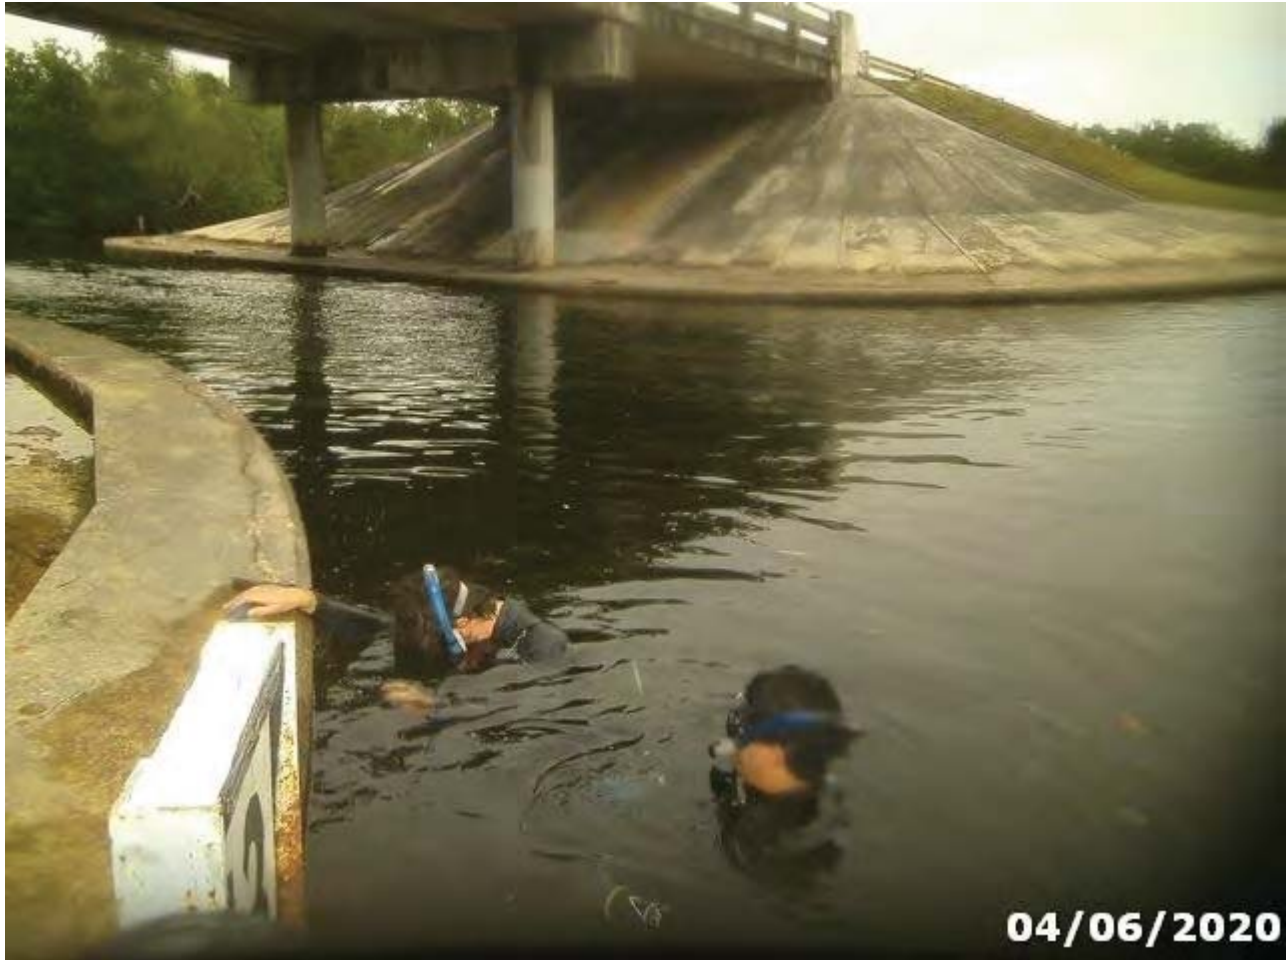
Photo 16 Element/Env 8290/3: Channel

Divers conducting the Underwater Inspection.

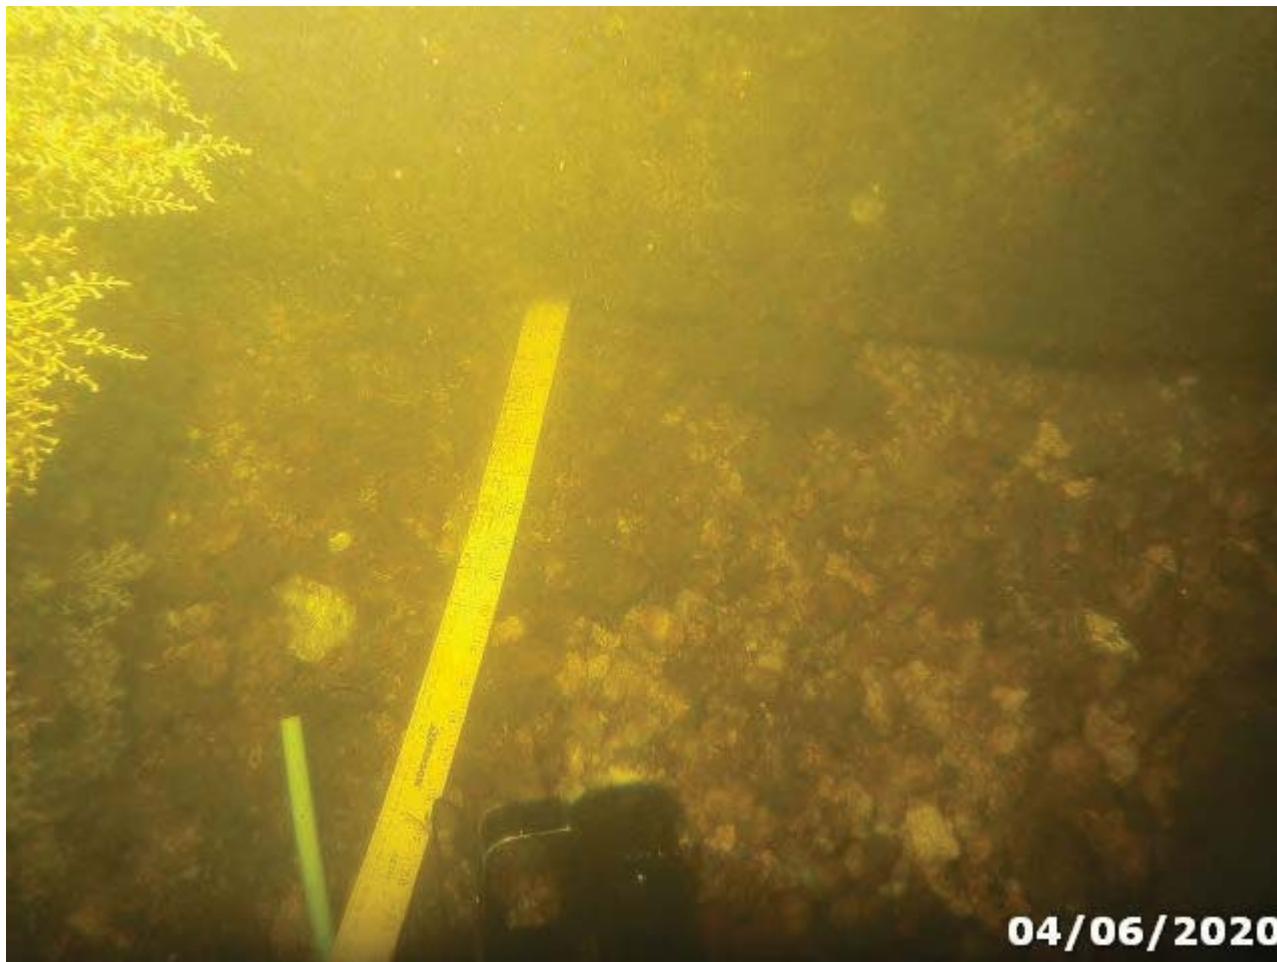
Photo 17 Element/Env 8290/3: Channel

undermining up to 22ft. L x 9in. H x 21in. of penetration. (Total 1 ea.) Refer to Photo
 17. NO CHANGE.

There are two areas of undermining up to 22ft. L x 3in. H x 21in. of penetration with backfill migration under the north seawall, below Slab Units 2-2 and 2-5.

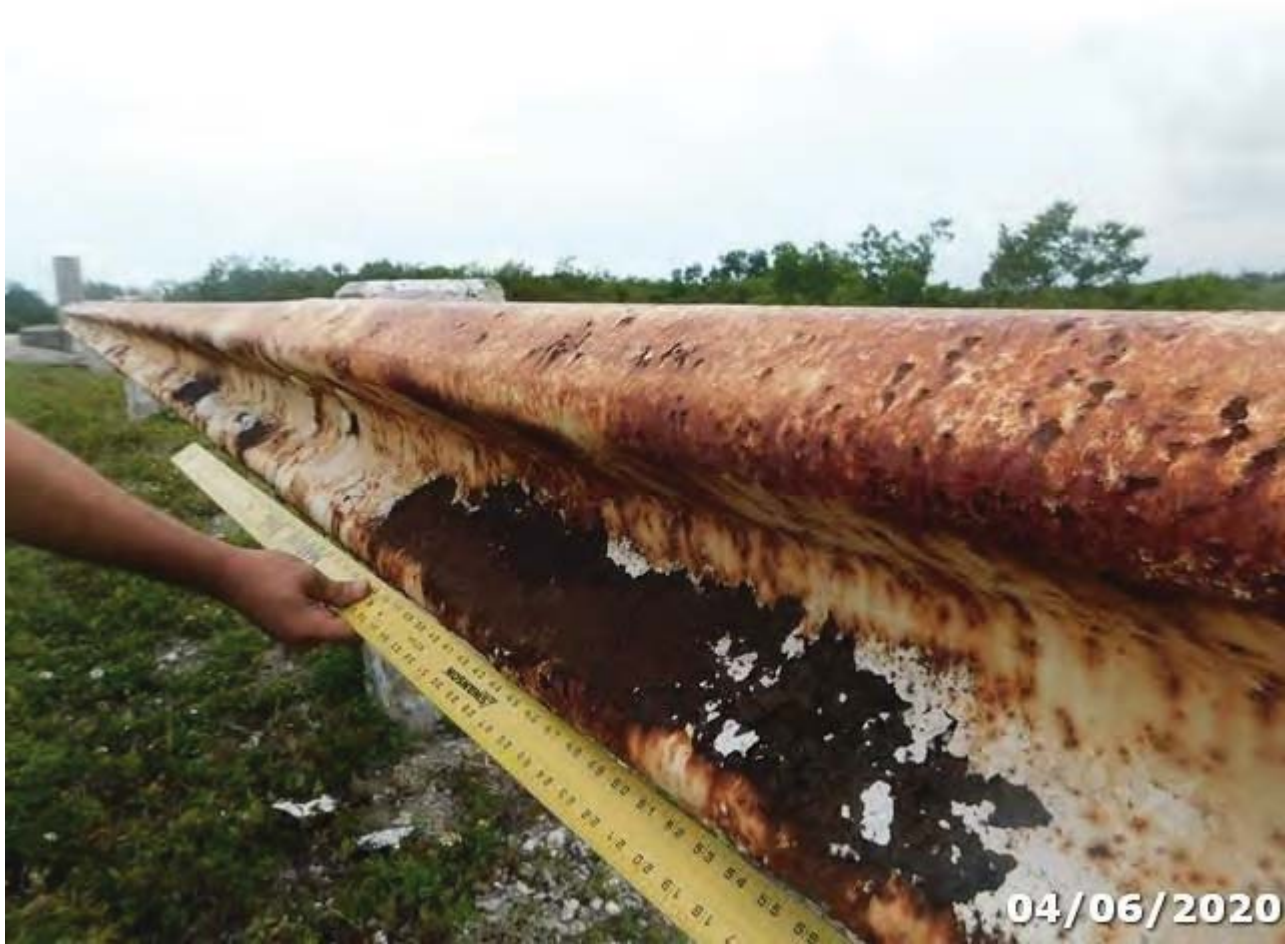
Photo 19 Element/Env 321/3: R/Conc Approach Slab

_The approach guardrail panels exhibit moderate to heavy corrosion with numerous corrosion holes throughout. Refer to Photo 19. NO CHANGE.

The approach guardrail panels exhibit moderate to heavy corrosion with numerous corrosion holes throughout.

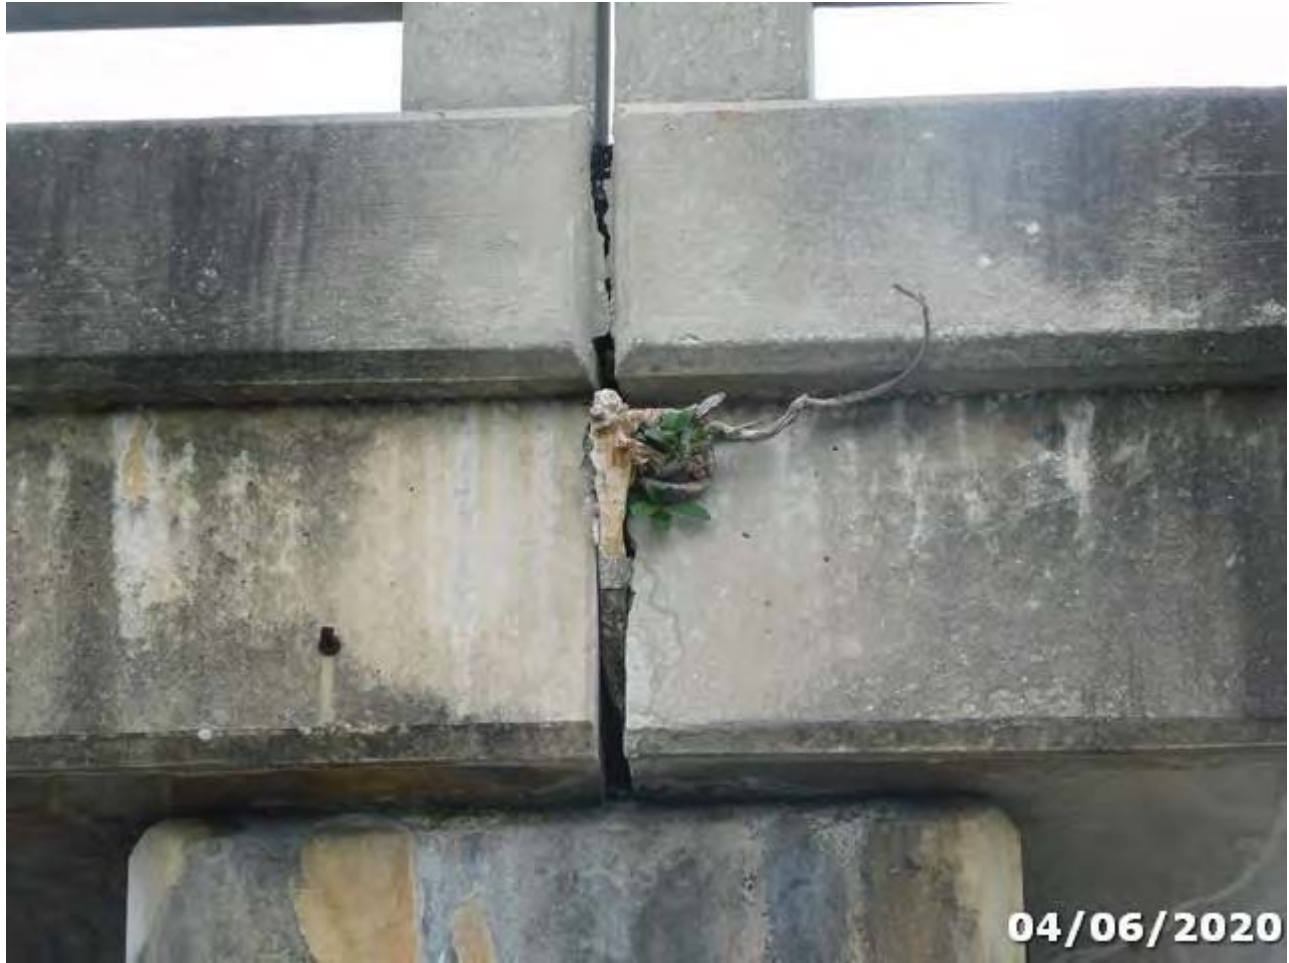
Photo 23 Element/Env 234/3: Re. Concrete Pier Cap

_Bents 2 and 3 caps have vegetation growth along the west end. Refer to Photo 23. NO CHANGE.

Bents 2 and 3 caps have vegetation growth along the west end.

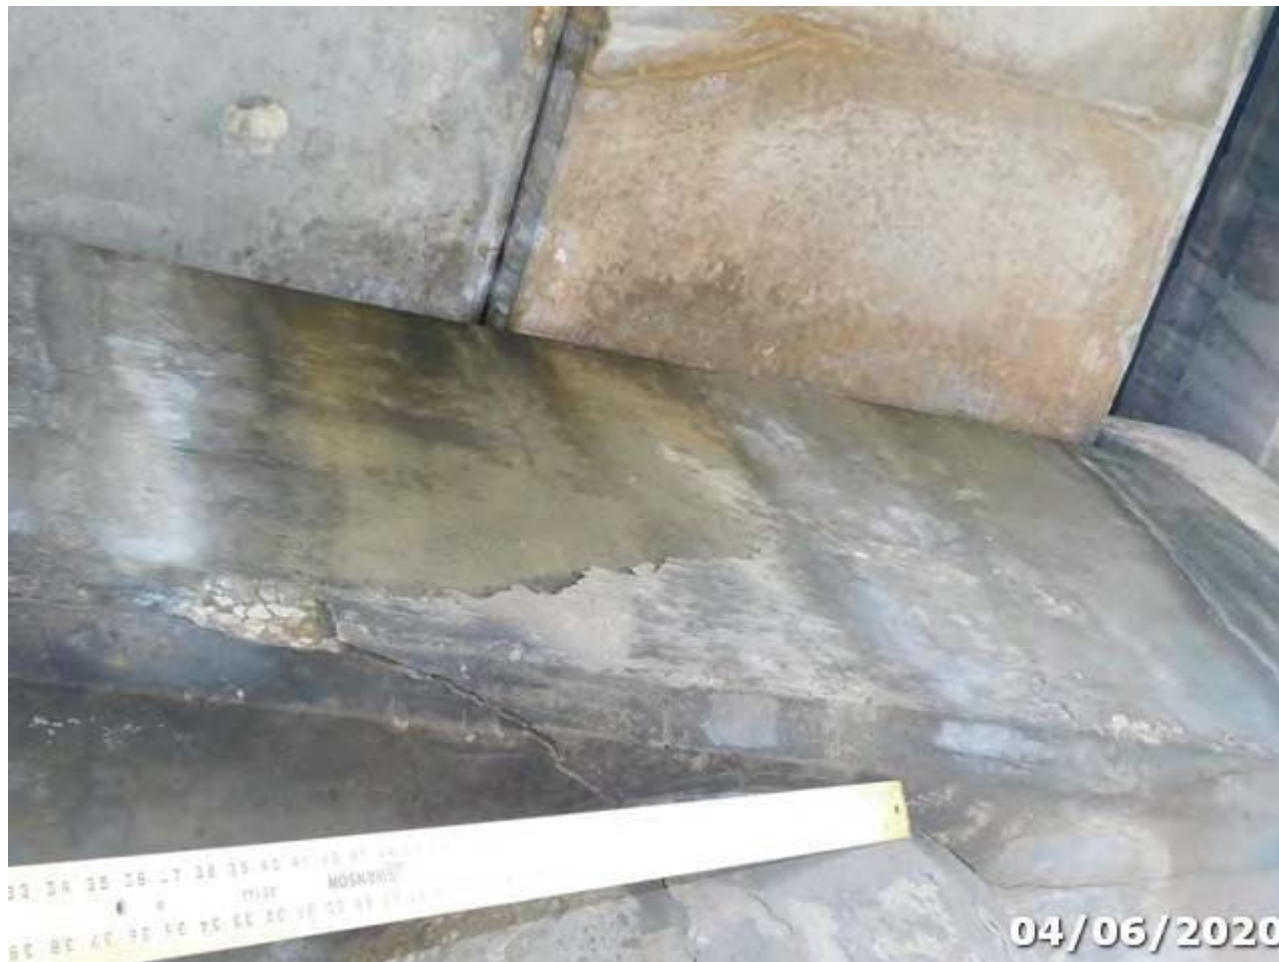
Photo 24 Element/Env 234/3: Re. Concrete Pier Cap

_Bent 2 cap has a spall/delamination up to 3ft. L x 16in. H x 1 in. D on the south face over Column 2-2, and on the same location, north face a delamination 20in. L x 12in. H. Previously noted only a delamination 3ft. L x 16in. H. (Total 3 LF) Refer to Photo 24. INCREASE.
 _Bent 3 cap, bottom and north faces has two unsound repaired areas with multidirectional cracks up to 1/64in. W. No unsound concrete with cracks was previously noted. (Total 4 LF) INCREASE.

Bent 2 cap has a spall/delamination up to 3ft. L x 16in. H x 1 in. D on the south face over Column 2-2, and on the same location, north face a delamination 20in. L x 12in. H.

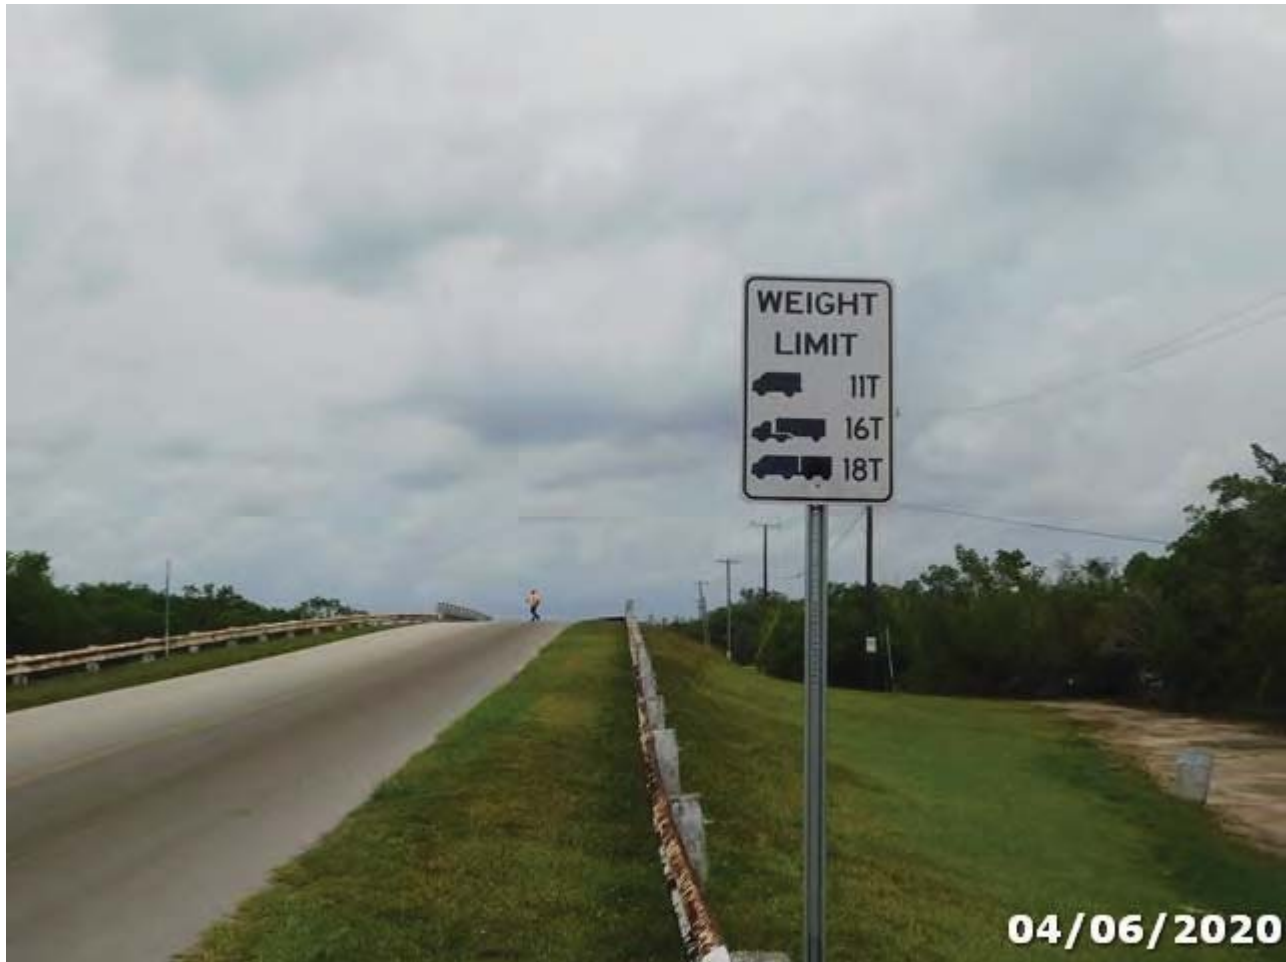
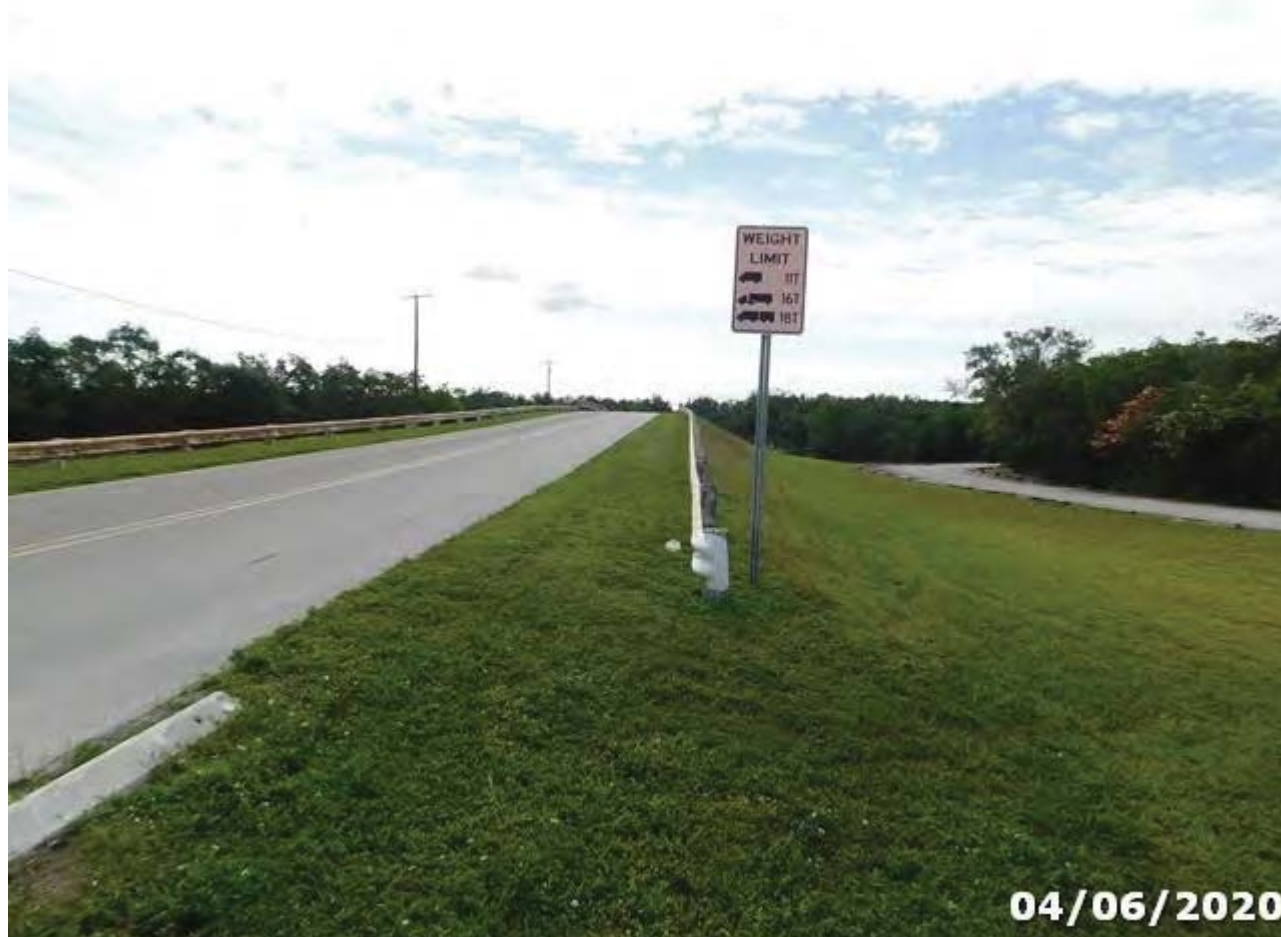
Photo 33 STRUCTURE NOTES: South Approach Posting Sign

Photo 34 STRUCTURE NOTES: North Approach Posting Sign

Based on the current load rating analysis dated 1/13/2020, it is recommended that this bridge be posted for the SU, C and ST5 type vehicles as follows: SU = 11 tons, C = 16 tons, ST5 = 18 tons. The bridge is currently posted for SU = 11 tons, C = 16 tons, ST5 = 18 tons. Refer to posting signs Photos 33 and 34.

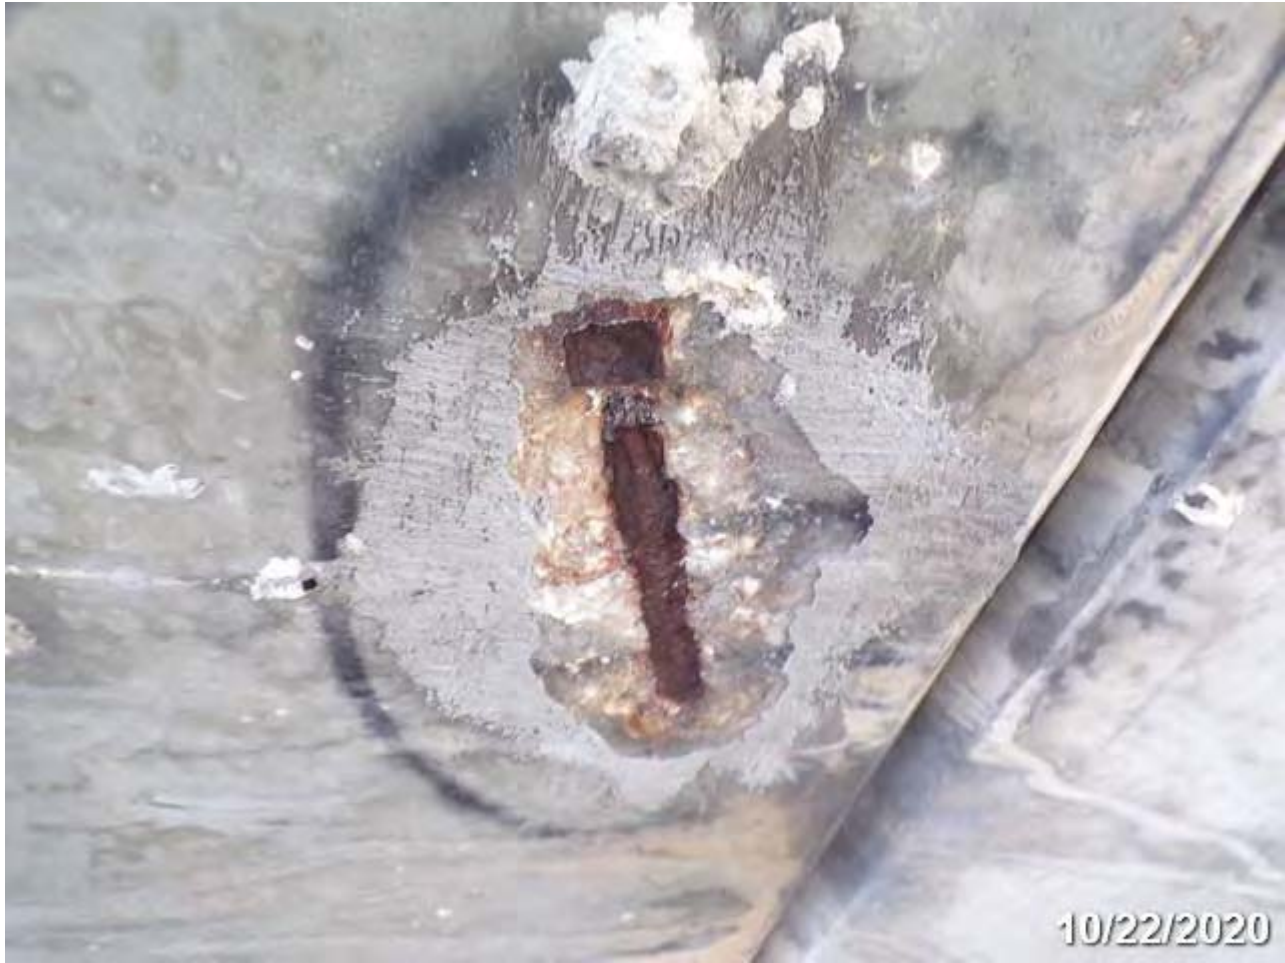
PHOTO 03: ELEMENT/ENV: 8099/3 PS Conc Slab (Sonovoid)

Slab Unit 1-6 exhibits a spall with exposed rebar up to 11in. L x 5in. W x 1/8in. D with minor section loss and evidence of previous failed repair, at 9ft. from Abutment 1.

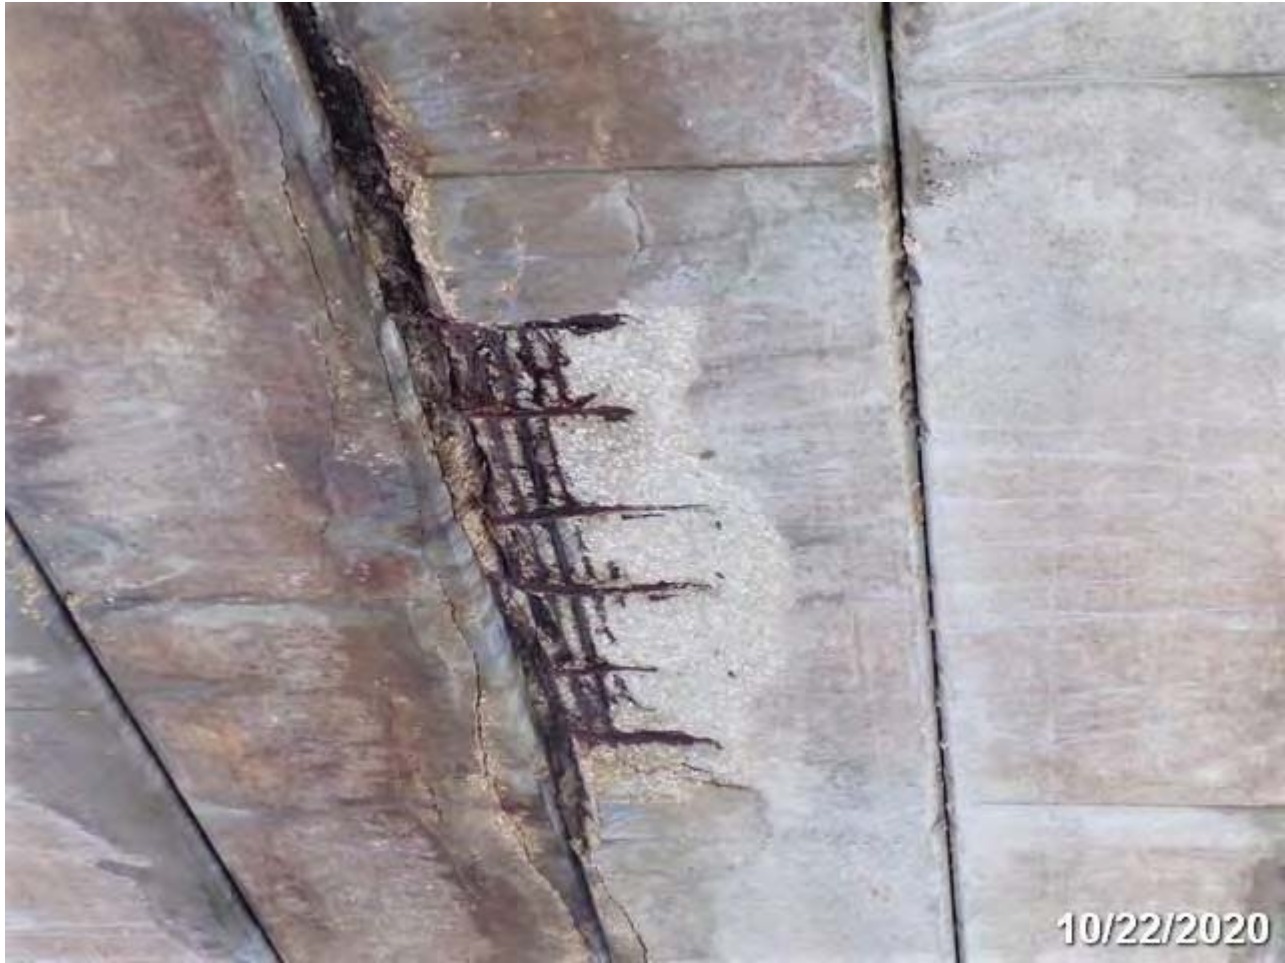
PHOTO 04: ELEMENT/ENV: 8099/3 PS Conc Slab (Sonovoid)

_Slab Unit 2-8 has a spall 10ft. L x 24in. W x up to 4in. D at mid-span with 6 exposed and corroded transverse rebars with up to 60% section remaining and 5 exposed and corroded prestressing strands with up to 0% section remaining (2 broken threads). (20 SF). - NO CHANGE. Refer to Photo 04.

Slab Unit 2-8 has a spall 10ft. L x 24in. W x up to 4in. D at mid-span with 6 exposed and corroded transverse rebars with up to 60% section remaining and 5 exposed and corroded prestressing strands with up to 0% section remaining (2 broken threads).

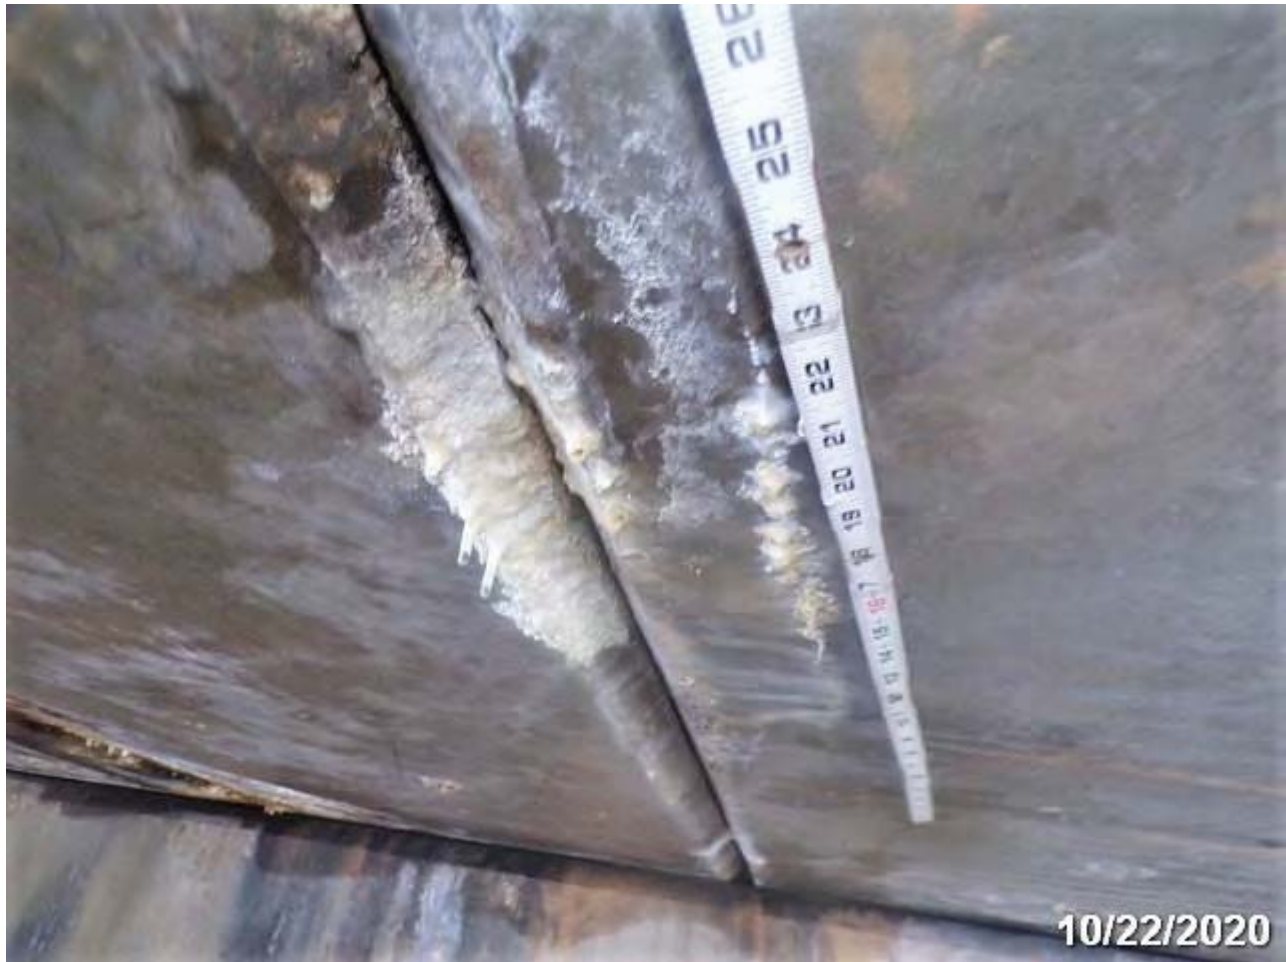
PHOTO 05: ELEMENT/ENV: 8099/3 PS Conc Slab (Sonovoid)

_Slab Unit 1-6 east edge has two delamination areas, one up to 5ft. L x 6in. W starting at Abutment 1 and the other starting at Pier Cap 2 up to 9ft. L x 12in. W with associated cracks up to 1/16in. W with efflorescence throughout. (Previously noted as a delamination full length x 12in. W.) (14 SF). - DECREASE. Refer to Photos 05 and 06.

Slab Unit 1-6 east edge has two delamination areas, one up to 5ft. L x 6in. W starting at Abutment 1 and the other starting at Pier Cap 2 up to 9ft. L x 12in. W with associated cracks up to 1/16in. W with efflorescence throughout. (Abutment 1 shown).

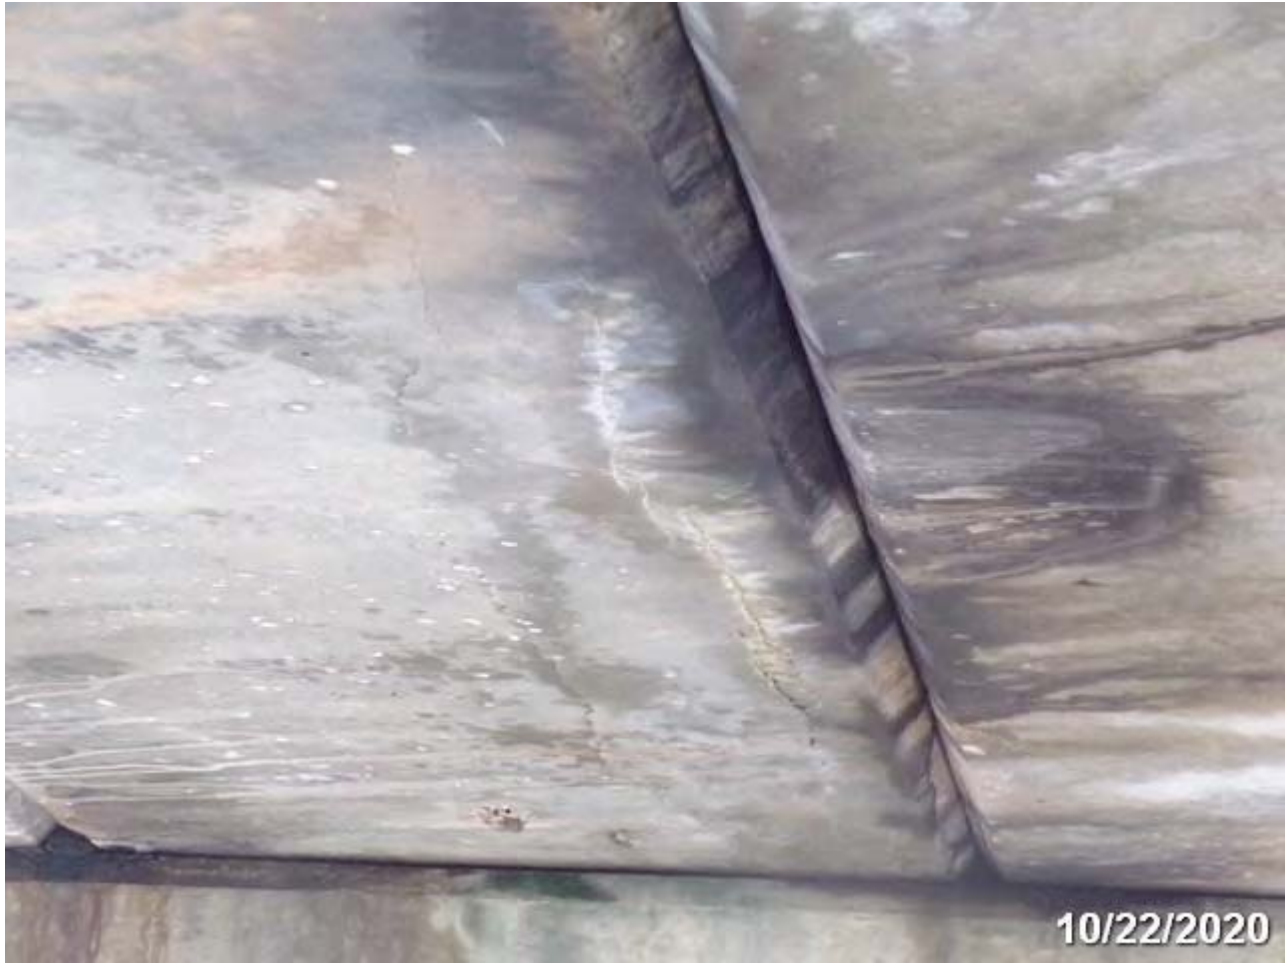
PHOTO 06: ELEMENT/ENV: 8099/3 PS Conc Slab (Sonovoid)

Slab Unit 1-6 east edge has two delamination areas, one up to 5ft. L x 6in. W starting at Abutment 1 and the other starting at Pier Cap 2 up to 9ft. L x 12in. W with associated cracks up to 1/16in. W with efflorescence throughout. (Pier Cap 2 shown).

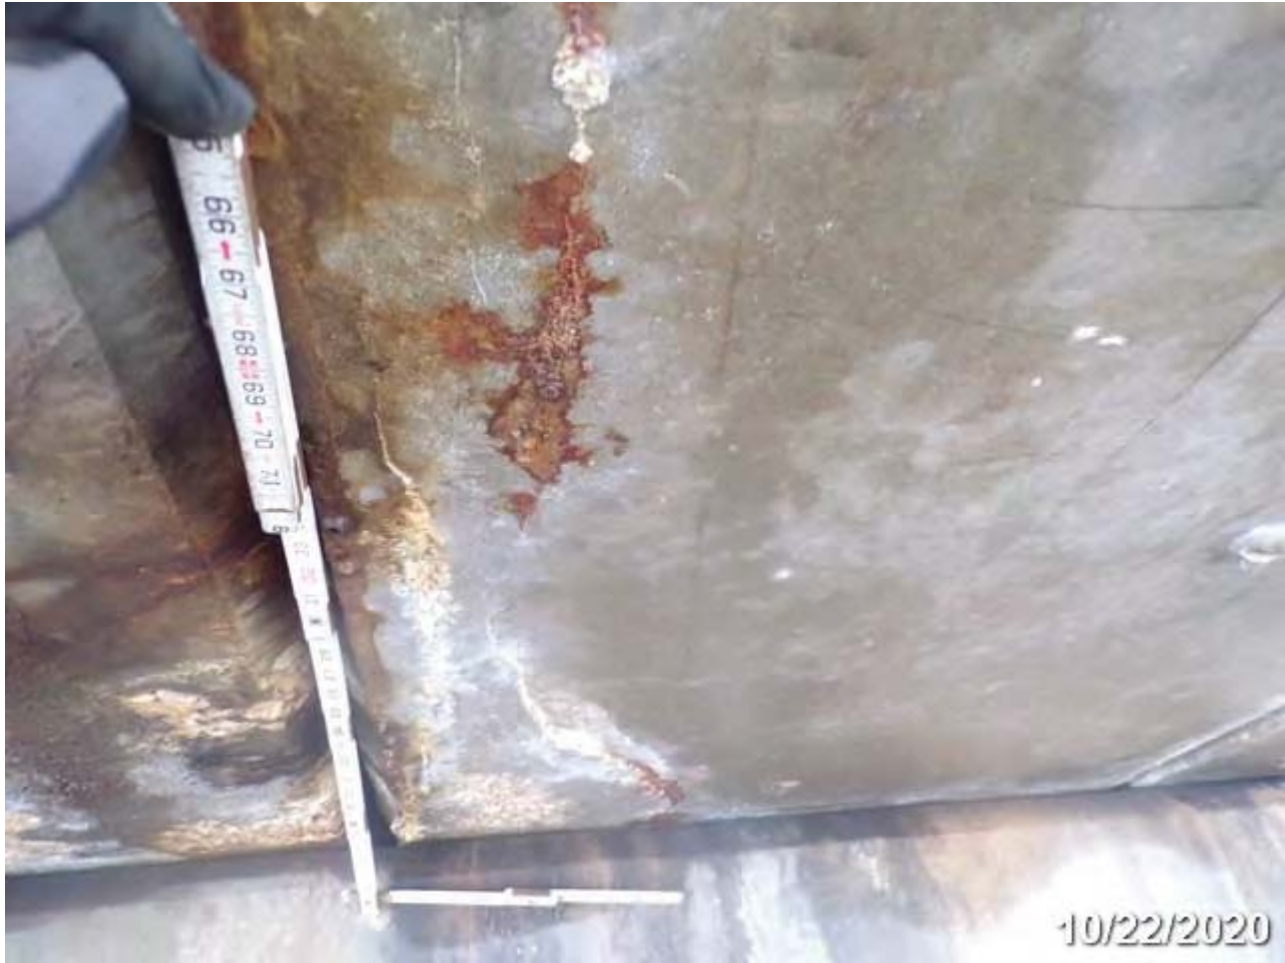
PHOTO 07: ELEMENT/ENV: 8099/3 PS Conc Slab (Sonovoid)

_Slab Unit 1-7 east edge has a spall/delamination 24in. L x 12in. W with associated cracks up to 1/32in. W with efflorescence and corrosion bleed-out over Abutment 1. (2 SF). - NO CHANGE. Refer to Photo 07.

Slab Unit 1-7 east edge has a spall/delamination 24in. L x 12in. W with associated cracks up to 1/32in. W with efflorescence and corrosion bleed-out over Abutment 1.

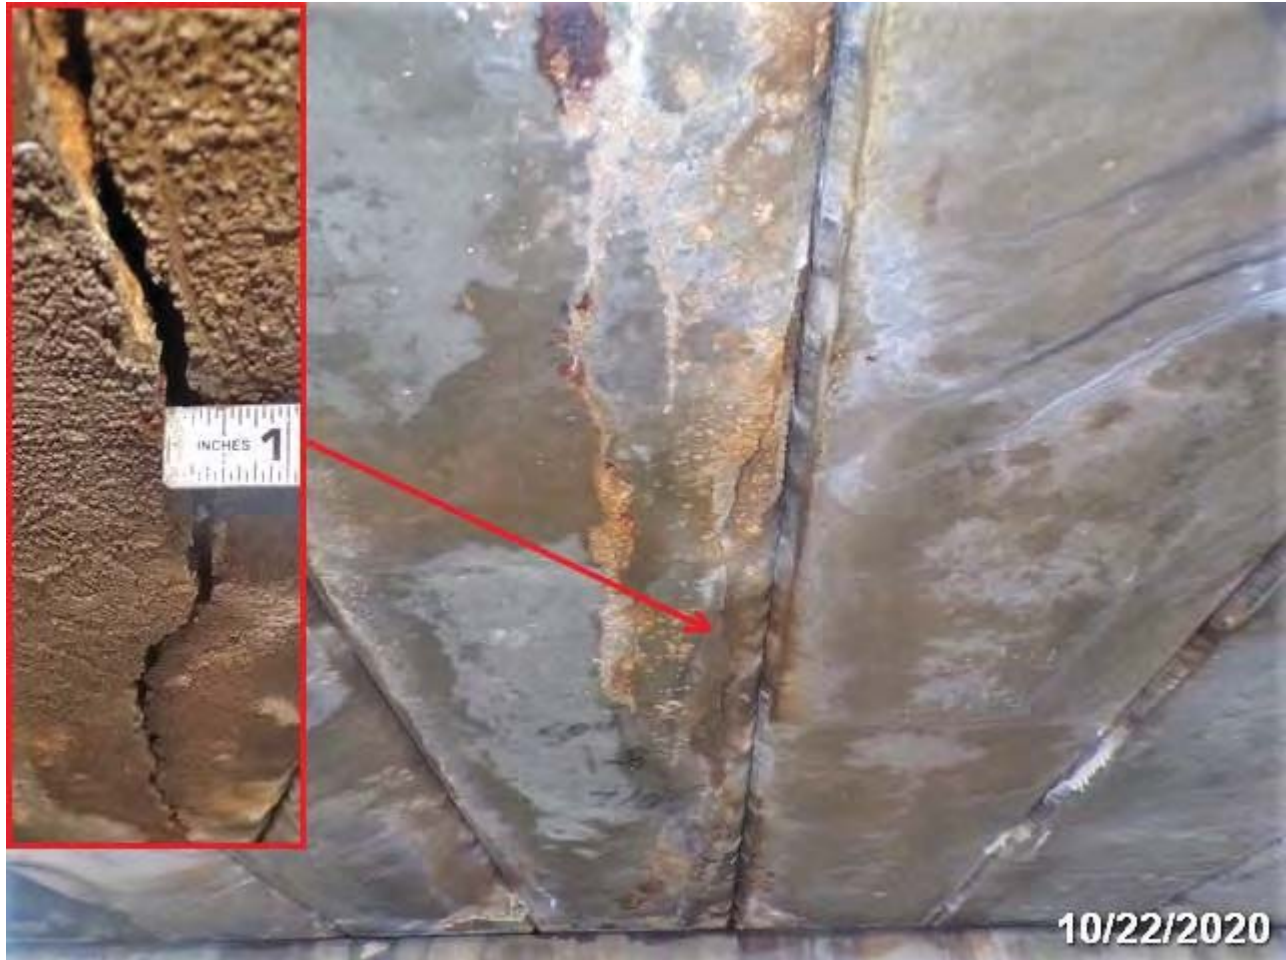
PHOTO 09: ELEMENT/ENV: 8099/3 PS Conc Slab (Sonovoid)

_Slab Unit 1-8 west edge is intermittently delaminated up to 15ft. L x 15in. W starting at Abutment 1 with associated cracks up to 1/4in. W with efflorescence and corrosion bleed-out and associated spalling up to 4ft. L x 6in. W x 2in. D approximately 10ft from Abutment 1. (Spalling was previously noted as spall/delamination on the east edge) (19 SF). - INCREASE. Refer to Photos 09 and 10.

Slab Unit 1-8 west edge is intermittently delaminated up to 15ft. L x 15in. W starting at Abutment 1 with associated cracks up to 1/4in. W with efflorescence and corrosion bleed-out and associated spalling up to 4ft. L x 6in. W x 2in. D approximately 10ft from Abutment 1.

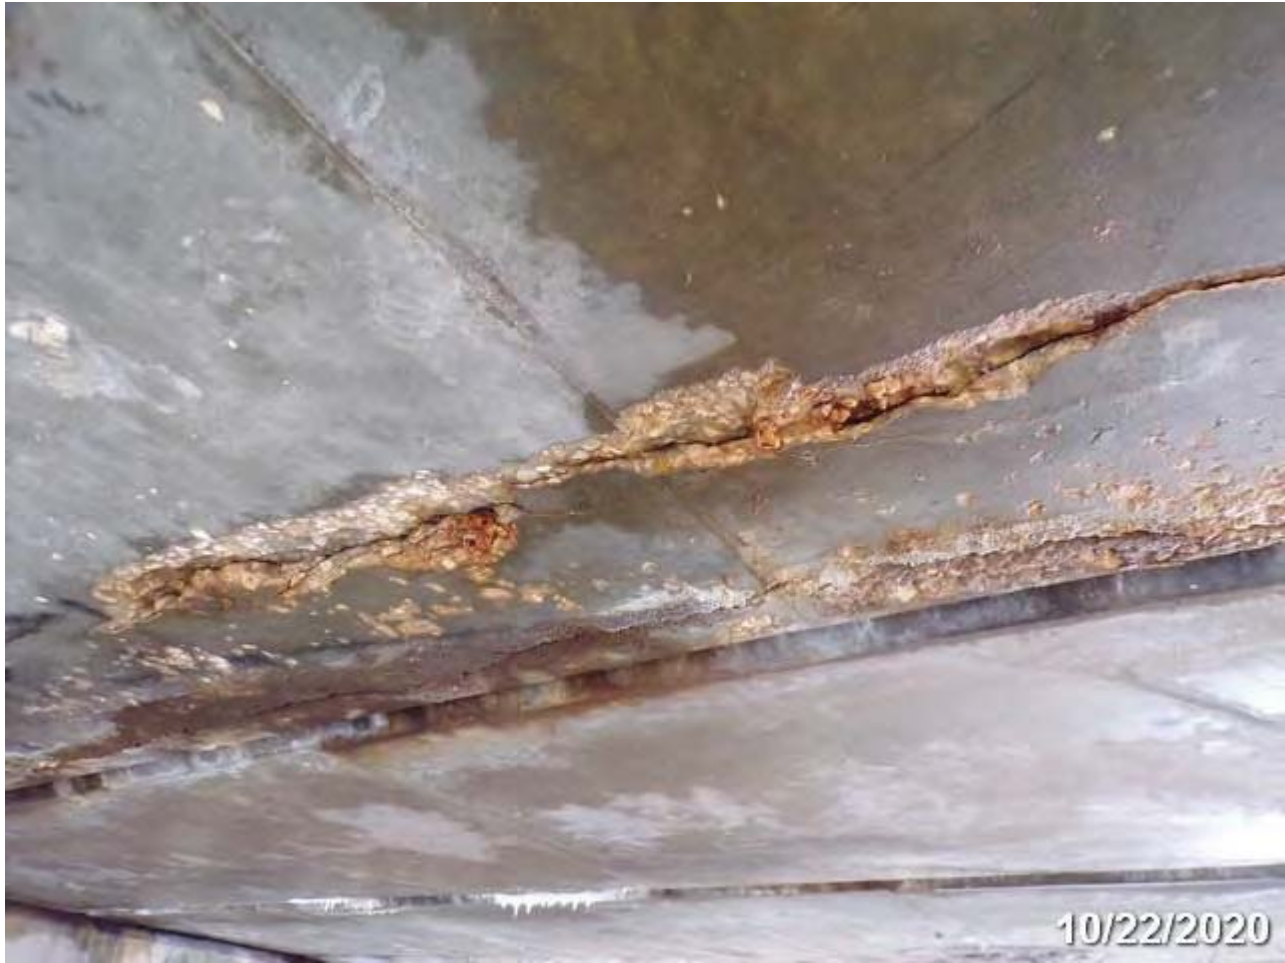
Slab Unit 1-8 west edge is intermittently delaminated up to 15ft. L x 15in. W starting at Abutment 1 with associated cracks up to 1/4in. W with efflorescence and corrosion bleed-out and associated spalling up to 4ft. L x 6in. W x 2in. D approximately 10ft from Abutment 1.

Repair spalls, delaminations, and cracks along the underside of the slab units.
