APPENDIX "F" TO SPECIAL PROVISIONS
STRUCTURES LOAD RATING CALCULATIONS

PW Project No. 20200315, EDP-MT-20200315

**Matheson Hammock Park Road (Bridge No.874294) over
Matheson Hammock Canal**

DEPARTMENT OF TRANSPORTATION AND PUBLIC WORKS

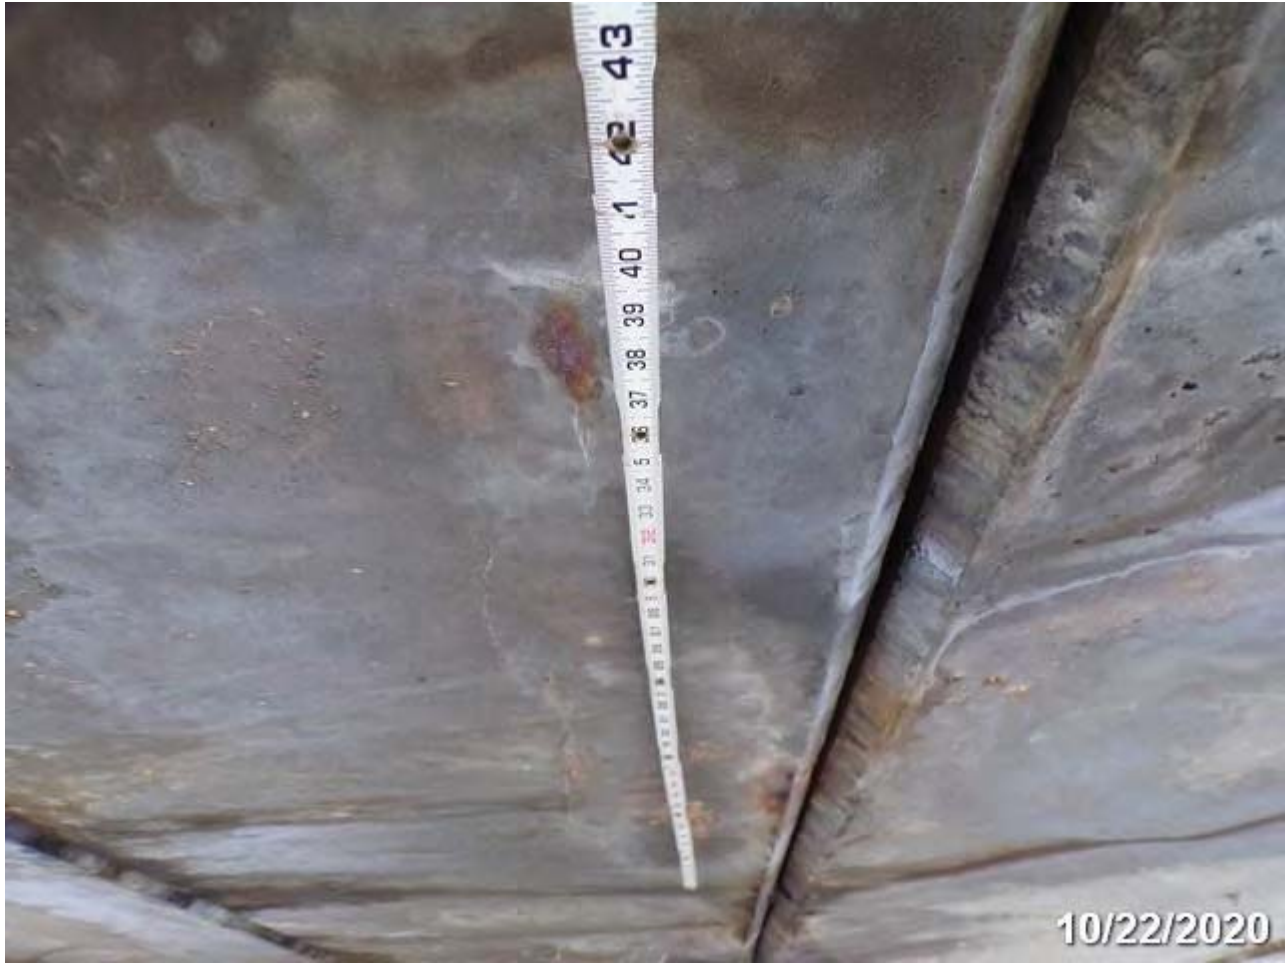
Slab Unit 1-8 east edge has a delamination 4ft. L x 15in. W and associated cracks up to 1/32in. W with efflorescence and corrosion bleed-out, 9ft. from Pier Cap 2.

Repair spalls, delaminations, and cracks along the underside of the slab units.

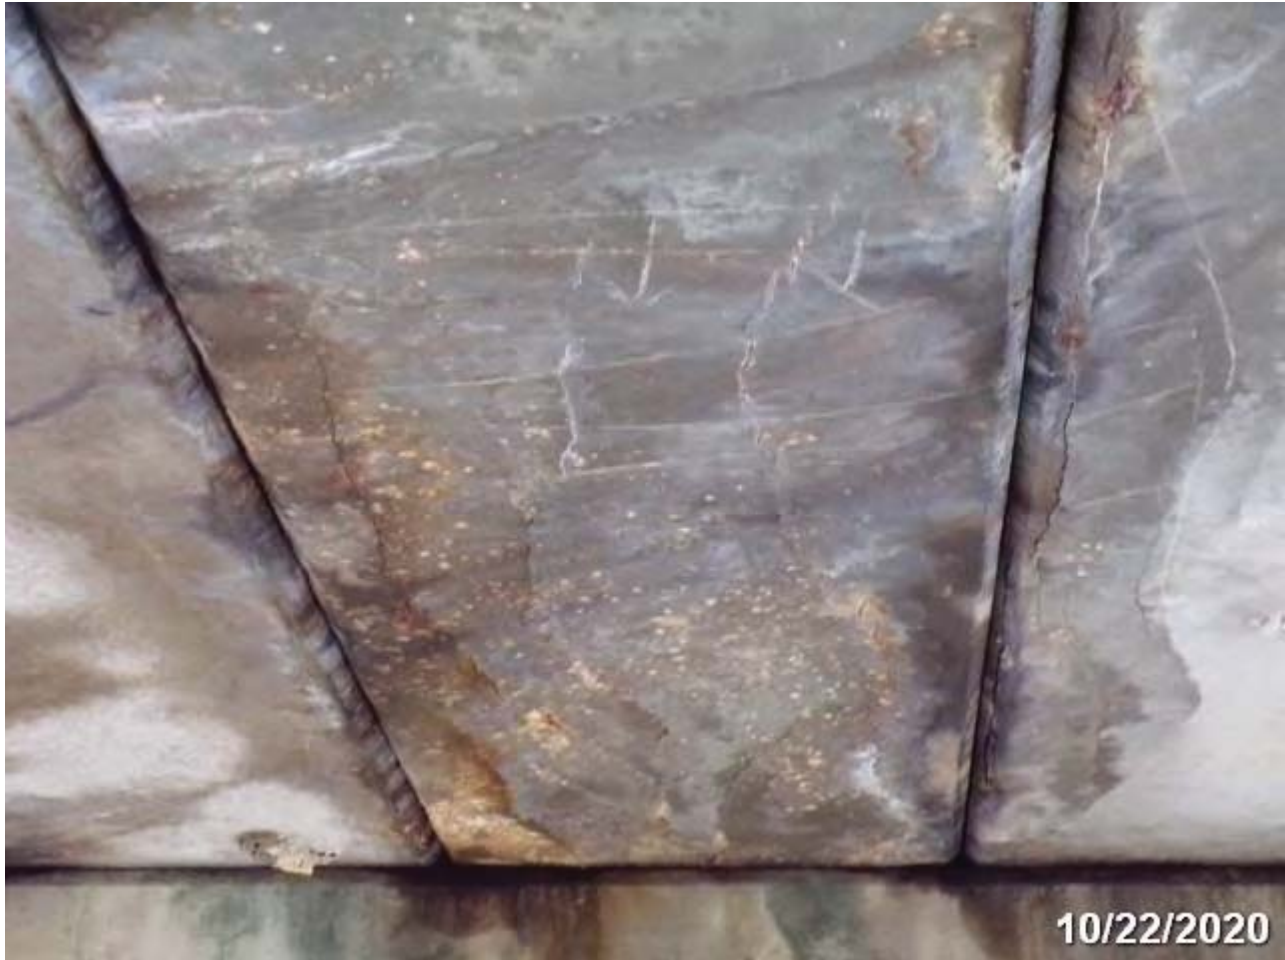
Slab Unit 1-8 has a delaminated area up to 8ft. L x 3ft. W and associated cracks up to 1/16in. W with efflorescence and corrosion bleed-out starting at Pier Cap 2.

Repair spalls, delaminations, and cracks along the underside of the slab units.

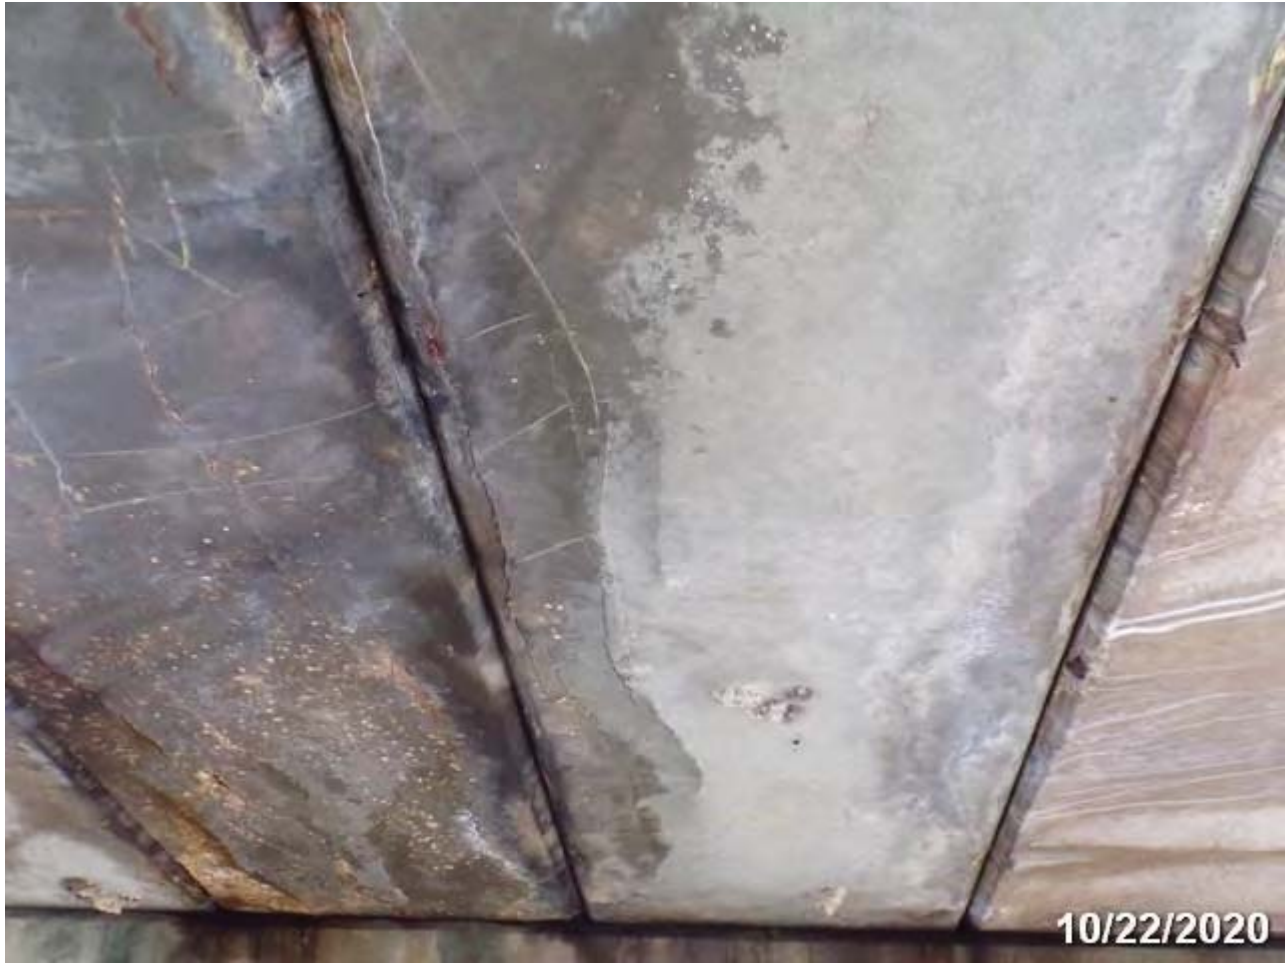
Slab Unit 1-9 west edge has a delaminated area 9ft. L x 10in. W and associated cracks up to 1/16in. W with efflorescence and corrosion bleed-out, starting near the 3/4 point and extending to Pier 2 cap.

Repair spalls, delaminations, and cracks along the underside of the slab units.

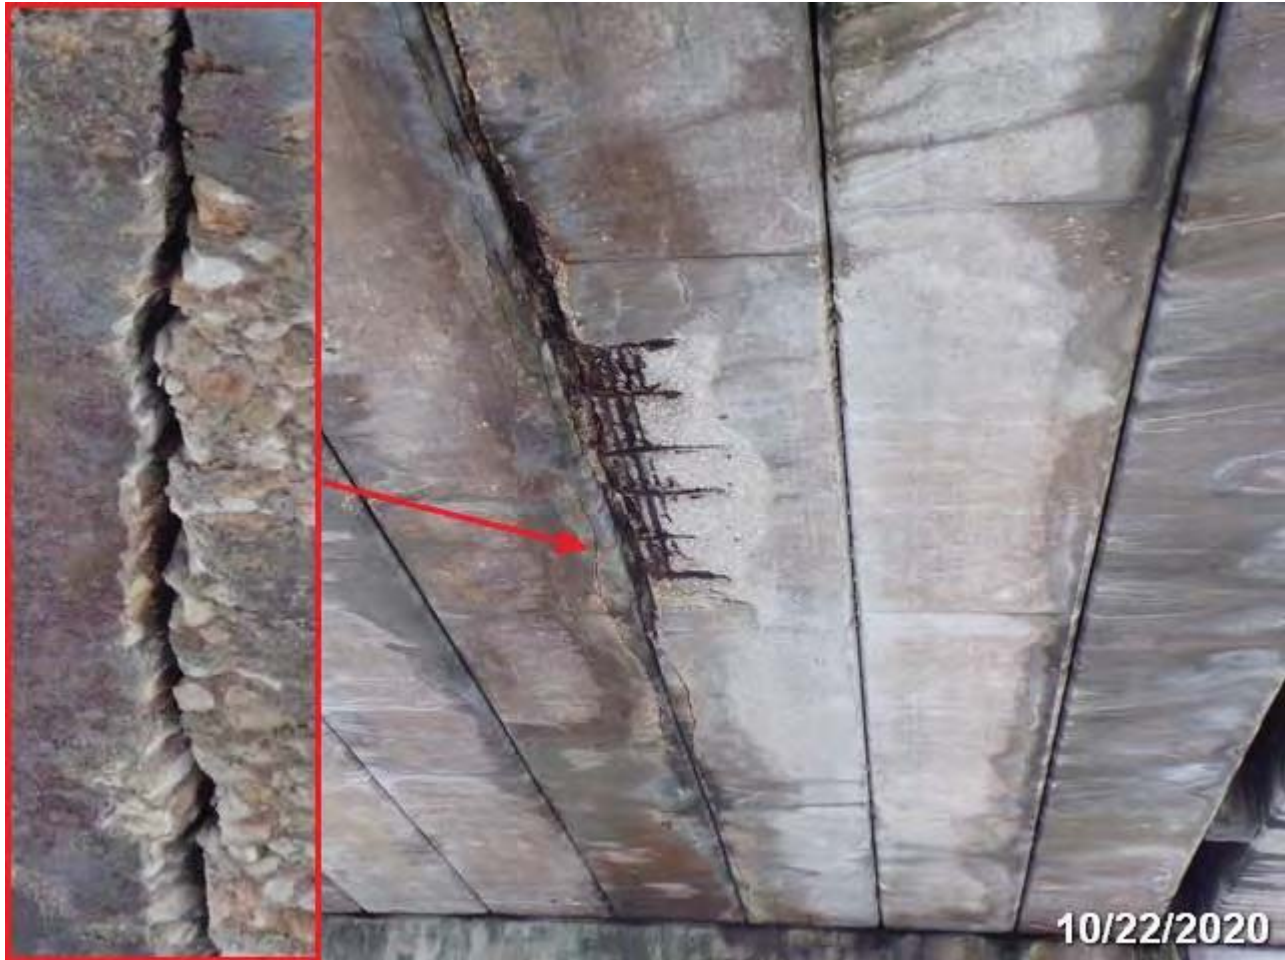
Slab Unit 2-7 east edge is intermittently cracked/delaminated up to span length x 16in. W (average width) with up to 1/4in. W cracks.

Repair spalls, delaminations, and cracks along the underside of the slab units.

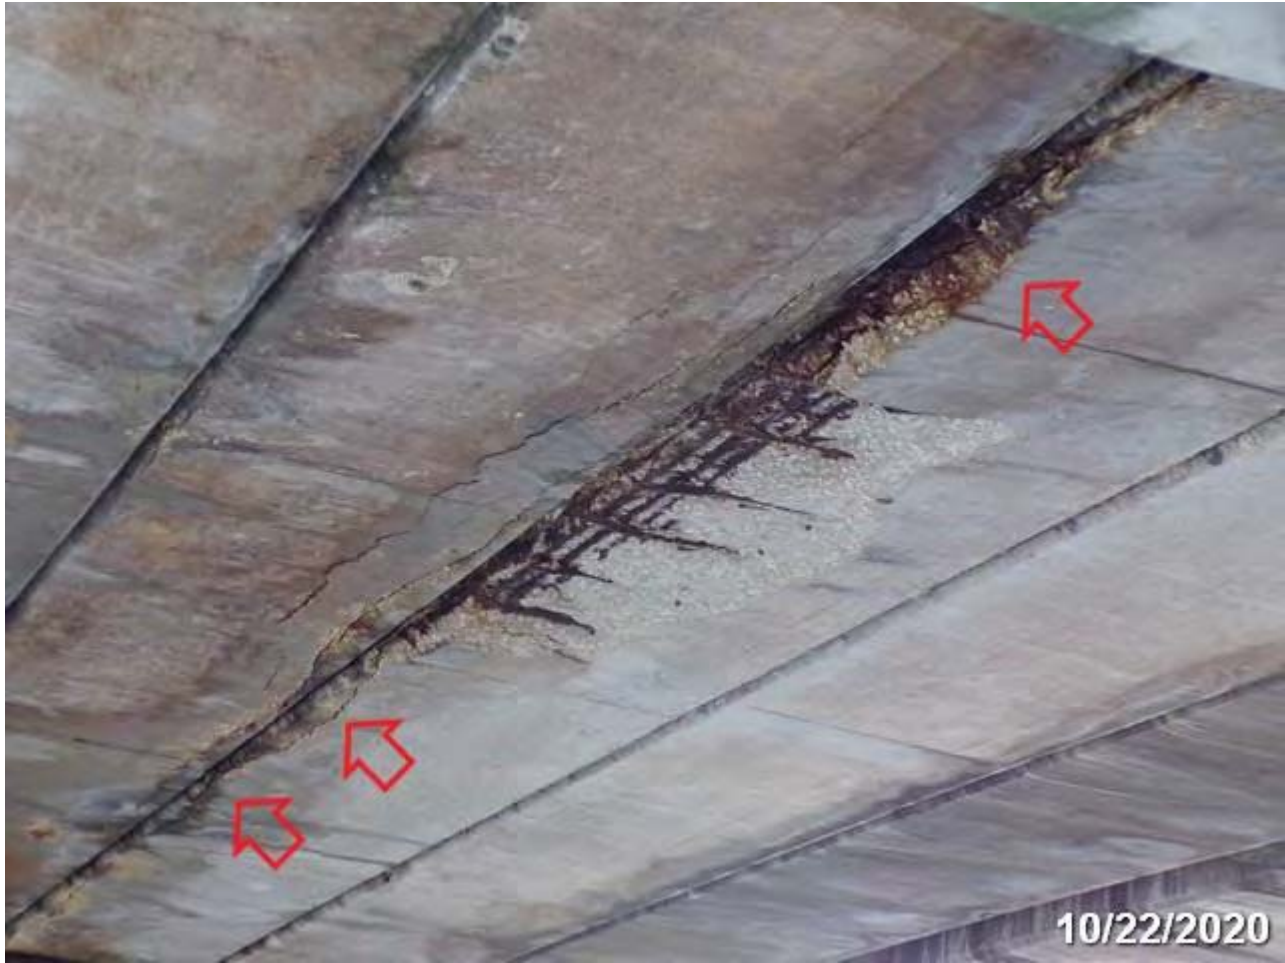
Slab Unit 2-8 west half has two delaminated areas up to 15ft. L x 18in. W (average width) at south and north ends, with associated cracks of up to 1/4in. W.

Repair spalls, delaminations, and cracks along the underside of the slab units.

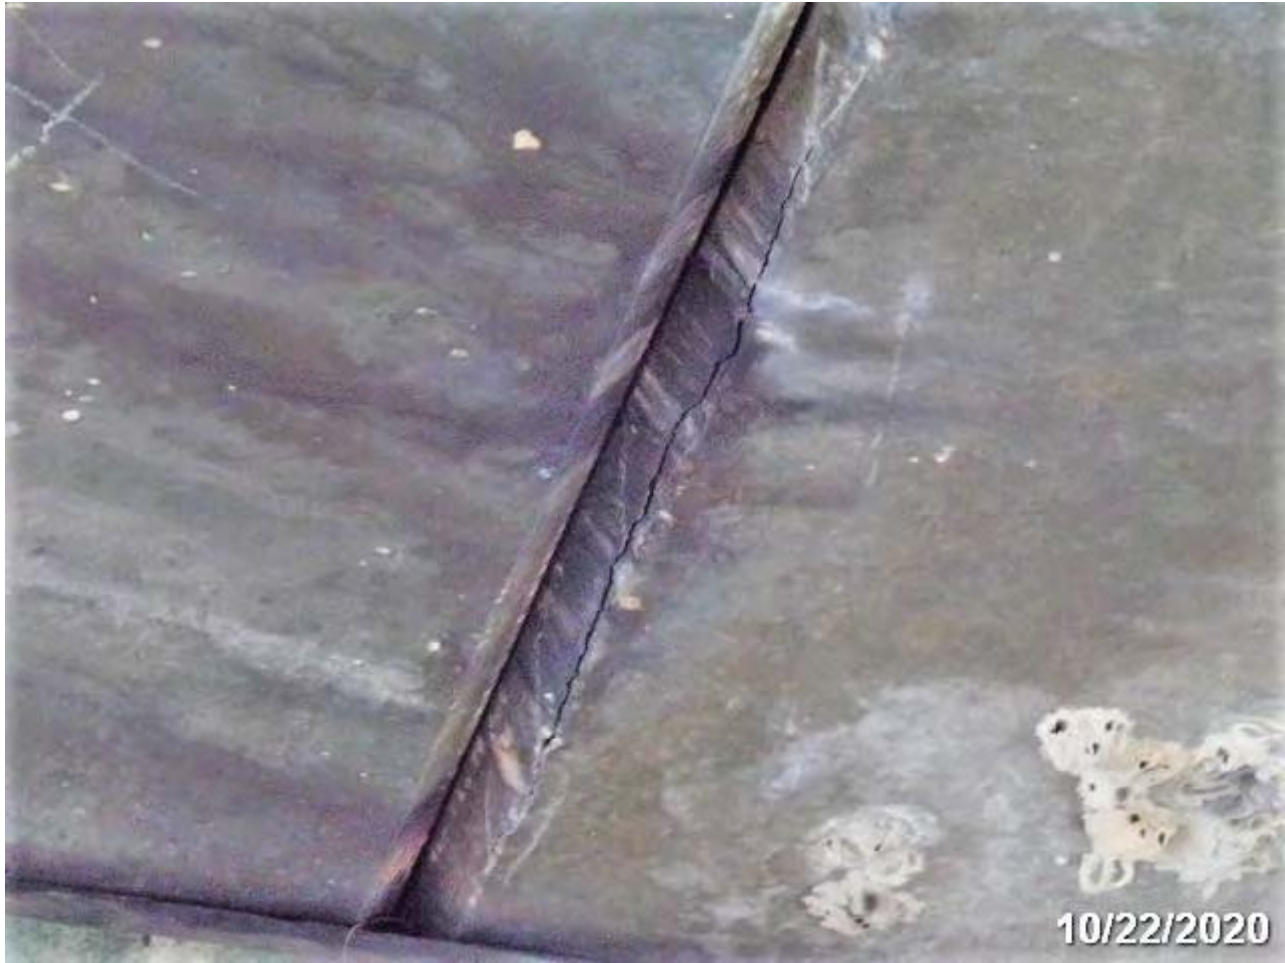
Slab Unit 3-6 has a delamination up to 24in. L x 6in. W on the east edge over Pier 3, with an associated crack of up to 1/16in. W.

Repair spalls, delaminations, and cracks along the underside of the slab units.

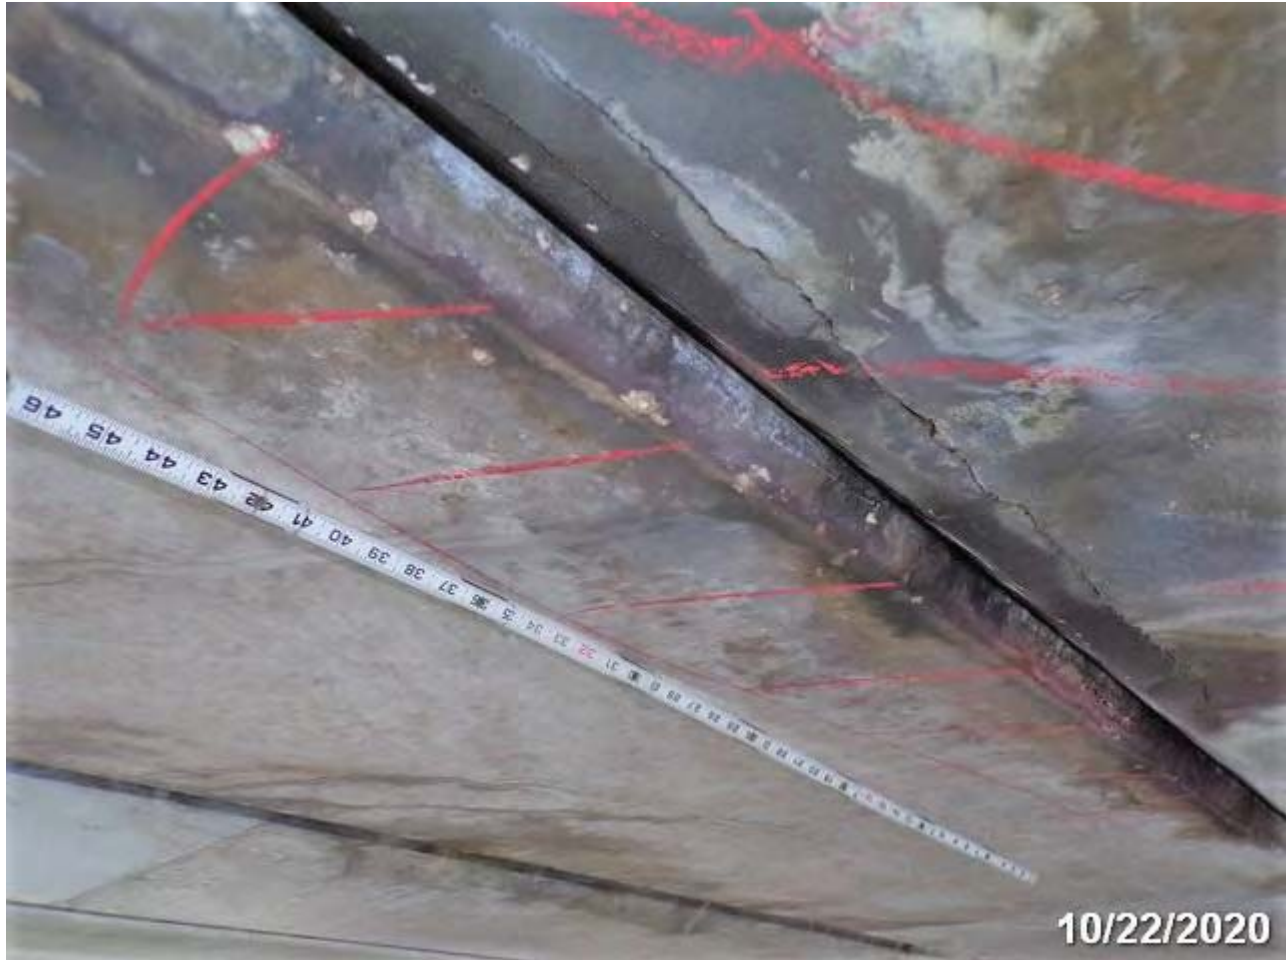
Slab Unit 3-6 east edge has a delaminated area up to 42in. L x 8in. W with associated cracks up to 1/16in. W.

Repair spalls, delaminations, and cracks along the underside of the slab units.

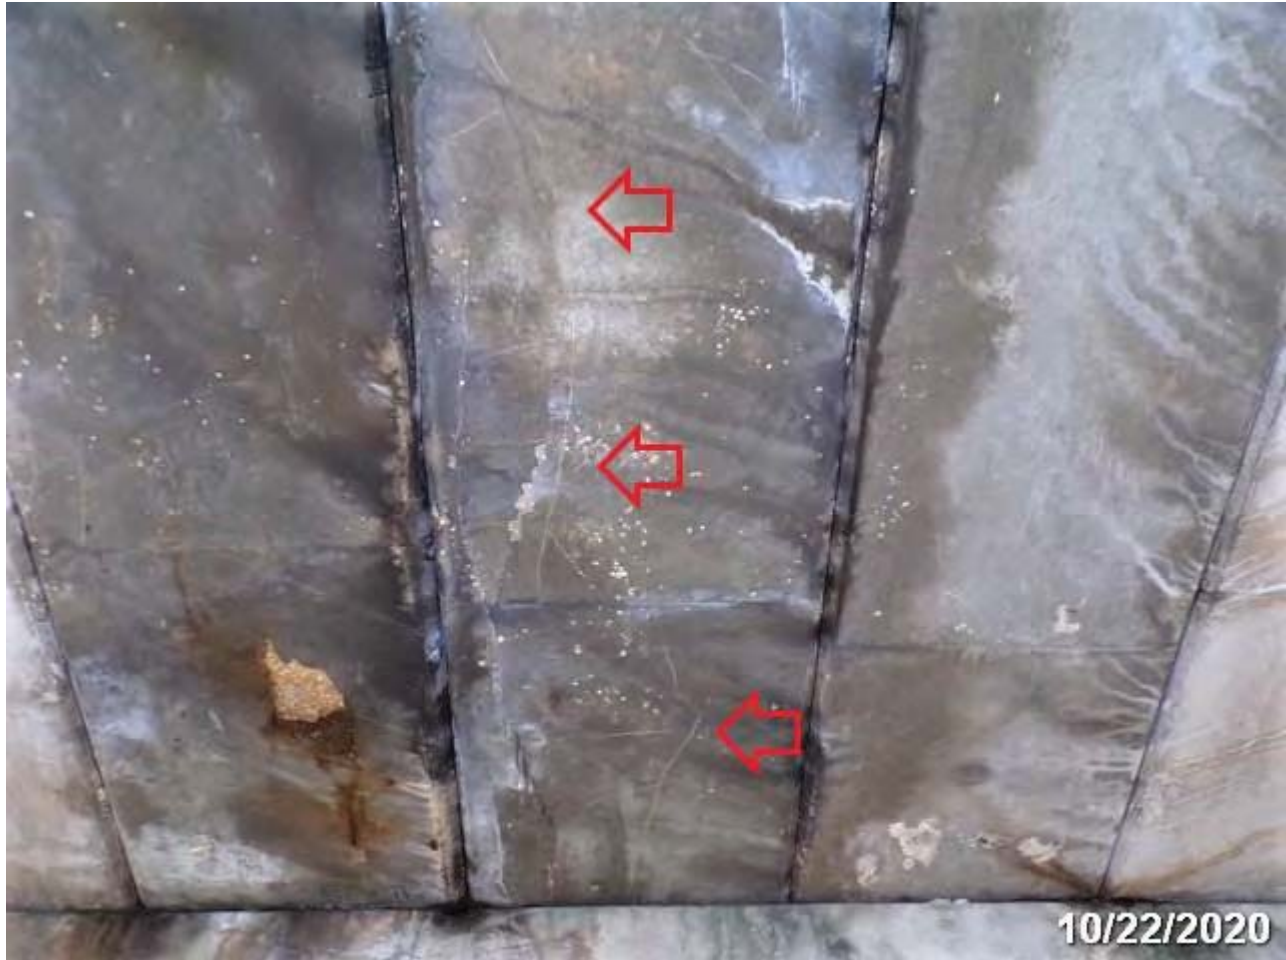
Slabs Unit 3-7 has two delaminated areas, one starting at Pier 3 up to 8ft. L x 15in. W (average width) with associated cracks, and the second, near mid-span up to 3ft. L x 30in. W. (Pier 3 shown).

Repair spalls, delaminations, and cracks along the underside of the slab units.

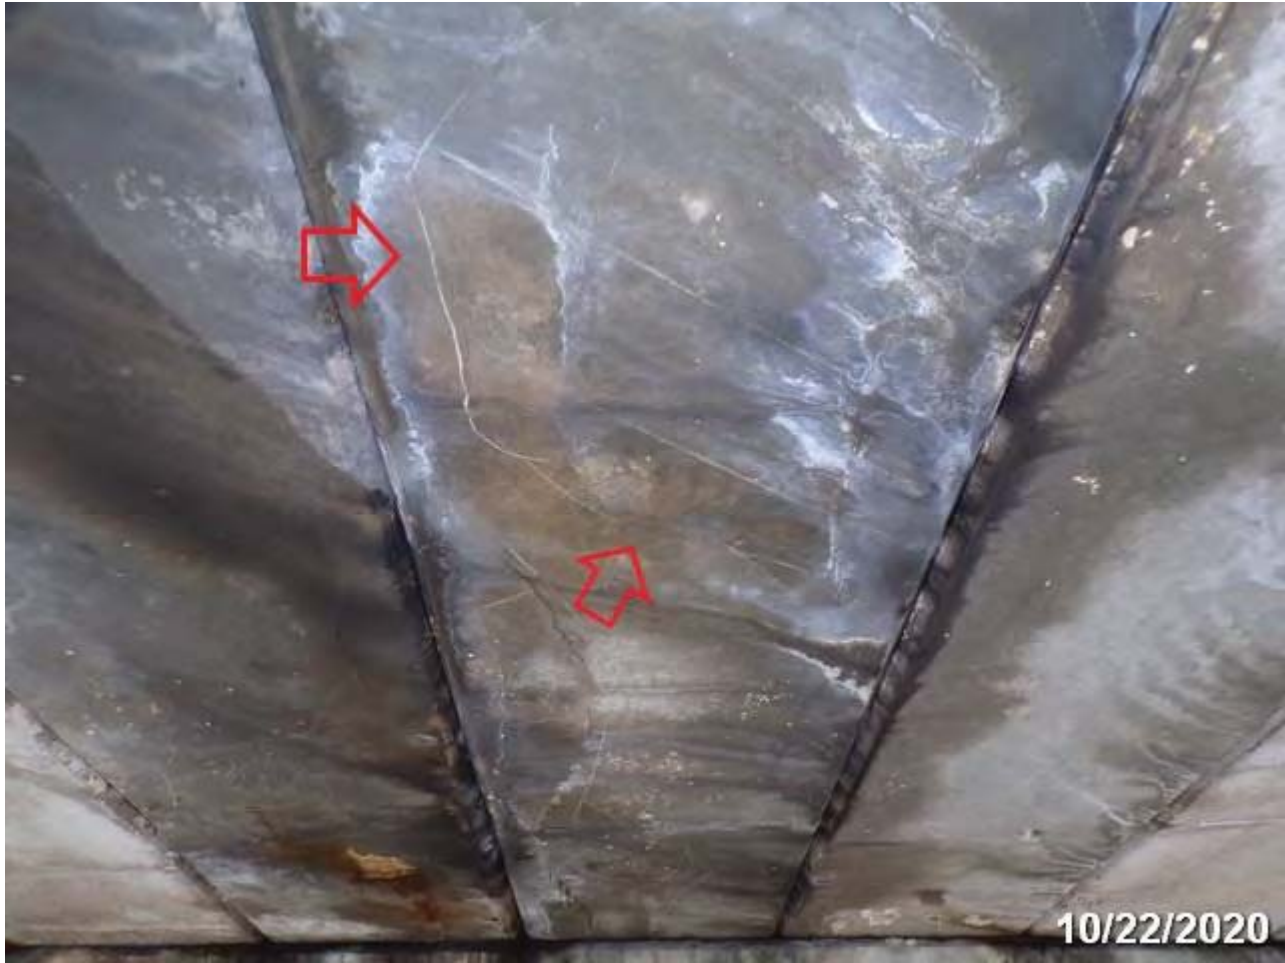
Slabs Unit 3-7 has two delaminated areas, one starting at Pier 3 up to 8ft. L x 15in. W (average width) with associated cracks, and the second, near mid-span up to 3ft. L x 30in. W. (Mid-span shown).

Repair spalls, delaminations, and cracks along the underside of the slab units.

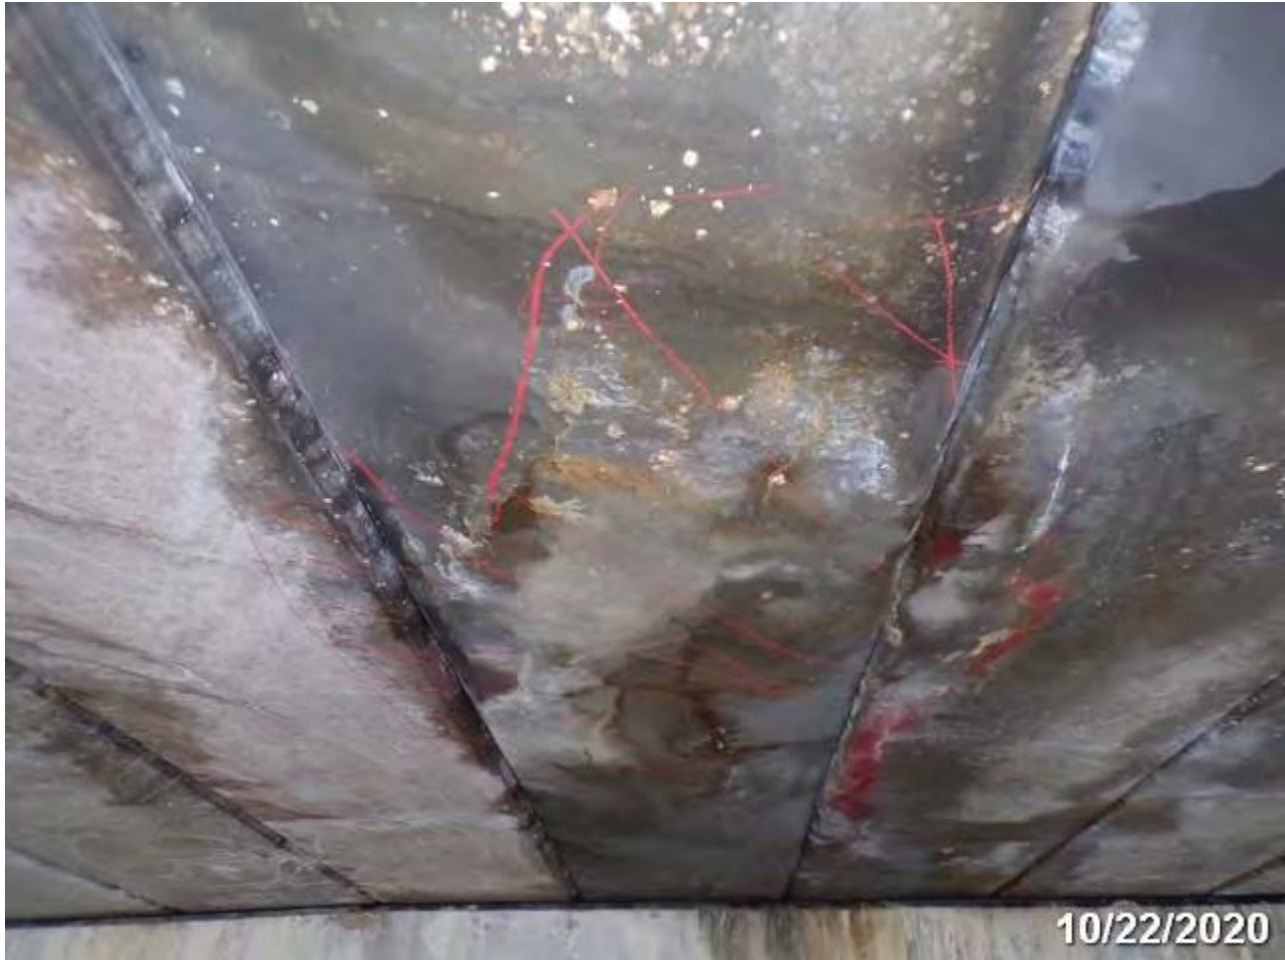
Slab Unit 3-7 has an unsound repaired area 12ft. L x up to slab width (3ft.) starting from Abutment 4 with hollow-sounding throughout and associated cracks up to 1/16in. W with efflorescence and corrosion bleed-out.

Repair spalls, delaminations, and cracks along the underside of the slab units.

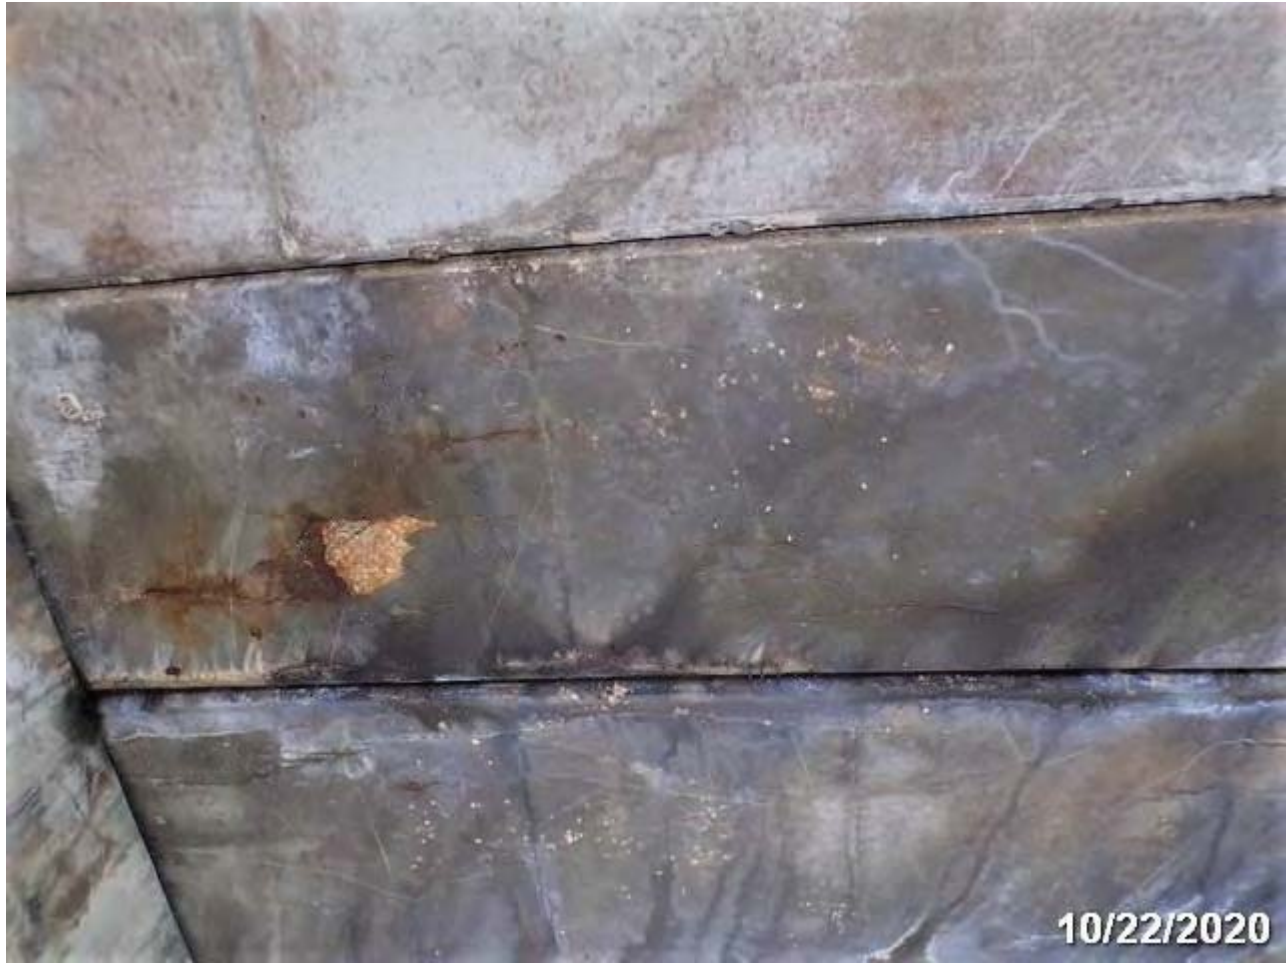
Slab Unit 3-8 has a spall/delamination up to 8ft. L x 3ft. W x 1in. D and associated cracks with corrosion bleed-out starting at Pier 3.

Repair spalls, delaminations, and cracks along the underside of the slab units.

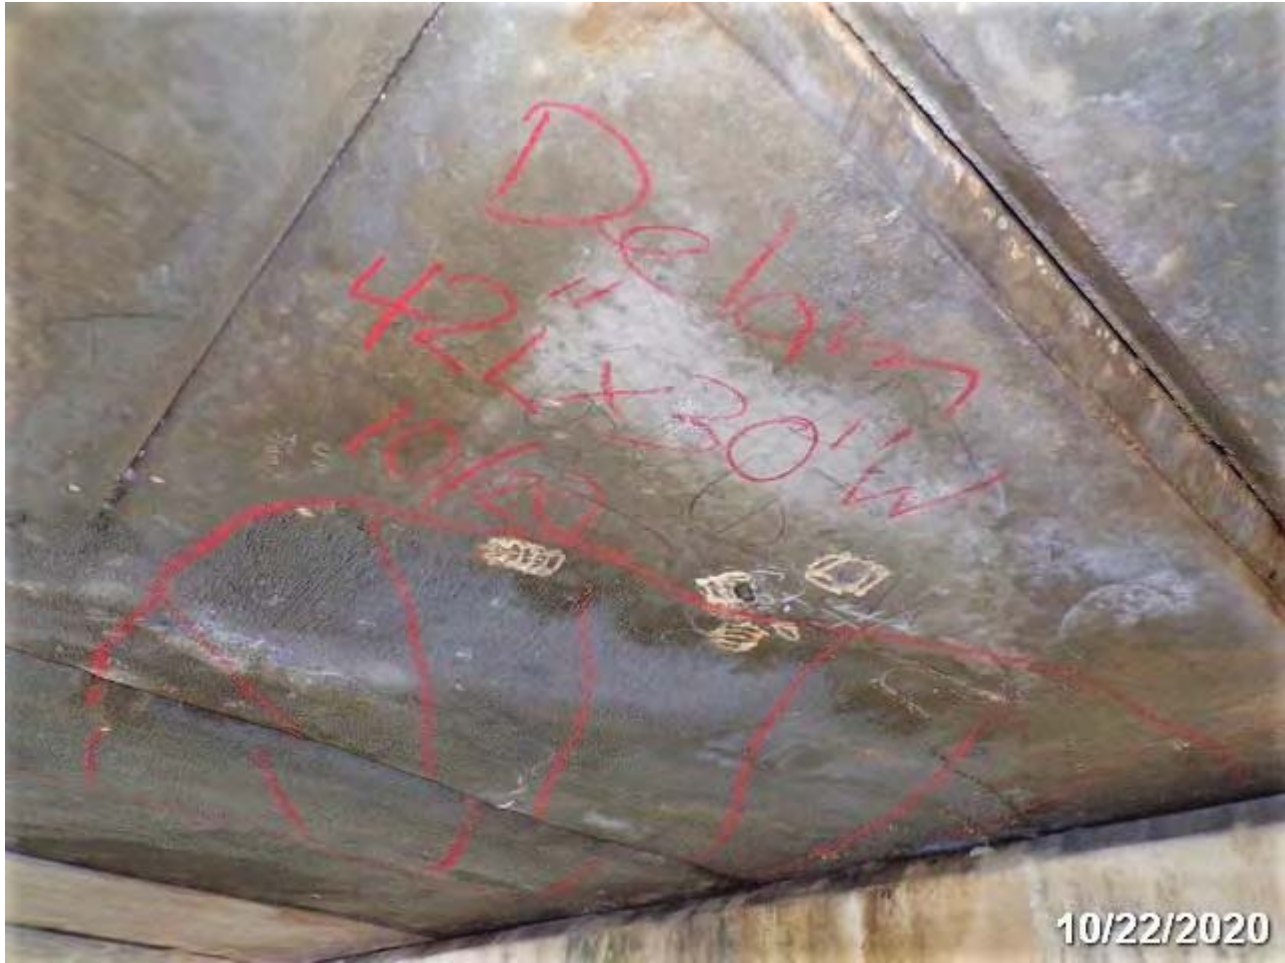
Slab Unit 3-8 has an unsound repair/delamination up to 42in. L x 30in. W with associated cracks up to 1/16in. W with efflorescence starting at Abutment 4.

Repair spalls, delaminations, and cracks along the underside of the slab units.

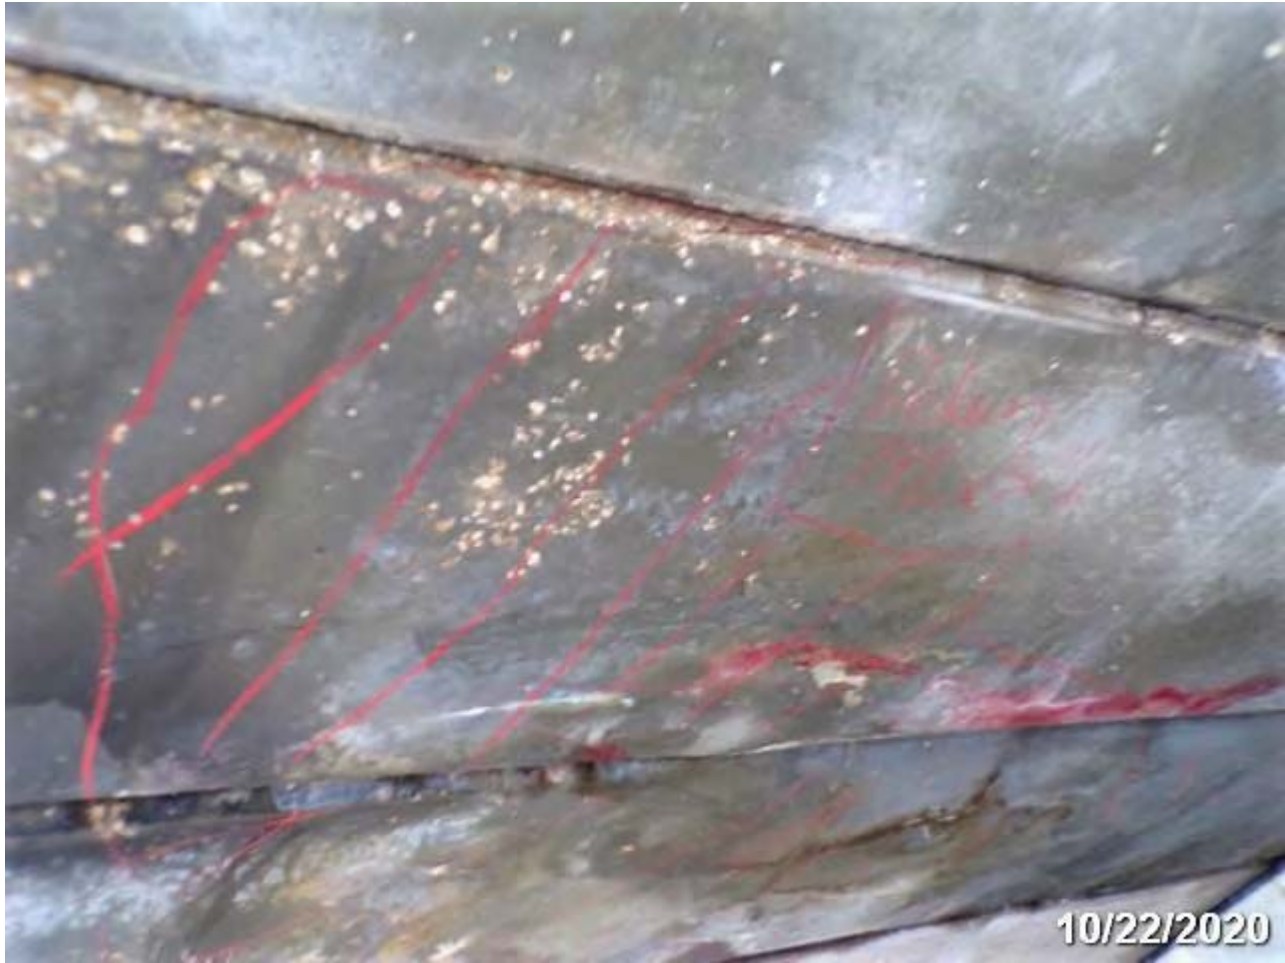
Slab Unit 3-8 has an unsound repair/delamination up to 74in. L x up to slab width (3ft.) with associated cracks up to 1/16in. W with efflorescence starting 5.5ft. from Abutment 4.

Repair spalls, delaminations, and cracks along the underside of the slab units.

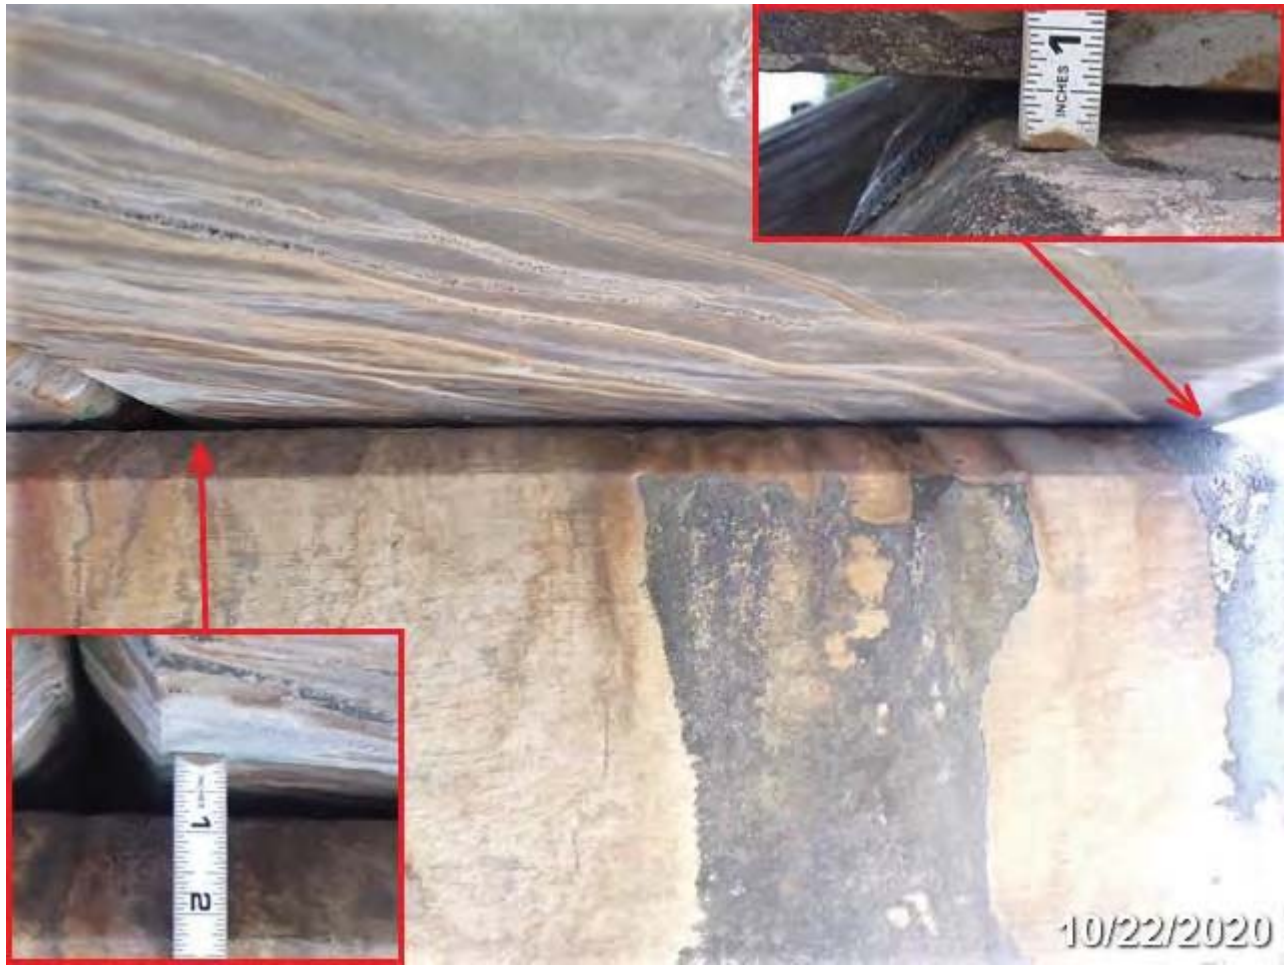
Slab Unit 1-1 exhibits a slight outward rotation at Abutment 1 with up to 1/4in. height difference in reference to the top of the cap, potentially indicating shear key failure.

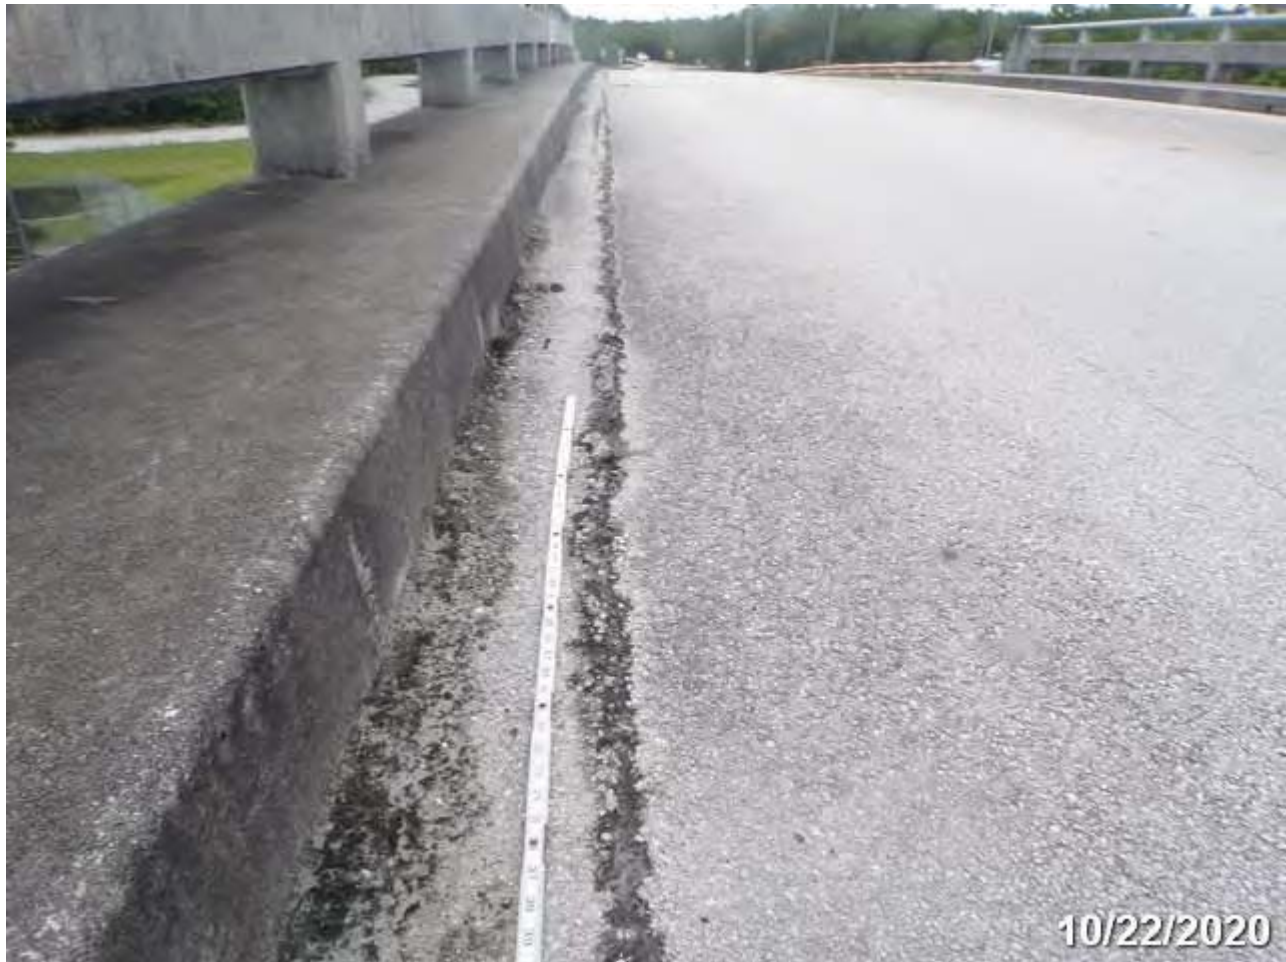
The asphalt overlay has longitudinal cracks up to span length x 1/4in. W with associated 1in. W rutting over the slab unit joints and upheaving up to 1in. H at the shoulders, possibly indicating independent slab unit movement.

- 1) Monitor cracks along slab unit joints for independent movement of the slab units.
- 2) Seal cracks on the asphalt along the slab unit joints and multi-directional cracks on Lane 2 (NB) in Spans 1 and 2.

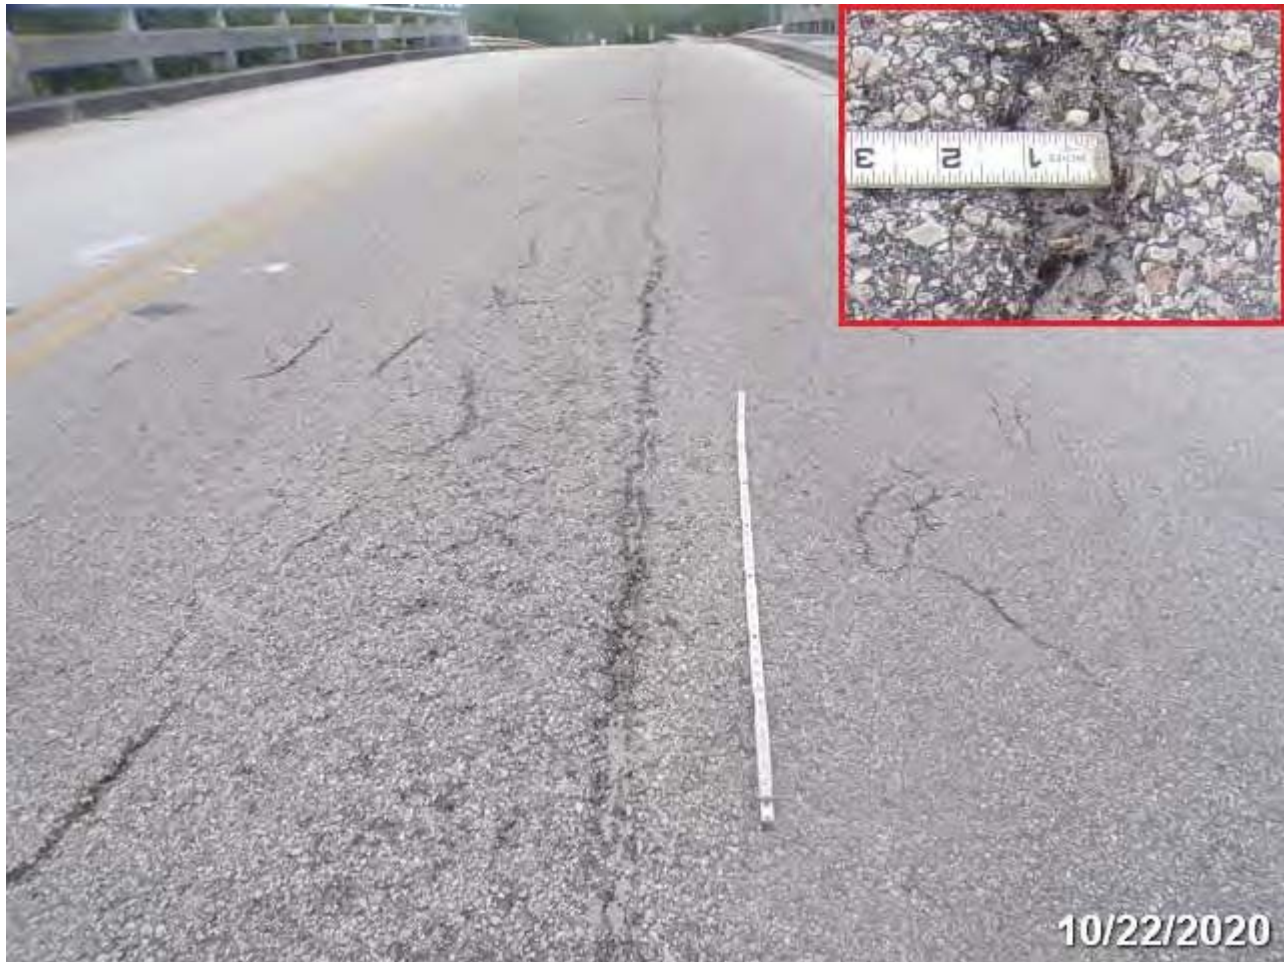
The asphalt overlay has longitudinal cracks up to span length x 1/4in. W with associated 1in. W rutting over the slab unit joints and upheaving up to 1in. H at the shoulders, possibly indicating independent slab unit movement.

- 1) Monitor cracks along slab unit joints for independent movement of the slab units.
- 2) Seal cracks on the asphalt along the slab unit joints and multi-directional cracks on Lane 2 (NB) in Spans 1 and 2.

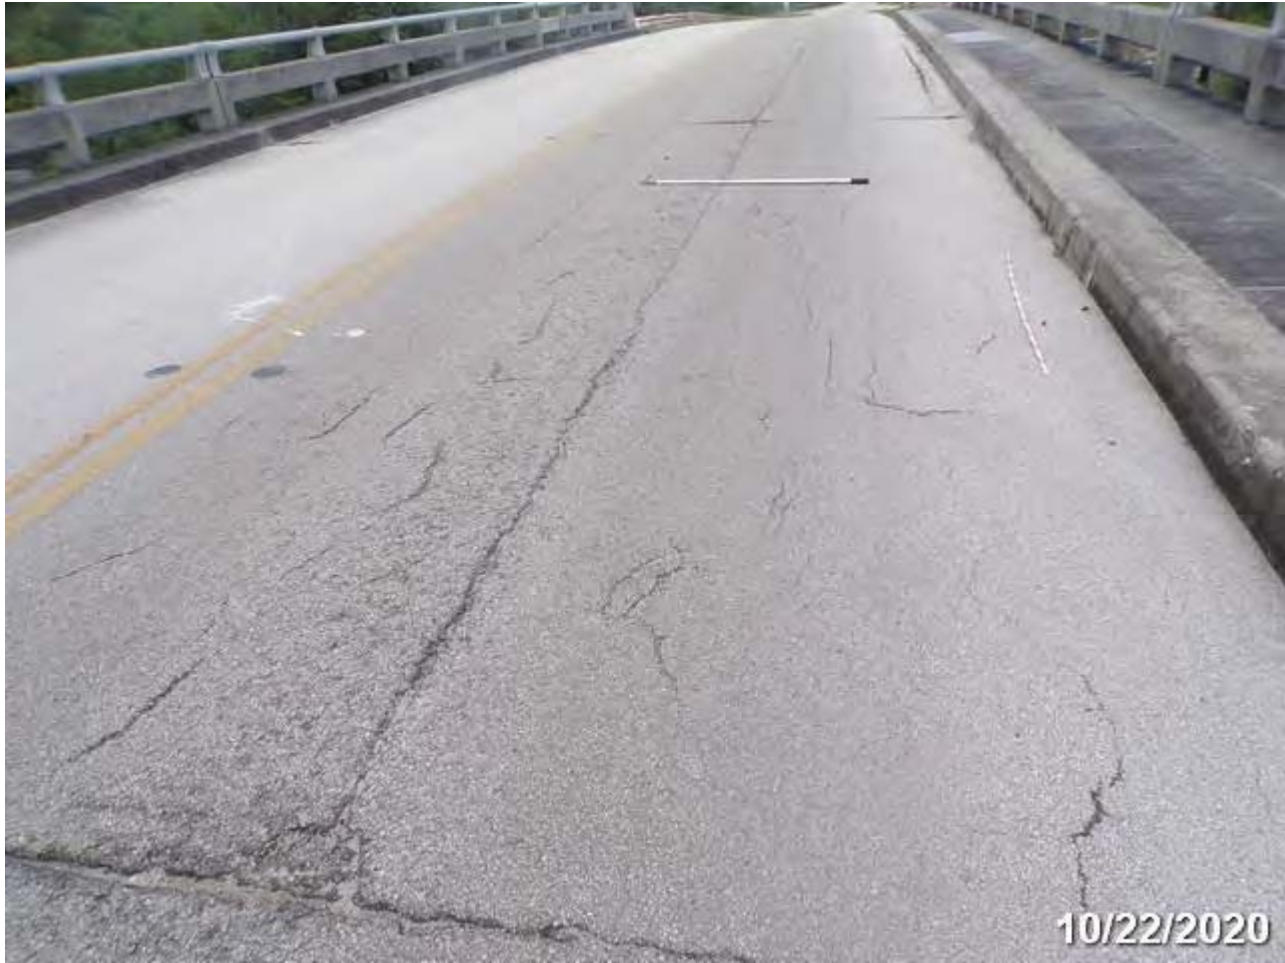
The asphalt overlay at Spans 1 and 2 has multi-directional cracking up to 1/2in. W on Lane 2 (NB), worse condition is on Span 1 which has a 19.5ft L x 11ft. W area with hollow-sounding starting 1 ft. from the right sidewalk.

Seal cracks on the asphalt along the slab unit joints and multi-directional cracks on Lane 2 (NB) in Spans 1 and 2.
