APPENDIX "F" TO SPECIAL PROVISIONS
STRUCTURES LOAD RATING CALCULATIONS

PW Project No. 20200315, EDP-MT-20200315

**Matheson Hammock Park Road (Bridge No.874294) over
Matheson Hammock Canal**

DEPARTMENT OF TRANSPORTATION AND PUBLIC WORKS

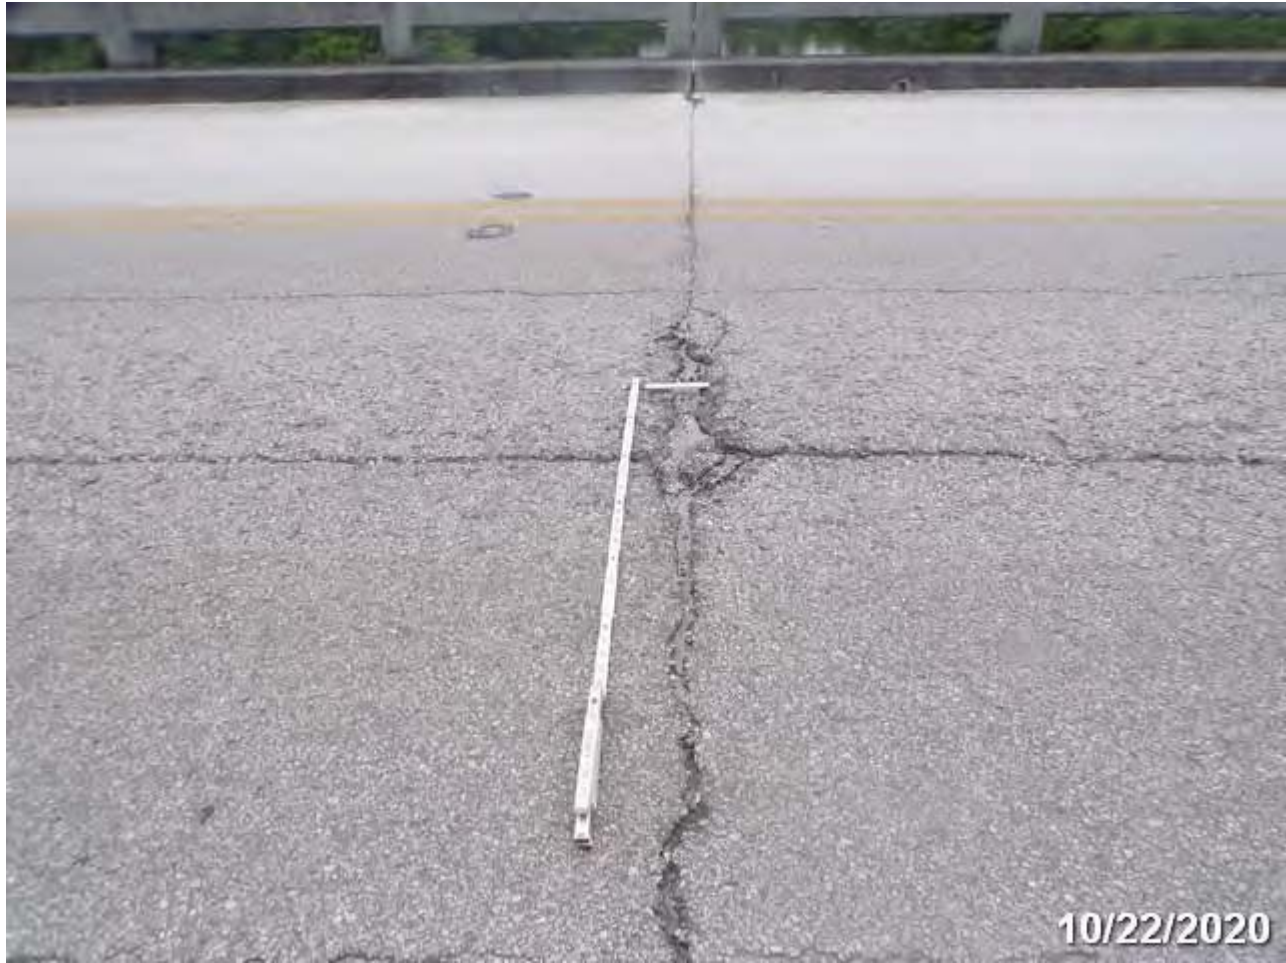
The asphalt overlay has transverse cracks up to roadway width x 1/4in. W with rutting and upheaving up to 3in. W and vegetation growth over the expansion joints.

Clean and seal cracks and rutting along the expansion joints.

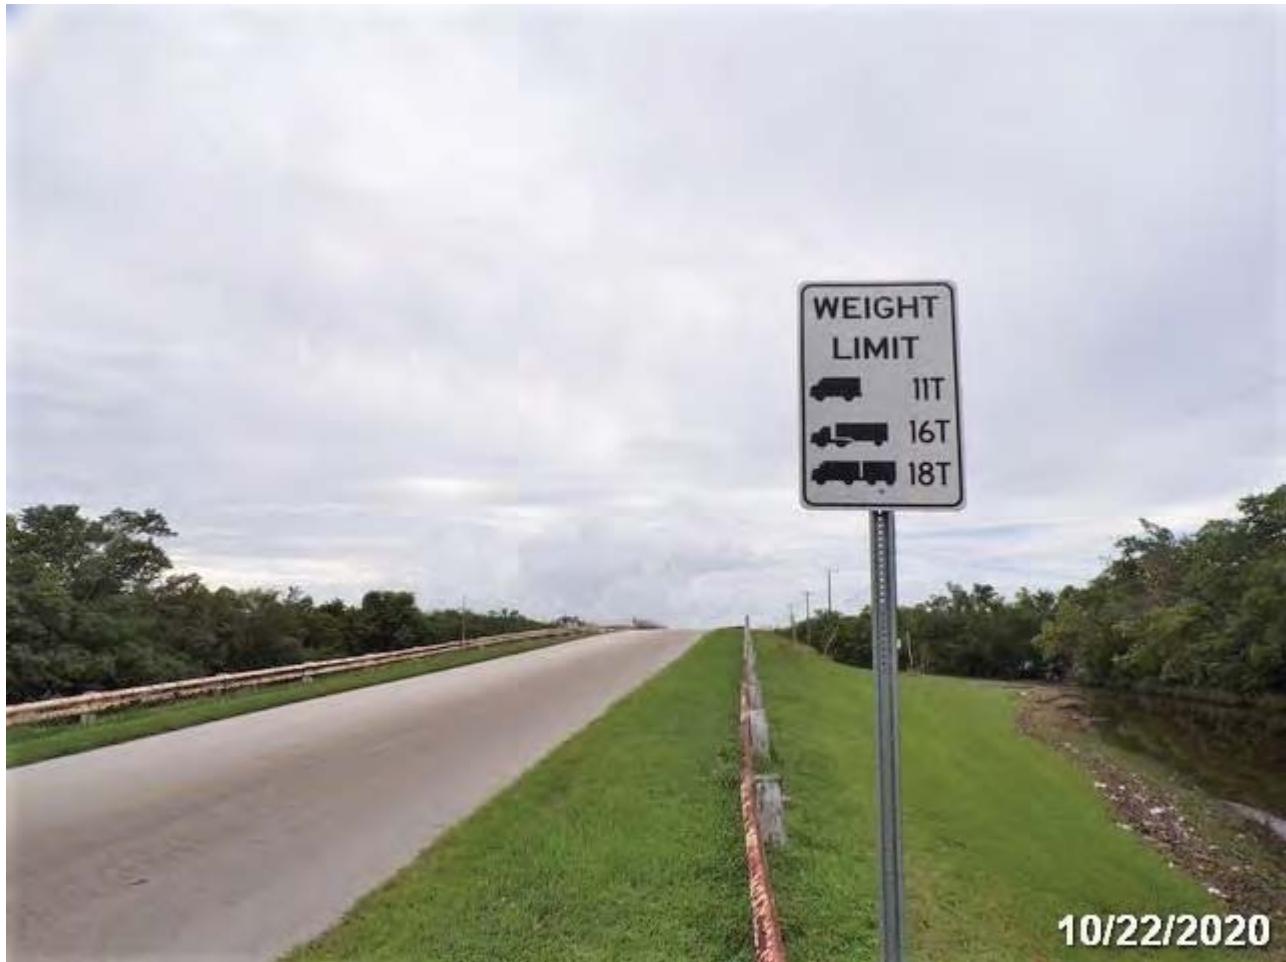
South Approach Posting Sign.

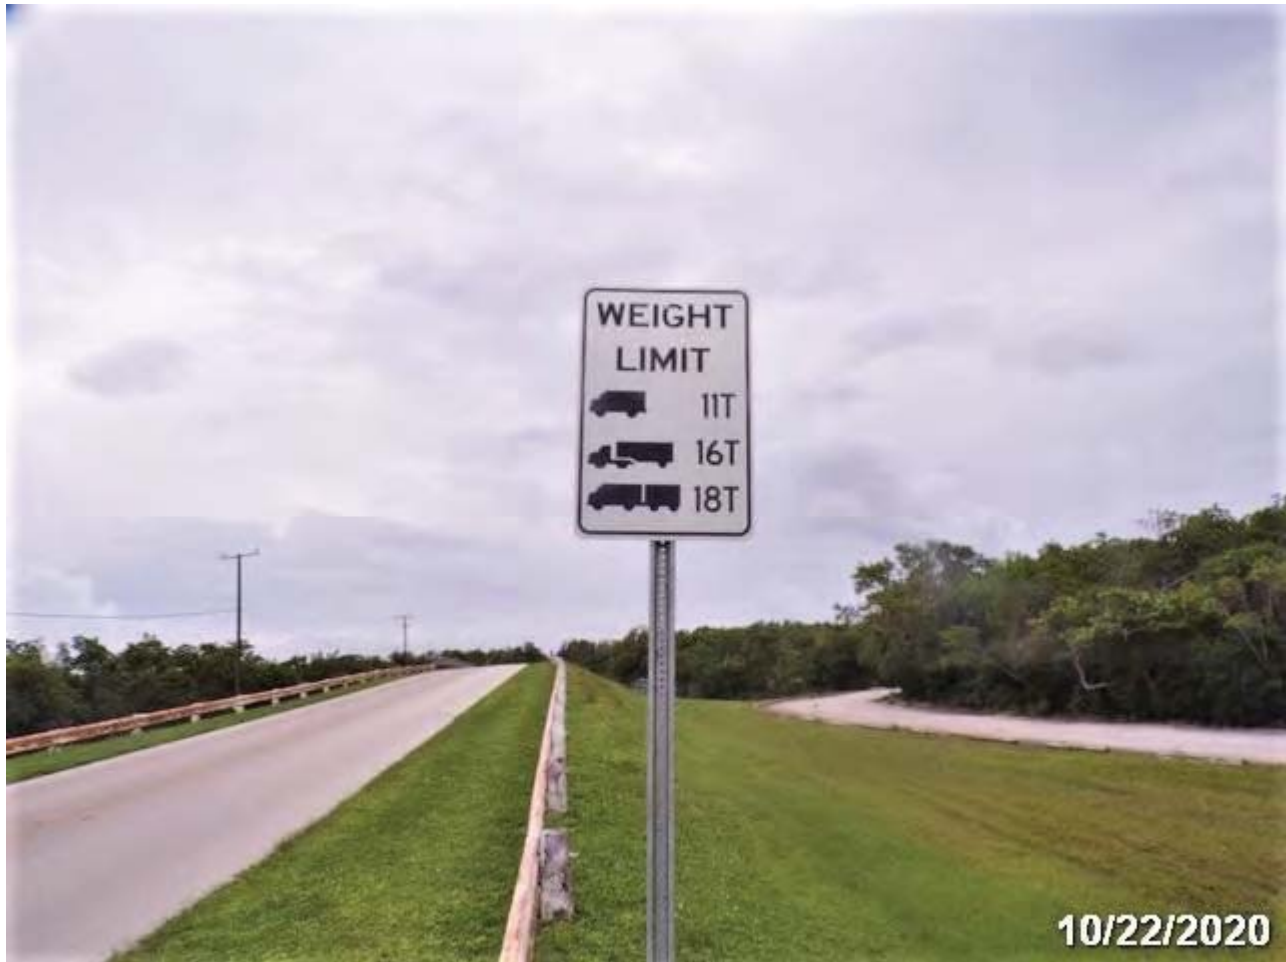
North Approach Posting Sign.

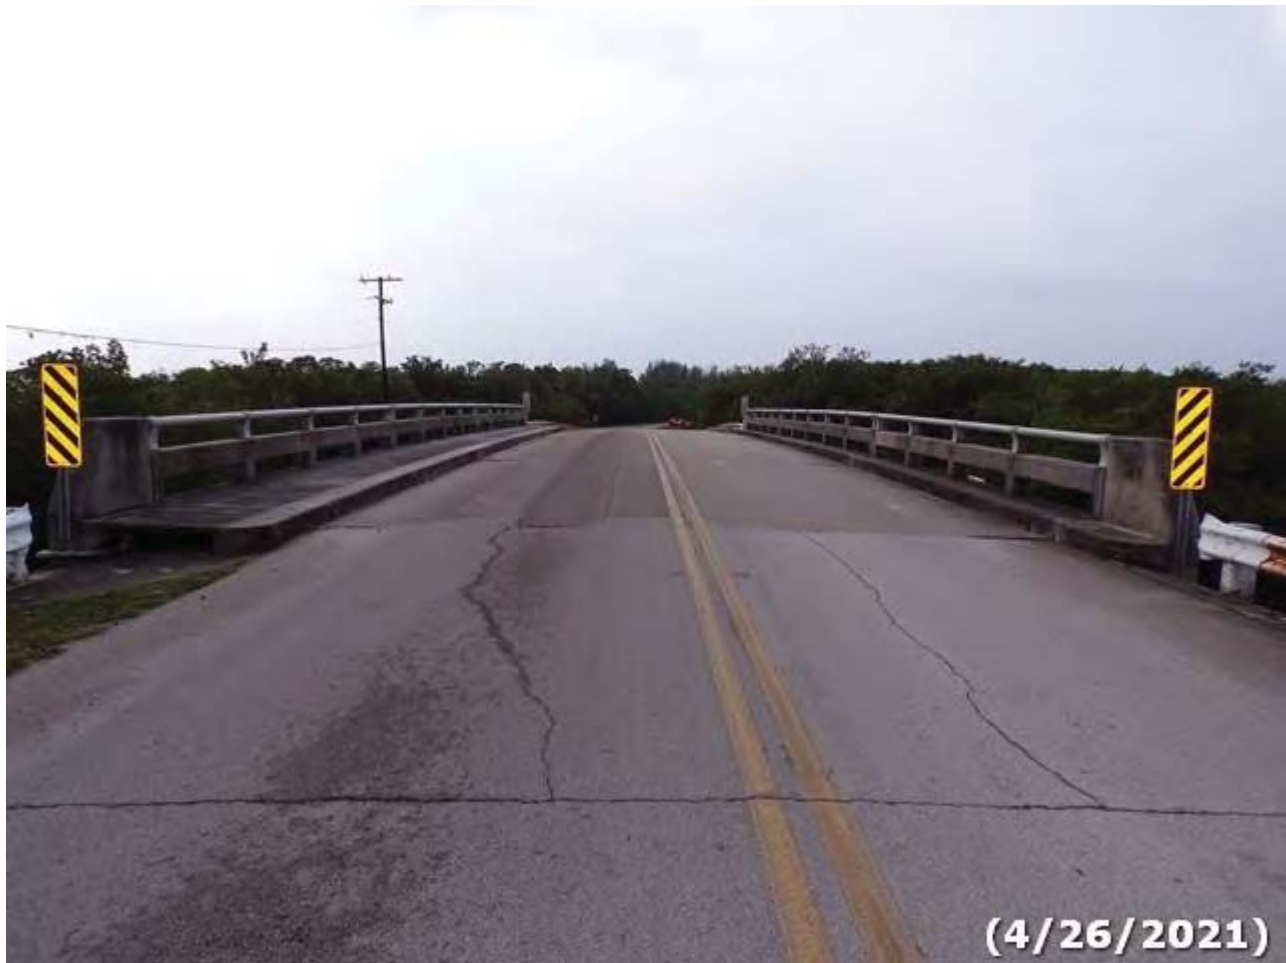
_Centerline raised pavement markers are missing along the structure. Previously missing object markers were installed. Refer to Photo 01. NO CHANGE.

Centerline raised pavement markers are missing along the structure. Previously missing object markers were installed.

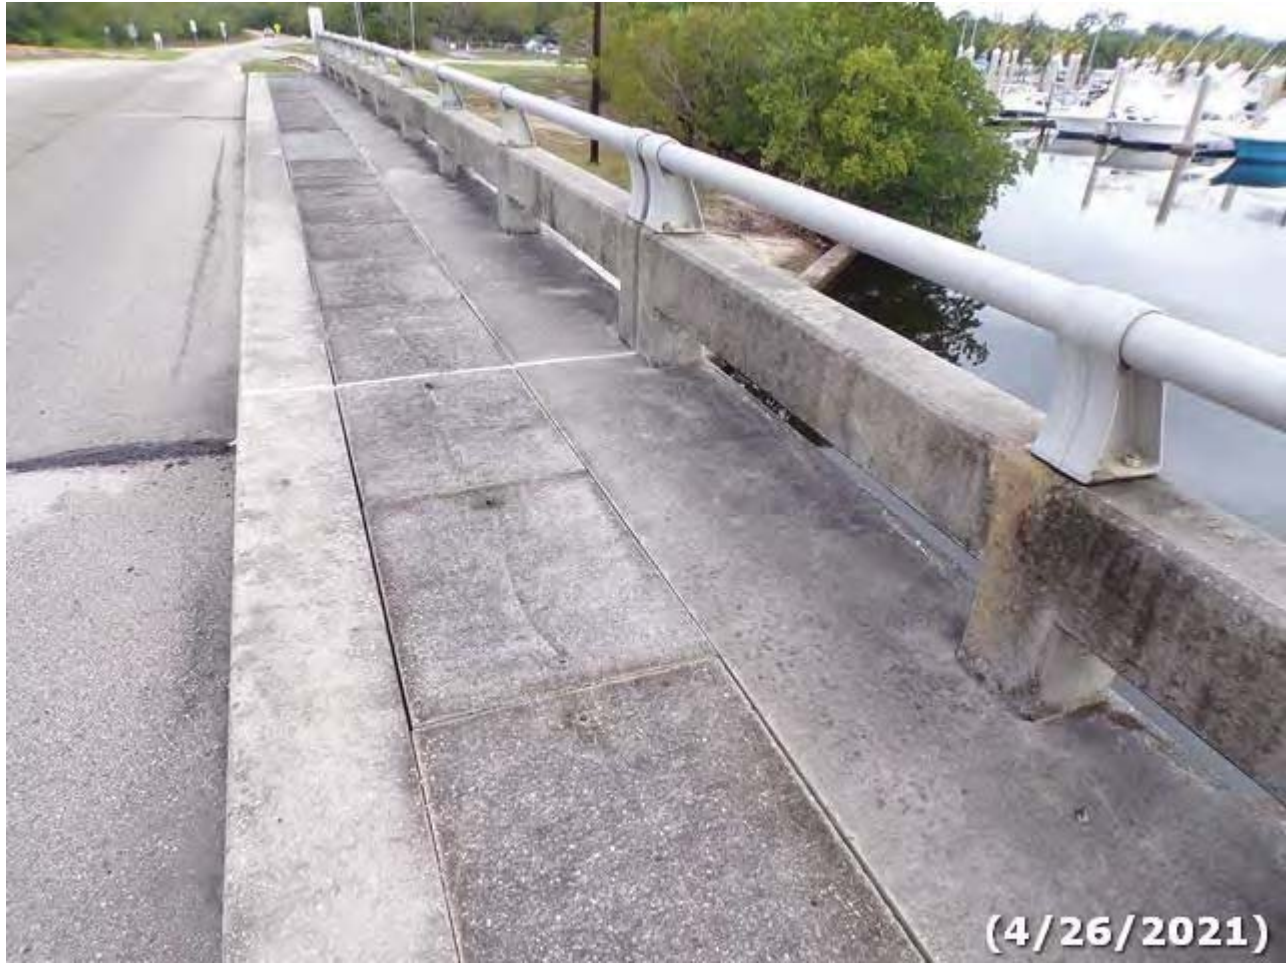
_Sidewalk concrete panels are loose and move under pedestrian load. (Total 300 SF). Refer to Photo 02. NO CHANGE.

Sidewalk concrete panels are loose and move under pedestrian load.

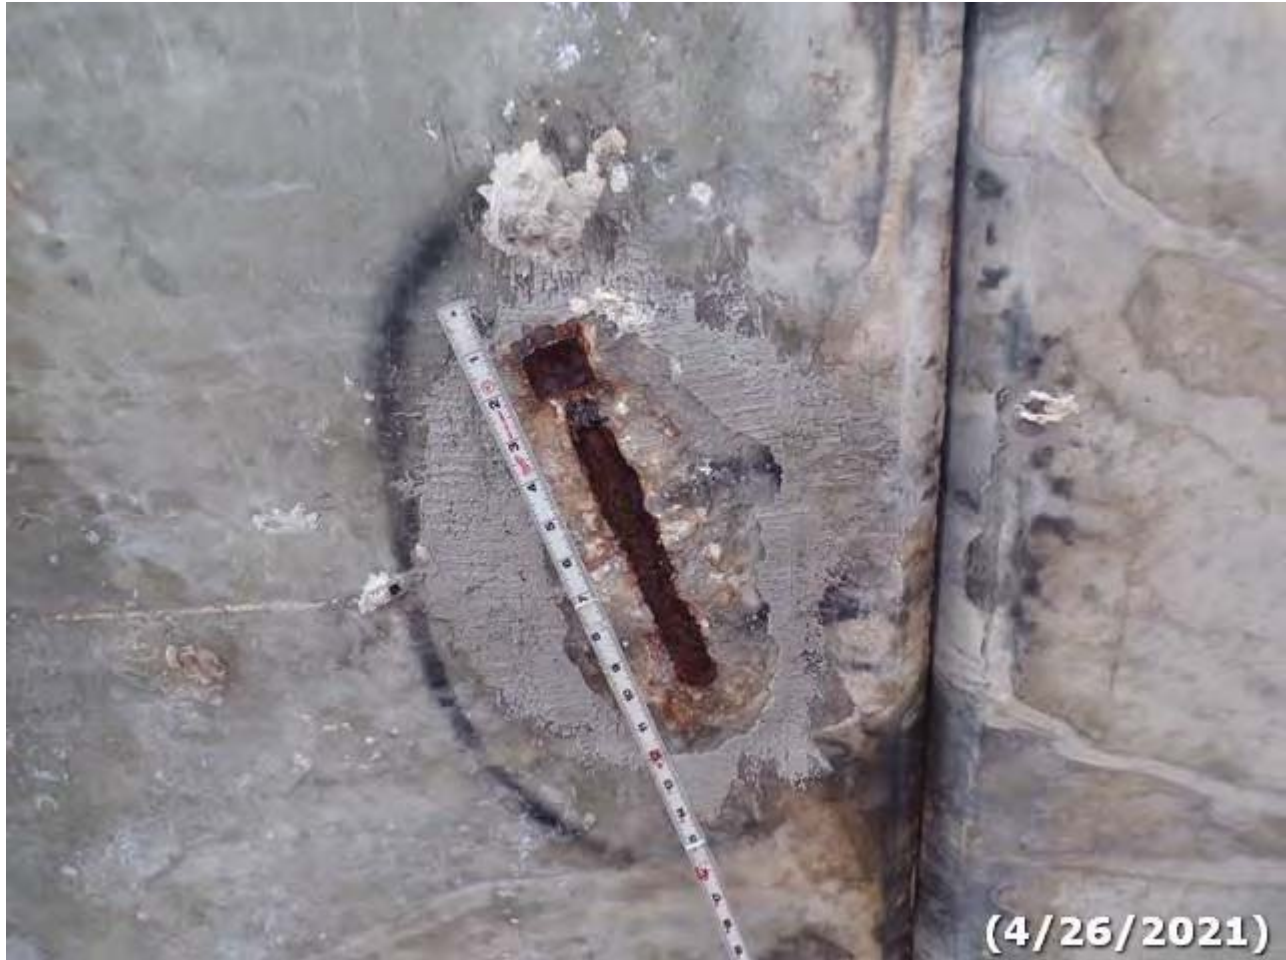
_There is one exposed piece of corroded scrap metal on Slab Unit 1-6 underside at 9ft. from Abutment 1. Previously documented under Defect 1090 as a spall with exposed rebar having minor section loss. Refer to Photo 03. NO CHANGE.

There is one exposed piece of corroded scrap metal on Slab Unit 1-6 underside at 9ft. from Abutment 1.

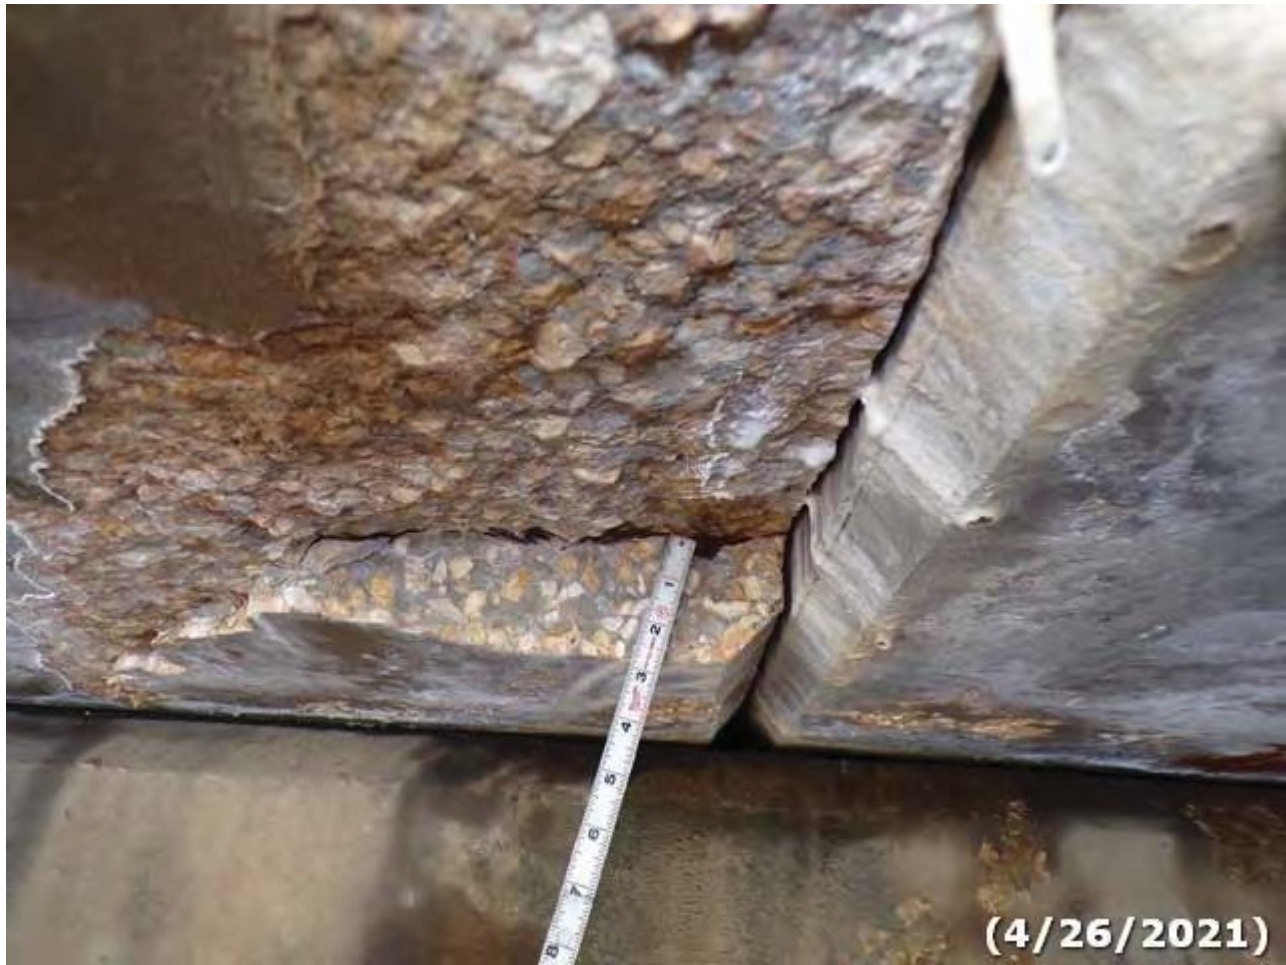
_Slab Unit 1-9 exhibits a spall/delamination up to 36in. L x 24in. W x 2.5in. D over Abutment 1, with an exposed stirrup, no measurable section loss. (Total 6 SF). Refer to Photo 04. NO CHANGE.

Slab Unit 1-9 exhibits a spall/delamination up to 36in. L x 24in. W x 2.5in. D over Abutment 1, with an exposed stirrup, no measurable section loss.

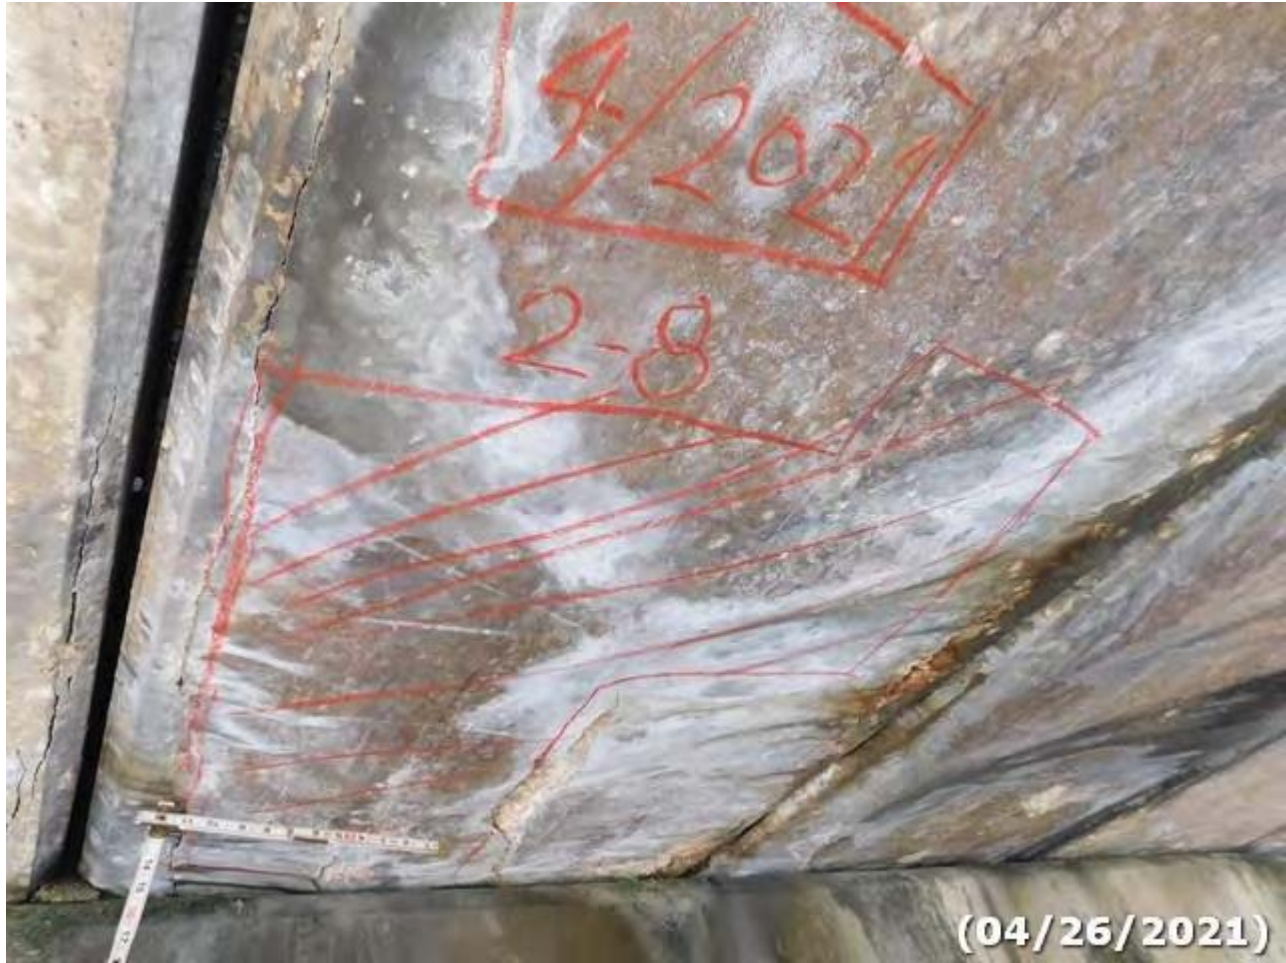
Slab Unit 2-8 underside exhibits a delamination up to full width x 36in. L with associated cracks and rust staining, starting at Bent 2 cap.

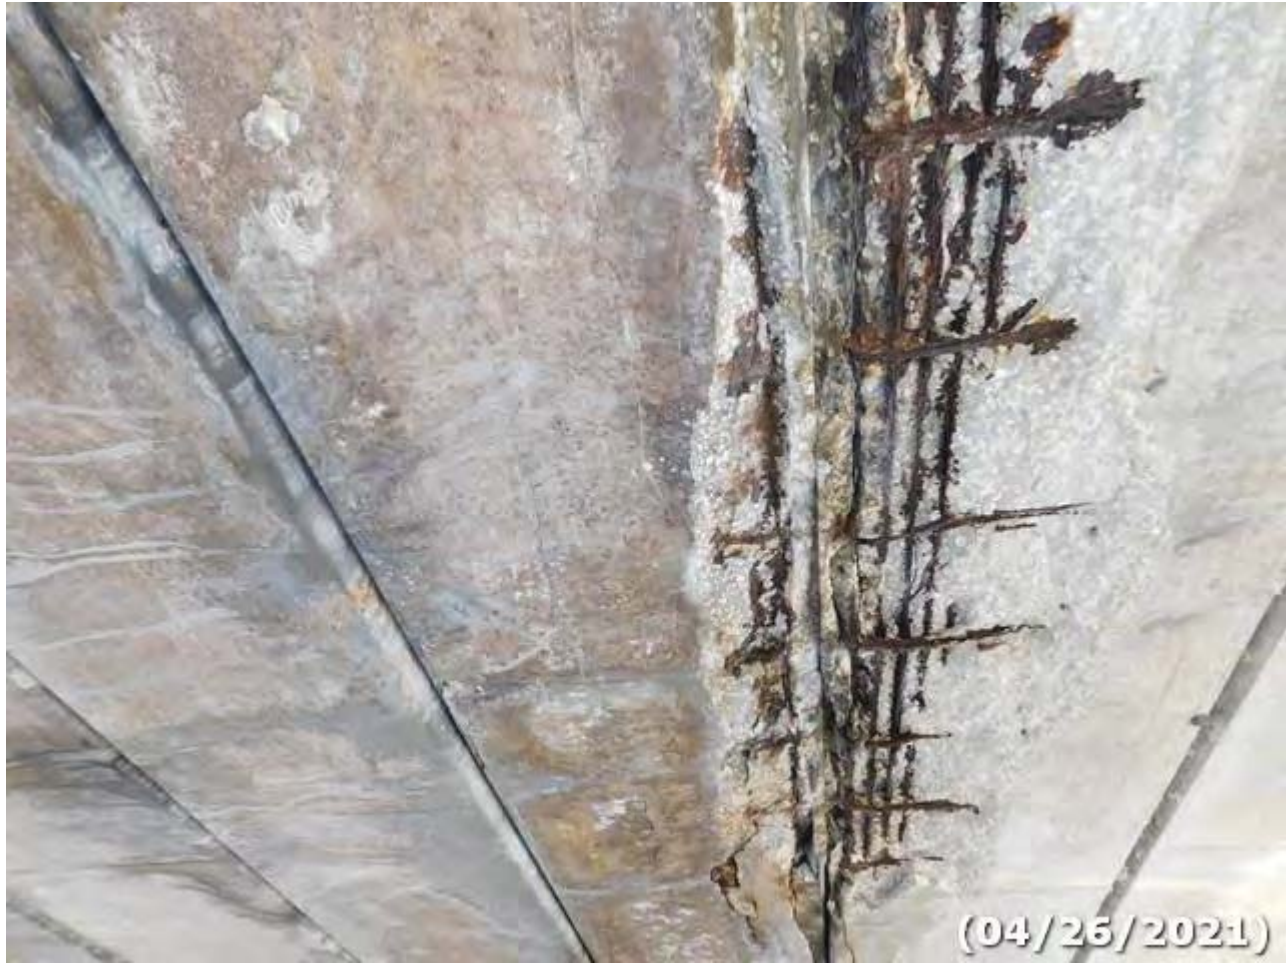
Slab Unit 2-8, midspan has a spall 15ft. L x 24in. W x up to 4in. D with 7 exposed and corroded transverse rebars with up to 60% section remaining and 5 exposed and corroded prestressing strands with up to 0% section remaining (3 broken strands).

ELEMENT/ENV:	8099:1080 / 3 Delamination/Spall/Patched Area	ELEM CATEGORY:	Decks/Slabs
CONDITION STATE			PRIORITY
2 , 3	MMS Quantity: 298 sf Element Estimated Quantity: 298 (SF)		3
WORK ORDER RECOMMENDATION:			
Clean and coat exposed steel and repair spalls and delaminations along the underside of sonovoid slabs. Photos 03 to 05 and 07 to 09			
ELEMENT/ENV:	8099:1100 / 3 Exposed Prestressing	ELEM CATEGORY:	Decks/Slabs
CONDITION STATE			PRIORITY
3	MMS Quantity: 35 sf Element Estimated Quantity: 35 (SF)		2
WORK ORDER RECOMMENDATION:			
Clean and coat exposed prestressing strands and rebars, repair spalls and reinforce the Slab units 2-8 and 2-9. Photo 06

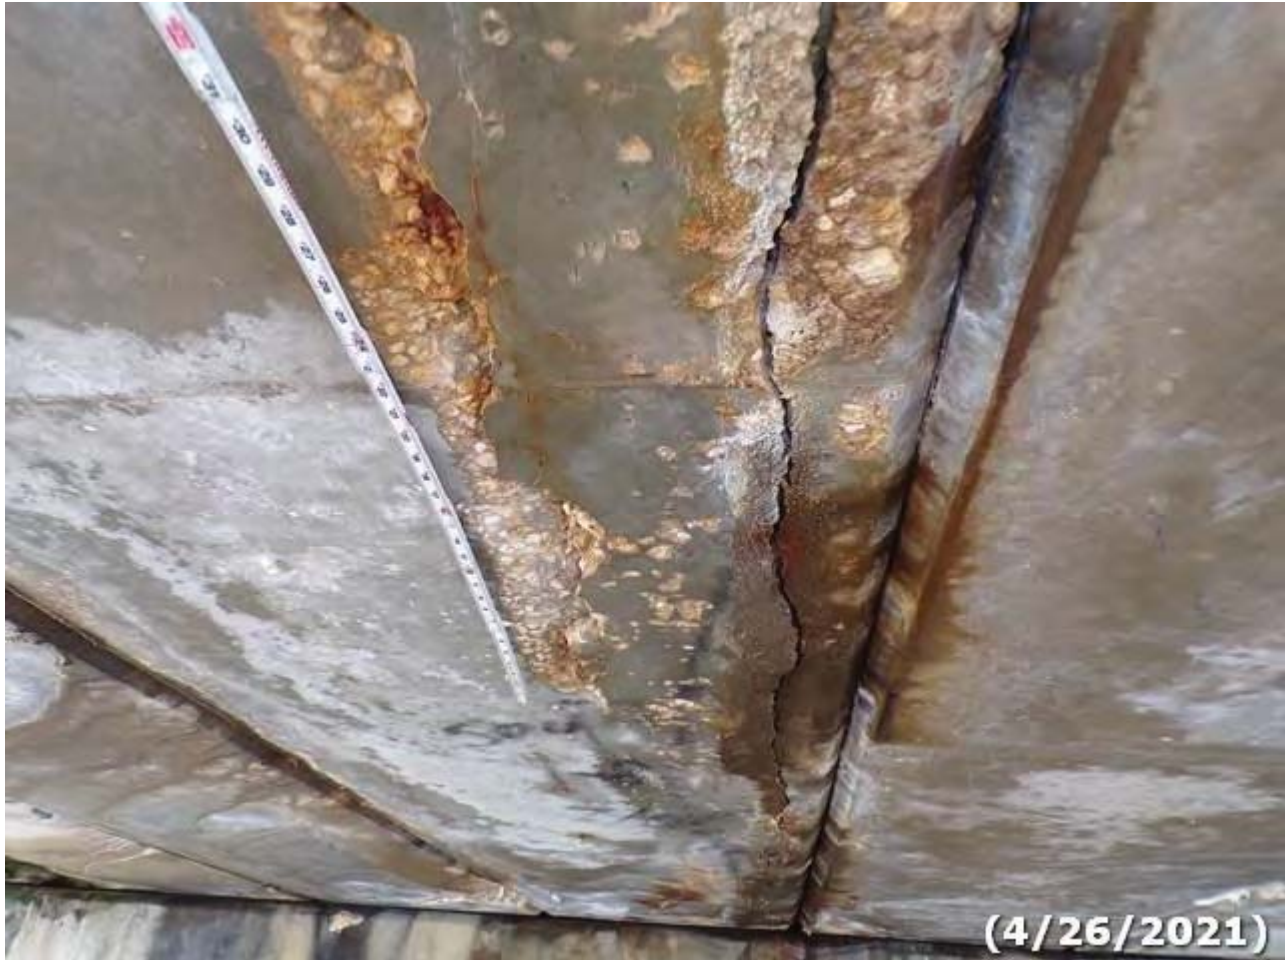
Slab Unit 1-8 west edge is intermittently delaminated up to 15ft. L x 15in. W starting at Abutment 1 with associated cracks up to 1/4in. W with efflorescence and corrosion bleed-out and associated spalling up to 4ft. L x 6in. W x 2in. D approximately 10ft from Abutment 1.

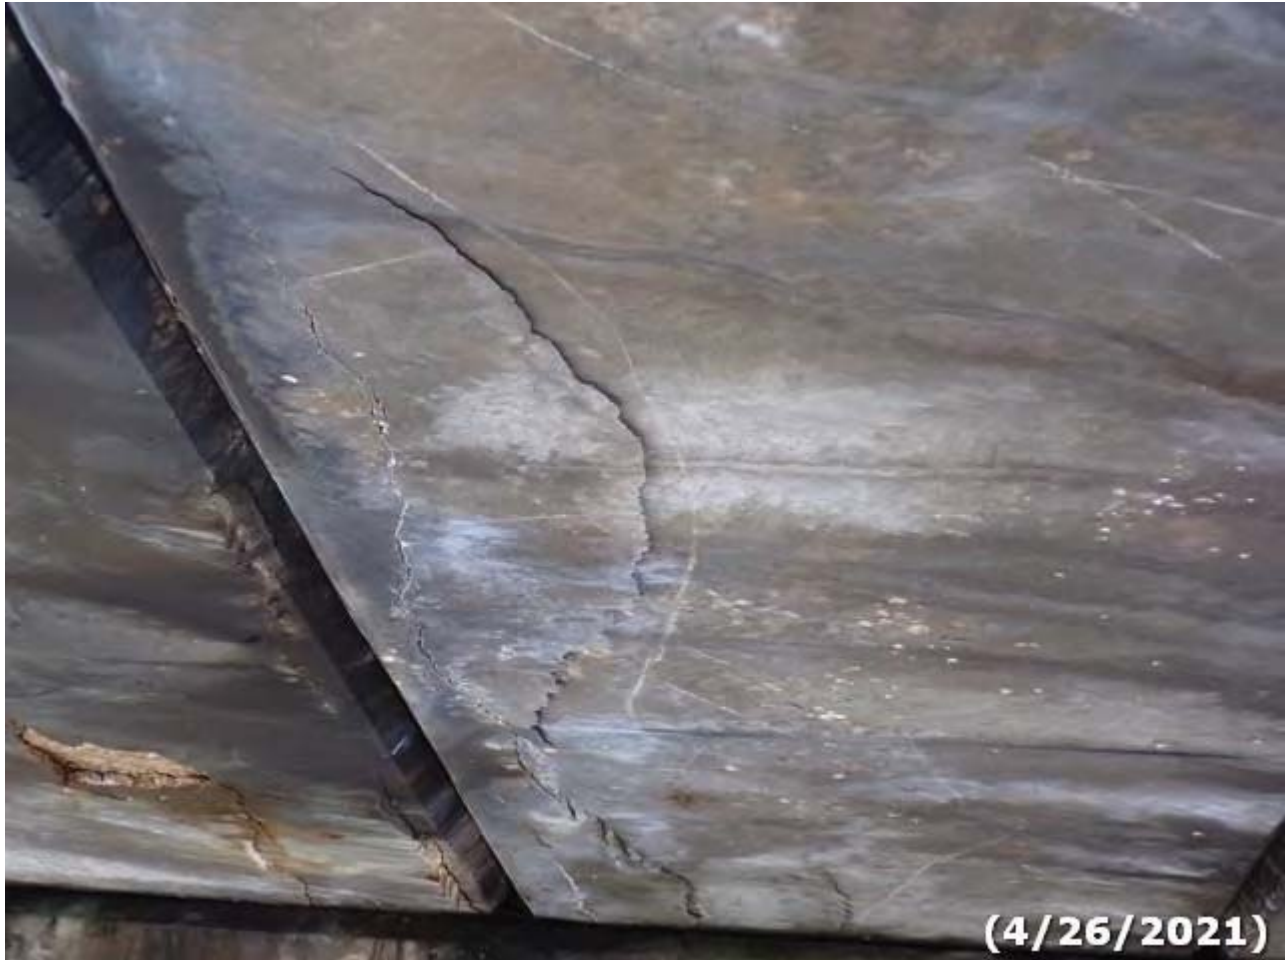
Slab Unit 3-7 has an unsound repaired area 12ft. L x up to slab width (3ft.) starting from Abutment 4 with hollow sounding throughout and associated cracks up to 1/16in. W with efflorescence and corrosion bleed-out.

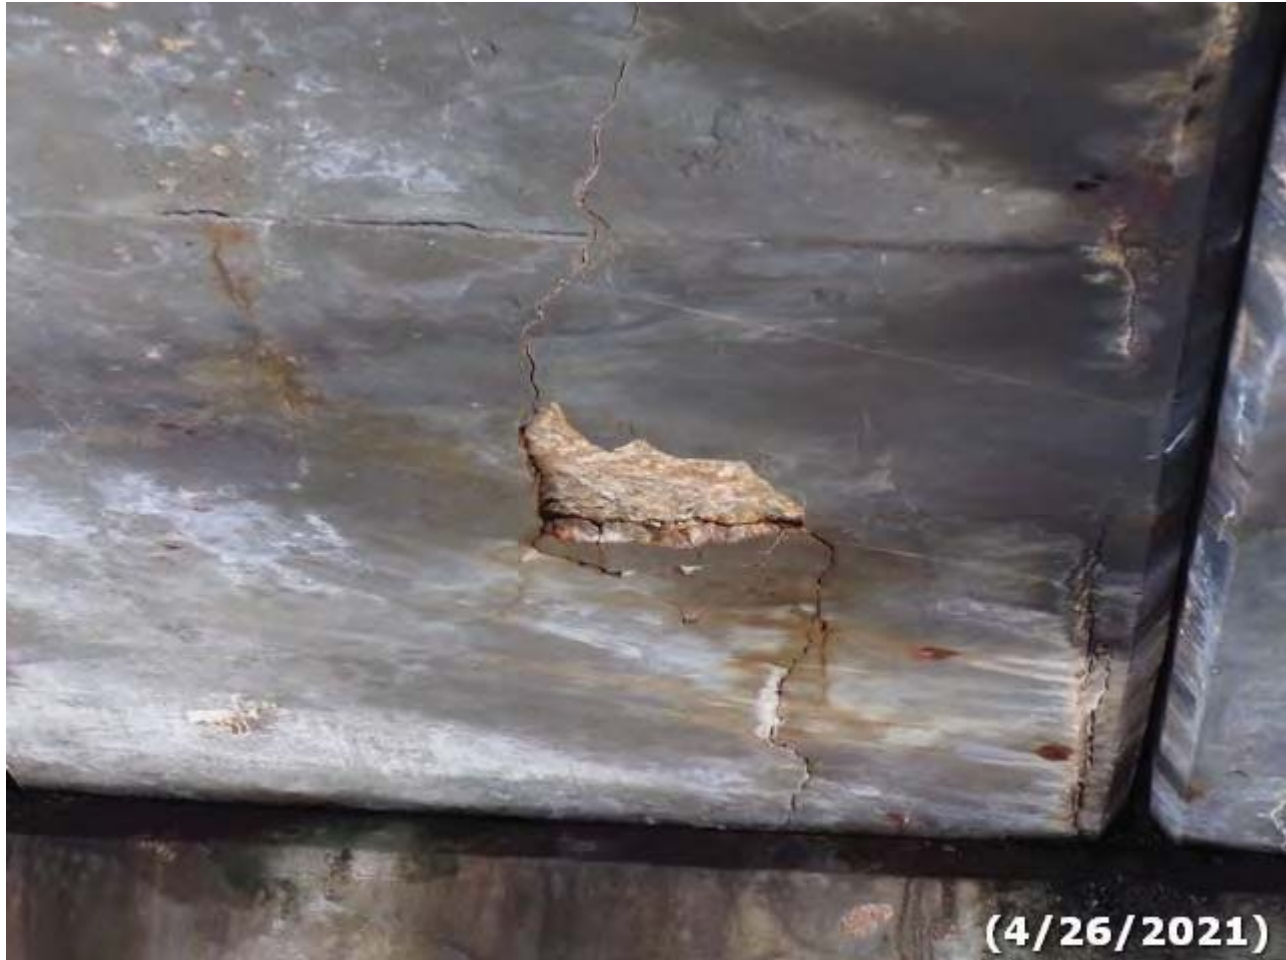
Slab Unit 3-8 has a spall/delamination up to 8ft. L x 3ft. W x 1in. D and associated cracks with corrosion bleed-out starting at Pier 3.

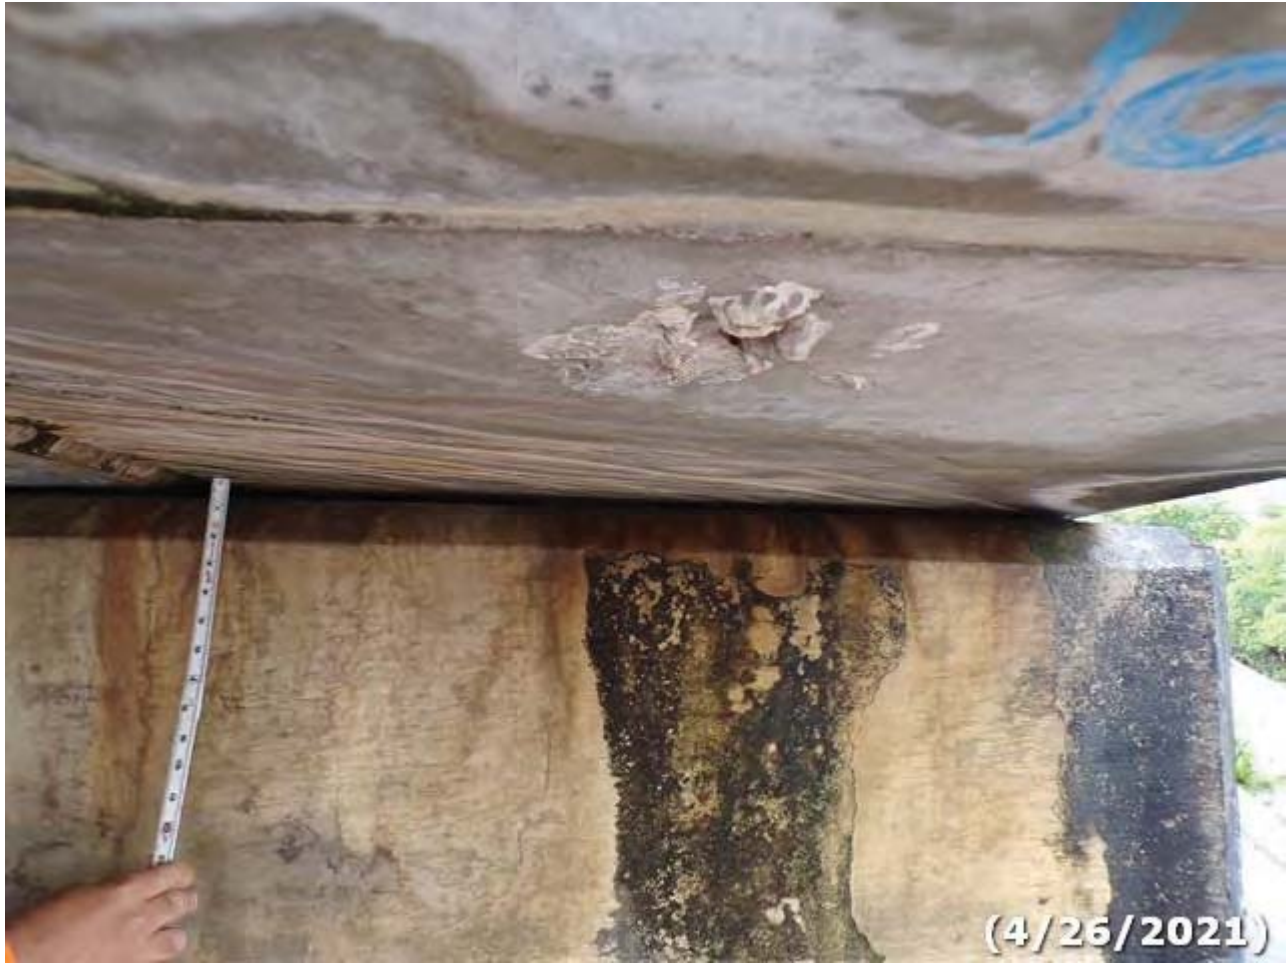
Slab Unit 1-1 exhibits a slight outward rotation at Abutment 1 with up to 1/4in. height difference in reference to the top of the cap, potentially indicating shear key failure. No anti-rotation block is in place.

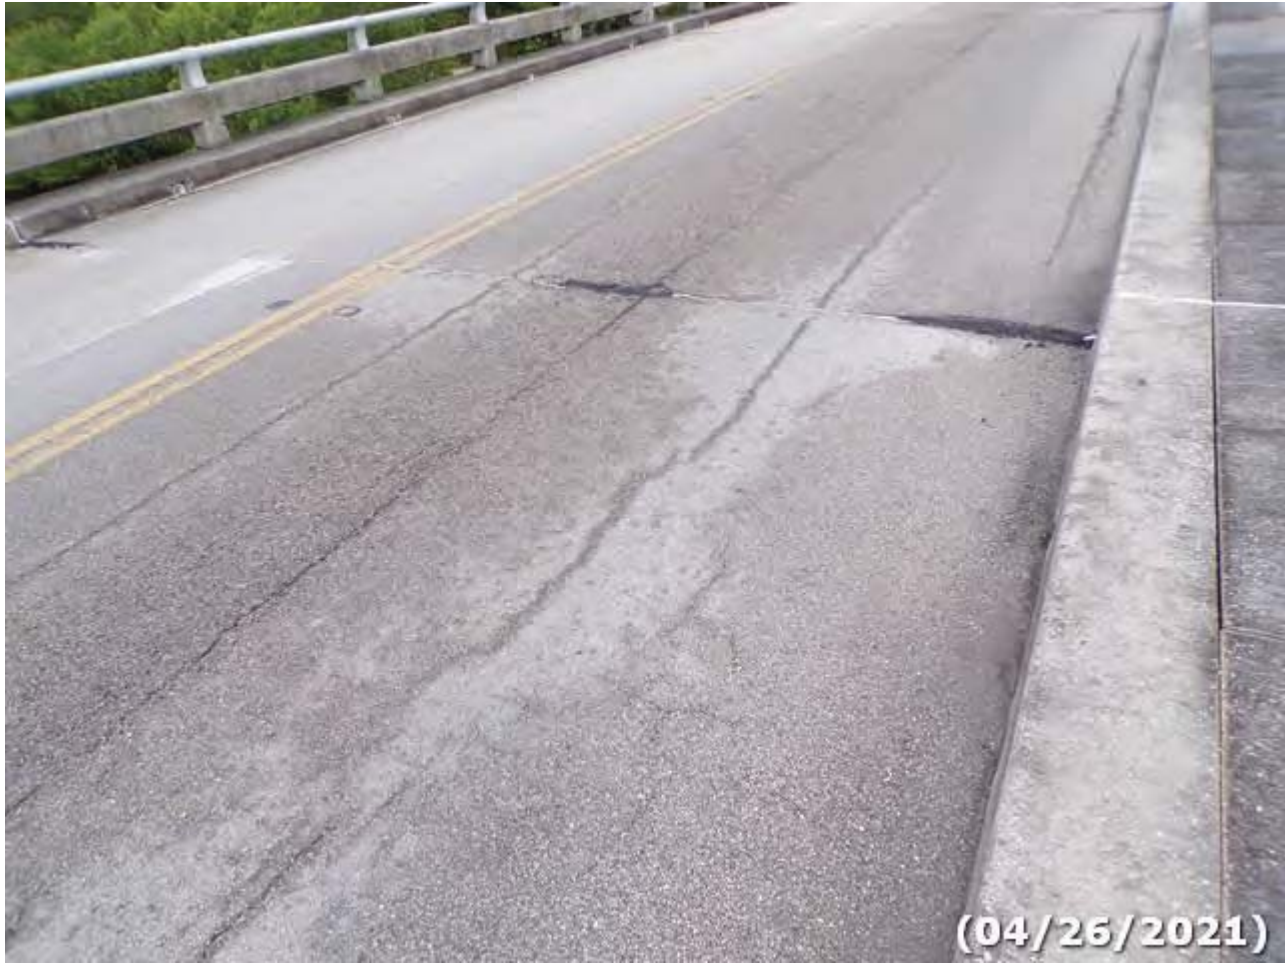
_The asphalt overlay has longitudinal cracks up to span length x 1/4in. W with associated 1in. W rutting over the slab unit joints and upheaving up to 1in. H at the shoulders, possibly indicating independent slab unit movement. (Total 600 SF). Refer to Photo 11. NO CHANGE.

The asphalt overlay has longitudinal cracks up to span length x 1/4in. W with associated 1in. W rutting over the slab unit joints and upheaving up to 1in. H at the shoulders, possibly indicating independent slab unit movement.

UNIT: 0	DECKS		
ELEMENT/ENV:	8099 / 3 PS Conc Slab (Sonovoid)	ELEM CATEGORY:	Decks/Slabs
CONDITION STATE			PRIORITY
1 , 2 , 3	MMS Quantity: 300 sf Element Estimated Quantity: 300 (SF)		3
WORK ORDER RECOMMENDATION:			
Properly secure the sidewalk concrete panels. Photo 02			
1 , 2 , 3	MMS Quantity: 10 sf Element Estimated Quantity: 10 (SF)		3
WORK ORDER RECOMMENDATION:			
Replace missing raised pavement markers along the centerline of the structure. Photo 01			
ELEMENT/ENV:	8099:510:3220 / 3 Crack (Wearing Surface)	ELEM CATEGORY:	Decks/Slabs
CONDITION STATE			PRIORITY
3	MMS Quantity: 600 sf Element Estimated Quantity: 600 sq.ft		3
WORK ORDER RECOMMENDATION:			
Monitor the slab units for independent movement. Photo 11			
3	MMS Quantity: 900 sf Element Estimated Quantity: 900 sq.ft		3
WORK ORDER RECOMMENDATION:			
Seal cracks on the asphalt along the slab unit joints and multi-directional cracks on Lane 2 (NB) in Spans 1 and 2. Photos 11 and 12

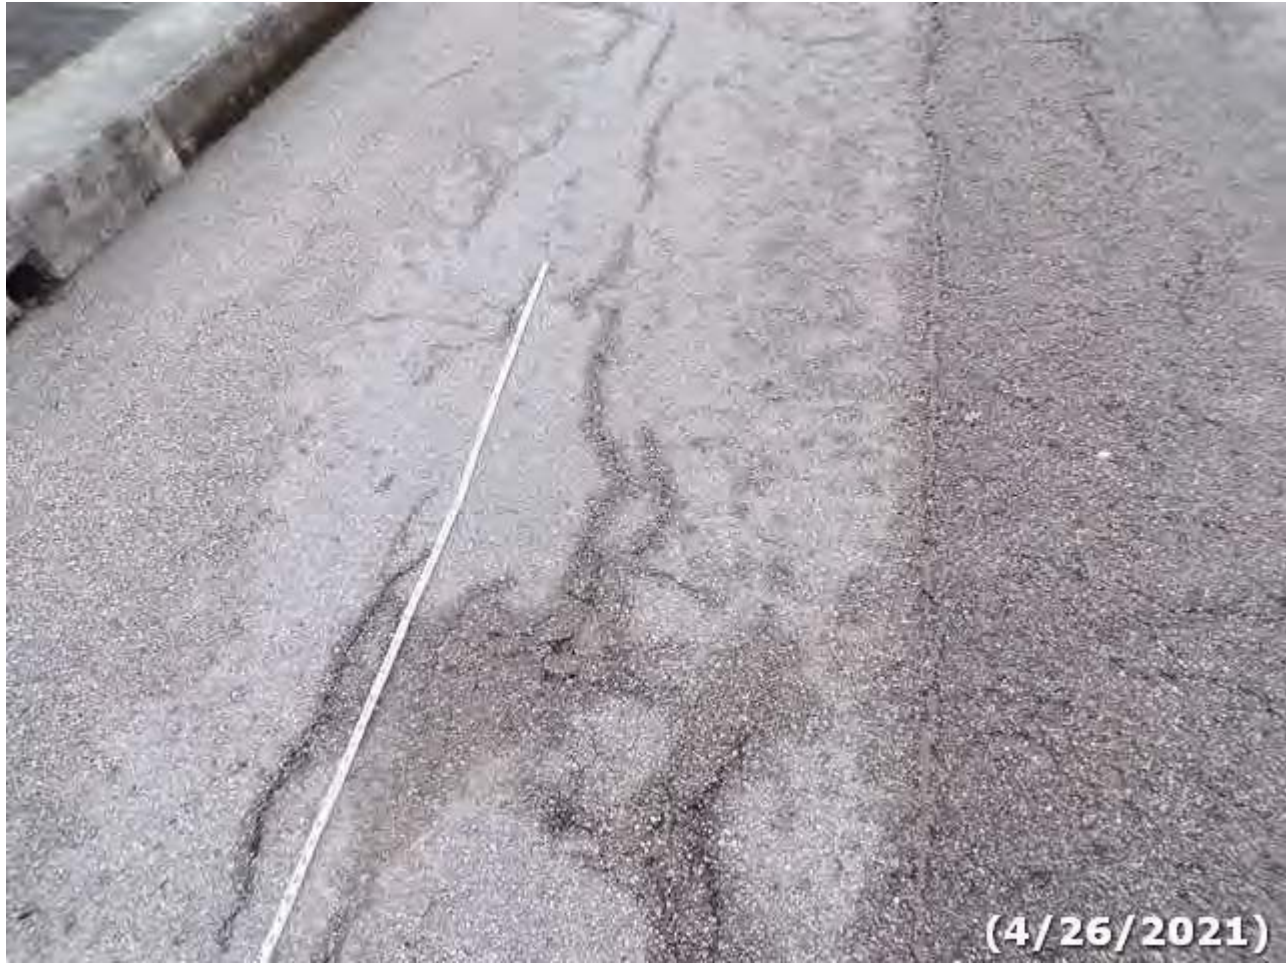
_The asphalt overlay at Spans 1 and 2 has multi-directional cracking up to 1/2in. W on Lane 2 (NB), worse condition is on Span 1 which has a hollow-sounding area 19.5ft L x 11ft. W, starting 1 ft. from the right sidewalk. (Total 300 SF). Refer to Photo 12. NO CHANGE.

The asphalt overlay at Spans 1 and 2 has multi-directional cracking up to 1/2in. W on Lane 2 (NB), worse condition is on Span 1 which has a hollow-sounding area 19.5ft L x 11ft. W, starting 1 ft. from the right sidewalk.

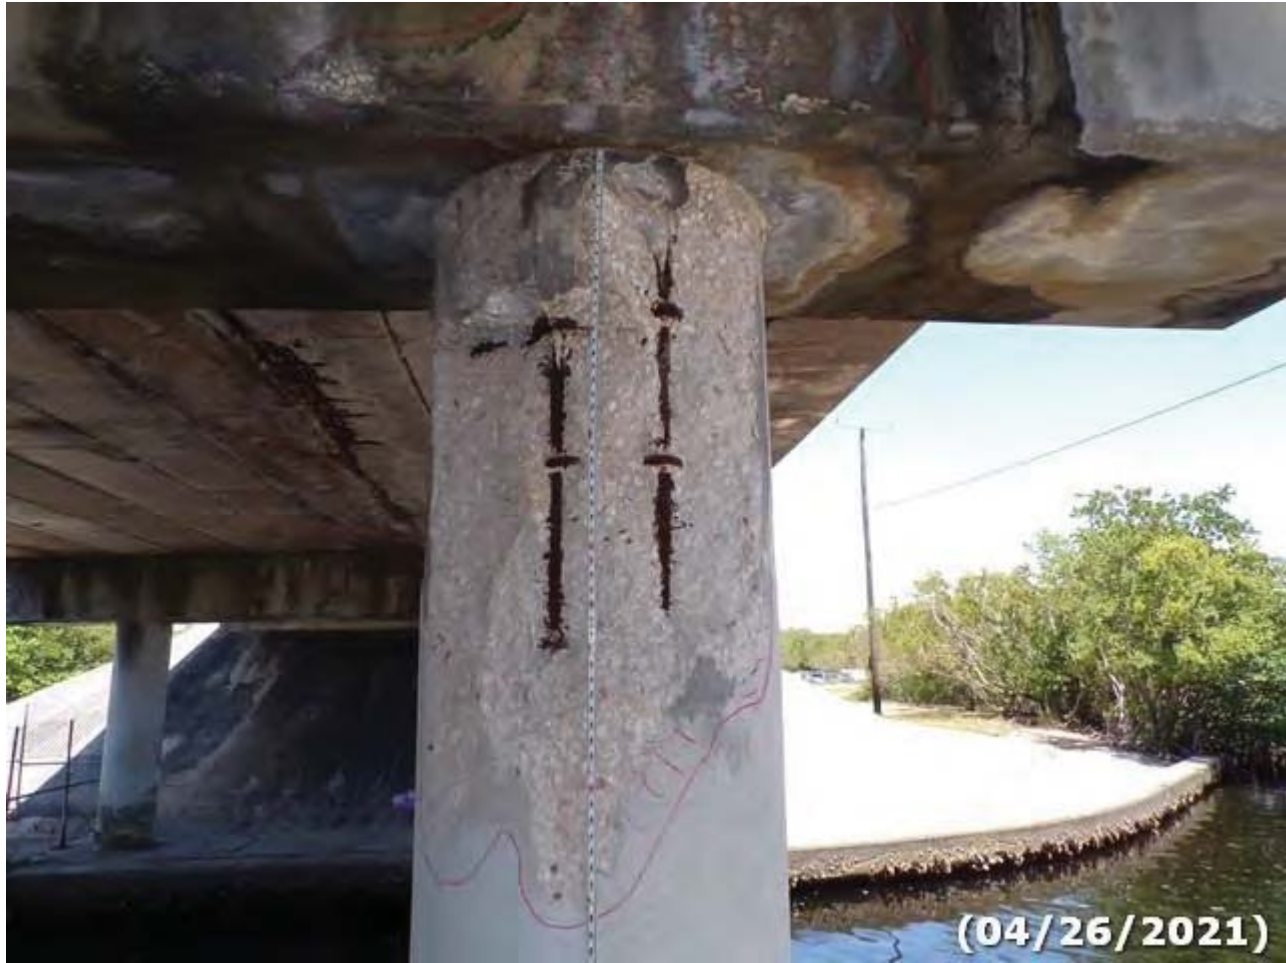
_Column 2-2, south face has a spall/delamination up to 55in. H x 32in. W x 4in. D with two exposed longitudinal rebars and five stirrups, having areas of up to 80% section remaining. Additionally, there are areas of delamination around the column circumference covering the entire column height with associated cracks up to 1/4in. W as a consequence of corrosion of the steel reinforcement. Previously noted as a spall/delamination 7ft. H x 3ft. W x 3in. D with one exposed rebar and one stirrup. (Total 1 ea.) Refer to Photos 13, 14, and 15. INCREASE.

Column 2-2, south face has a spall/delamination up to 55in. H x 32in. W x 4-3/4in. D with two exposed longitudinal rebars and five stirrups, having areas of up to 80% section remaining.

CONDITION STATE			PRIORITY
3	MMS Quantity: 40 mh	Element Estimated Quantity: 1 each	2
WORK ORDER RECOMMENDATION: Clean and coat exposed rebars, repair spalls/delaminations and reinforce Column 2-2. Photos 13 to 15

CONDITION STATE			PRIORITY
3	MMS Quantity: 40 mh	Element Estimated Quantity: 4 each	3
WORK ORDER RECOMMENDATION: Repair delaminations and seal cracks along Bents 2 and 3 columns. Photos 13 to 15			
3	MMS Quantity: 80 mh	Element Estimated Quantity: 4 each	3
WORK ORDER RECOMMENDATION: Install jackets with cathodic protection to Bents 2 and 3 columns. Photos 13 to 15

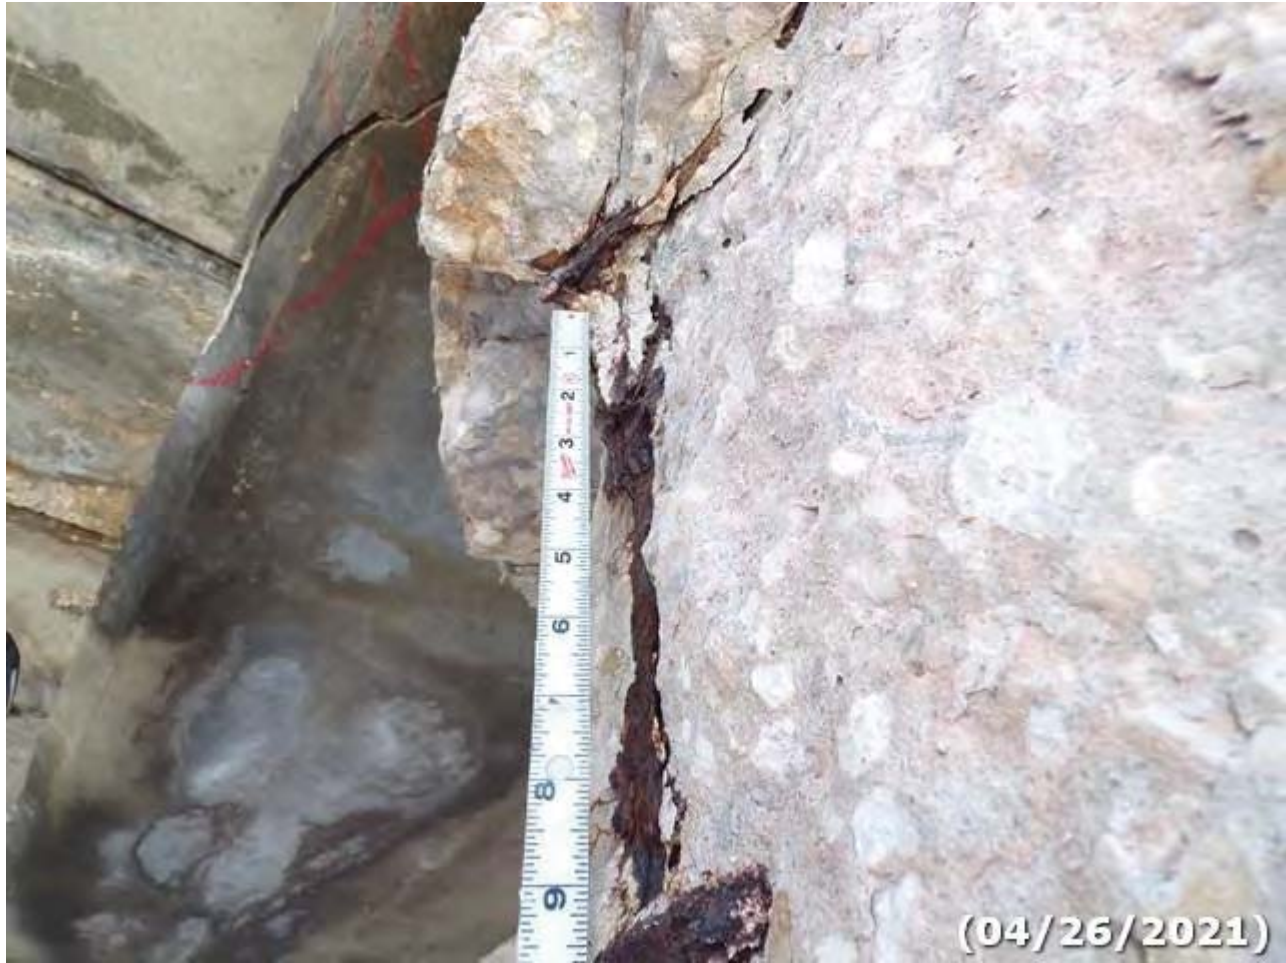
Spall/delamination with exposed reinforcement having up to 80% remaining in south face of Column 2-2. (close up view)
