APPENDIX "F" TO SPECIAL PROVISIONS
STRUCTURES LOAD RATING CALCULATIONS

PW Project No. 20200315, EDP-MT-20200315

**Matheson Hammock Park Road (Bridge No.874294) over
Matheson Hammock Canal**

DEPARTMENT OF TRANSPORTATION AND PUBLIC WORKS

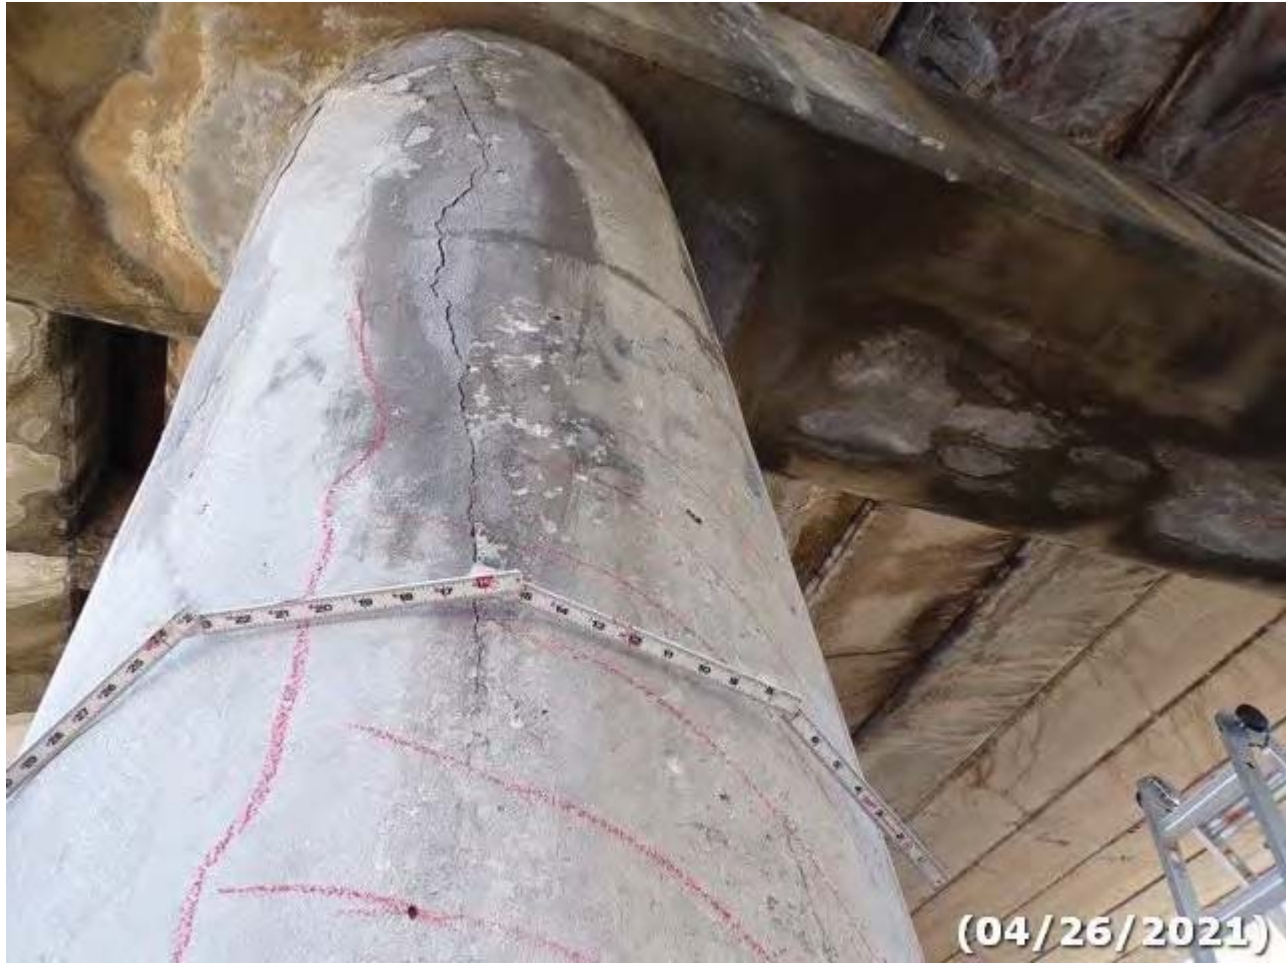
Areas of delamination around the column circumference covering the entire column height with associated cracks up to 1/4in. W as a consequence of corrosion of the steel reinforcement.

CONDITION STATE			PRIORITY
3	MMS Quantity: 40 mh	Element Estimated Quantity: 1 each	2
WORK ORDER RECOMMENDATION: Clean and coat exposed rebars, repair spalls/delaminations and reinforce Column 2-2. Photos 13 to 15

CONDITION STATE			PRIORITY
3	MMS Quantity: 40 mh	Element Estimated Quantity: 4 each	3
WORK ORDER RECOMMENDATION: Repair delaminations and seal cracks along Bents 2 and 3 columns. Photos 13 to 15			
3	MMS Quantity: 80 mh	Element Estimated Quantity: 4 each	3
WORK ORDER RECOMMENDATION: Install jackets with cathodic protection to Bents 2 and 3 columns. Photos 13 to 15

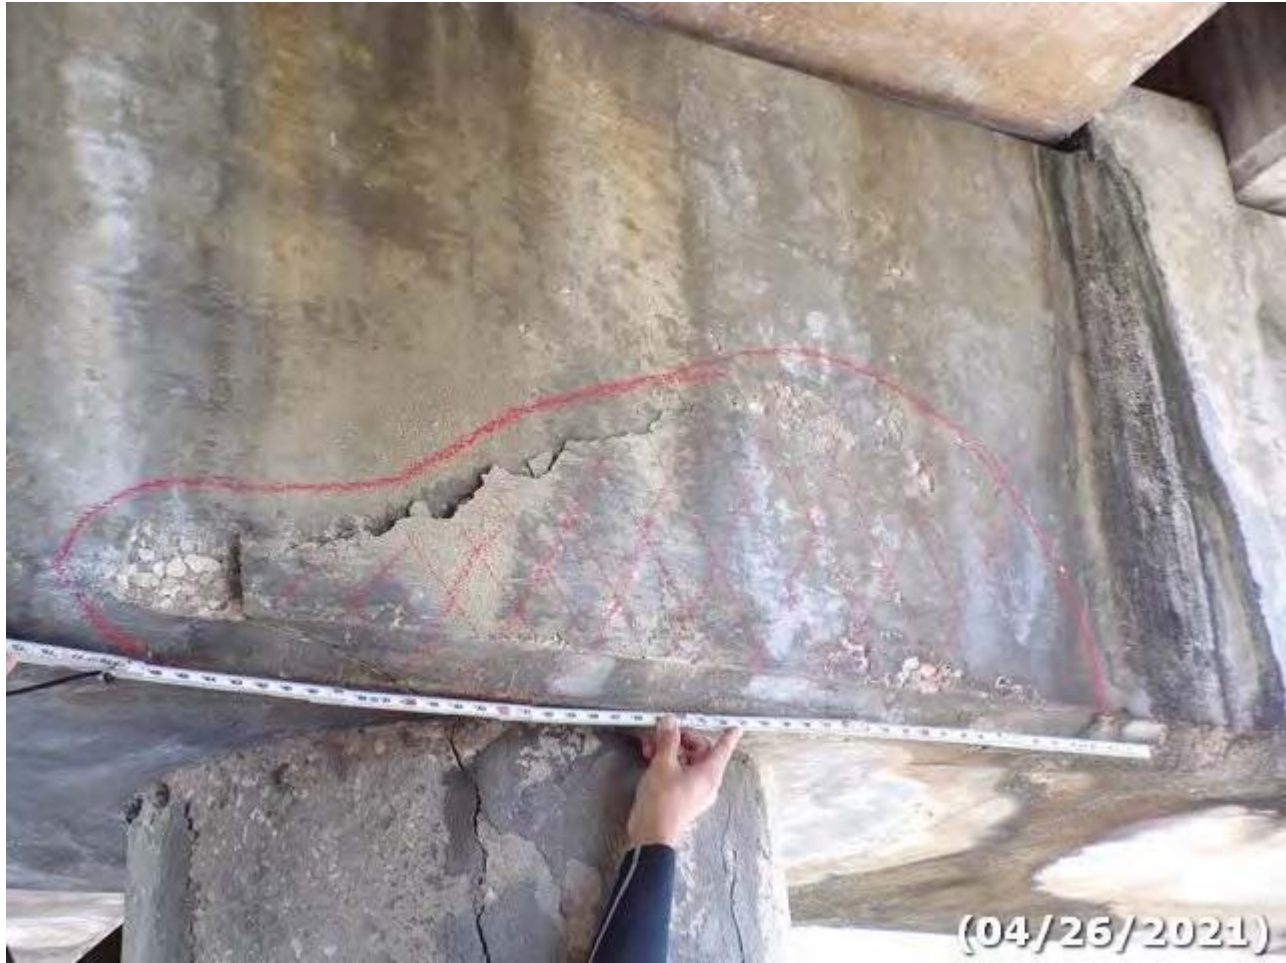
Bent 2 cap, south face has a spall/delamination up to 48in. L x 17in. H x 3/4 in. D over Column 2-2, and on the same location, north face a delamination 20in. L x 12in. H. (south view)

CONDITION STATE			PRIORITY
2 , 3	MMS Quantity: 40 mh	Element Estimated Quantity: 20 ft	2
WORK ORDER RECOMMENDATION: Repair spalls and delaminations along Bents 2 and 3 caps. Photos 16 to 18

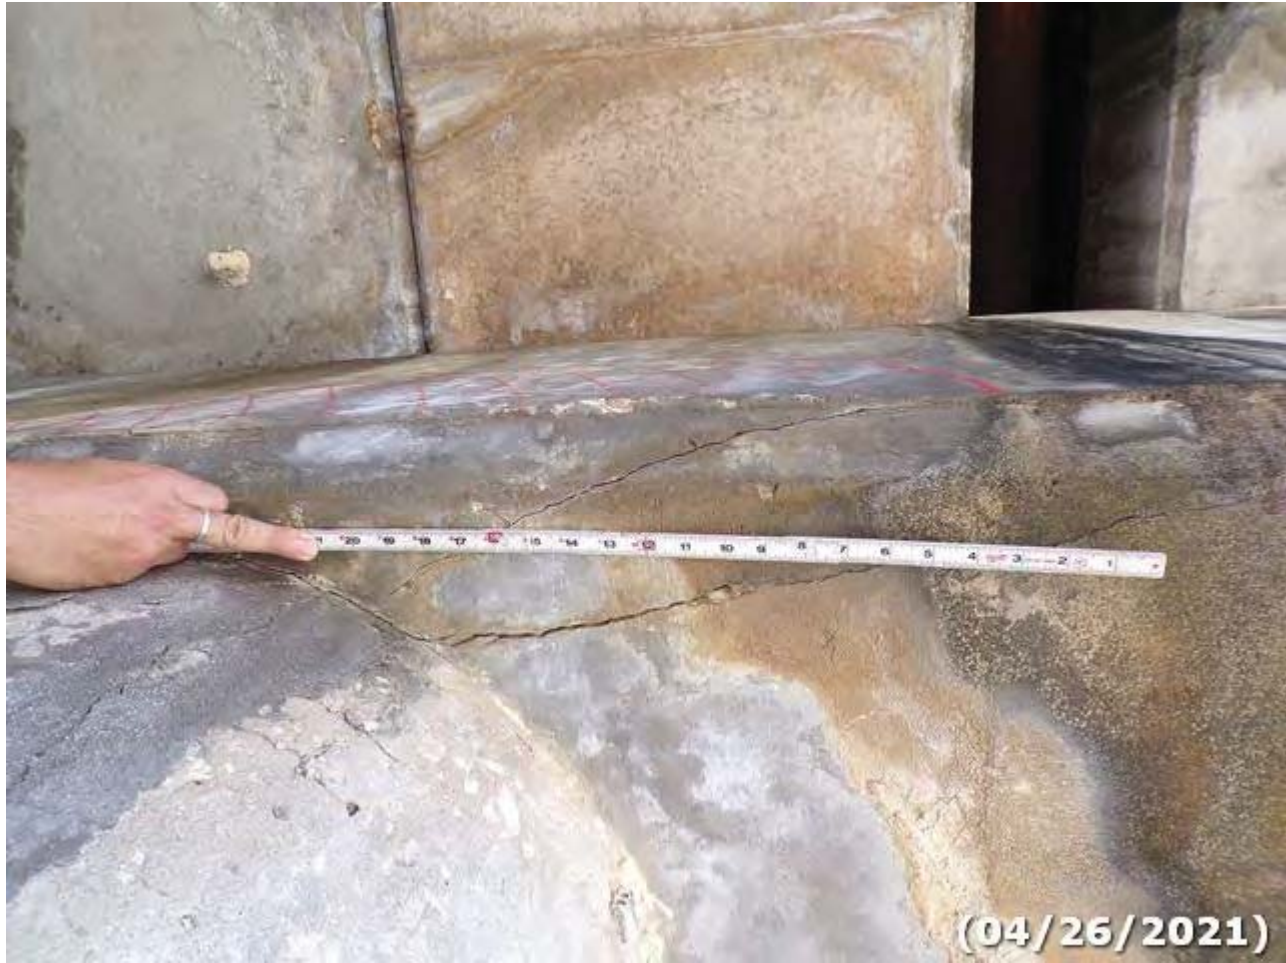
Bent 2 cap, south face has a spall/delamination up to 48in. L x 17in. H x 3/4 in. D over Column 2-2, and on the same location, north face a delamination 20in. L x 12in. H. (bottom view)

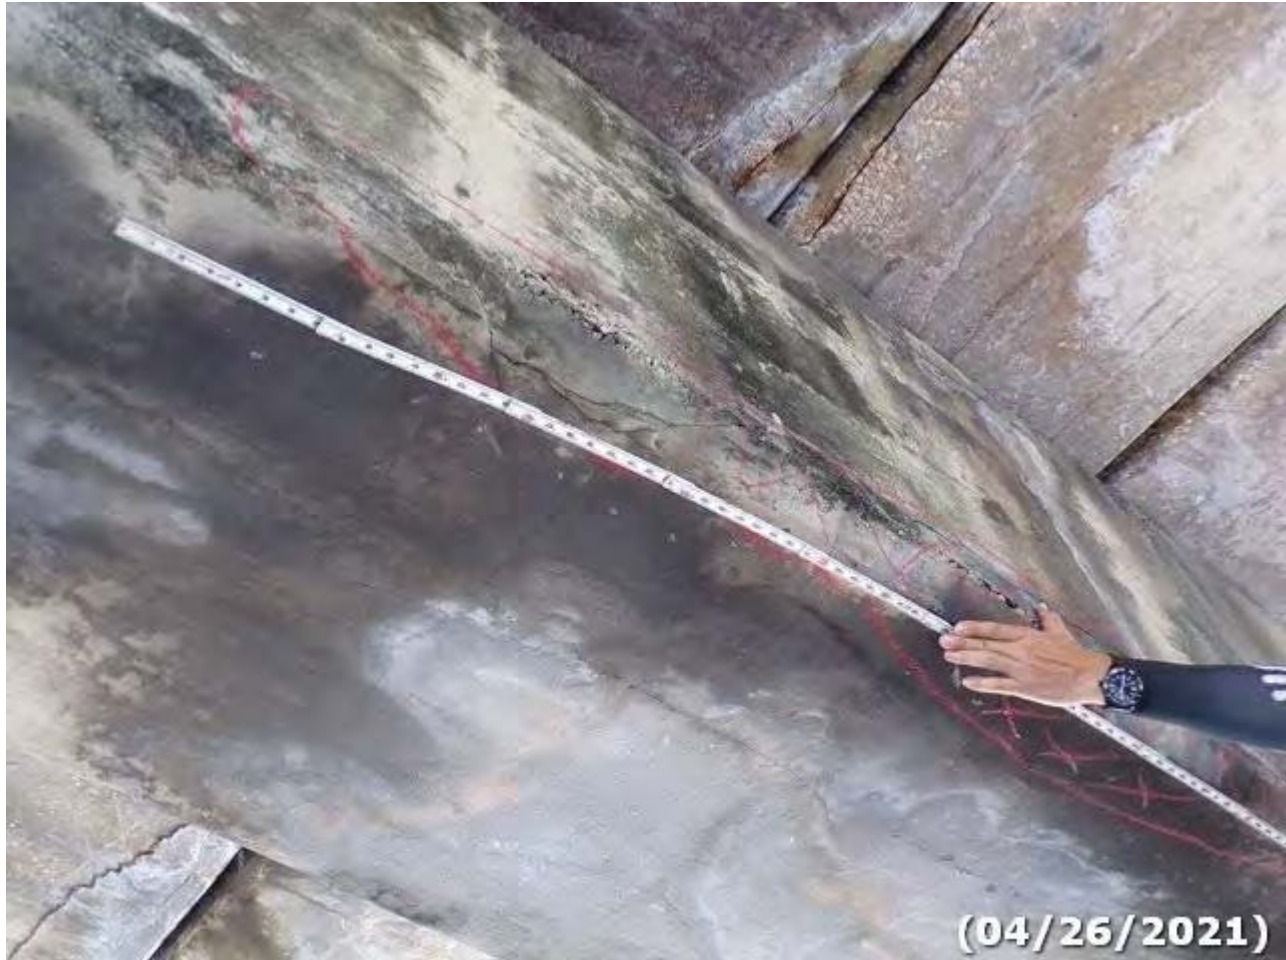
Photo 18 Element/Env 234/3: Re. Concrete Pier Cap

_Bent 3 cap, bottom and north faces has two unsound repaired areas up to 30in. L x 24in. W with multidirectional cracks up to 1/64in. W between Columns 3-1 and 3-2. (Total 4 LF) Refer to Photo 18. NO CHANGE.

_Pier 3 cap has intermittent delaminated areas up to 3ft. L x 16in. H between Columns 3-1 and 3-2, along the top and bottom north edges. (Total 12 LF) Refer to Photo 18. NO CHANGE.

Areas of unsound repairs on the bottom face of Pier 3 cap, intermittent delaminated areas up to 3ft. L x 16in. H between Columns 3-1 and 3-2, along the top and bottom north edges.

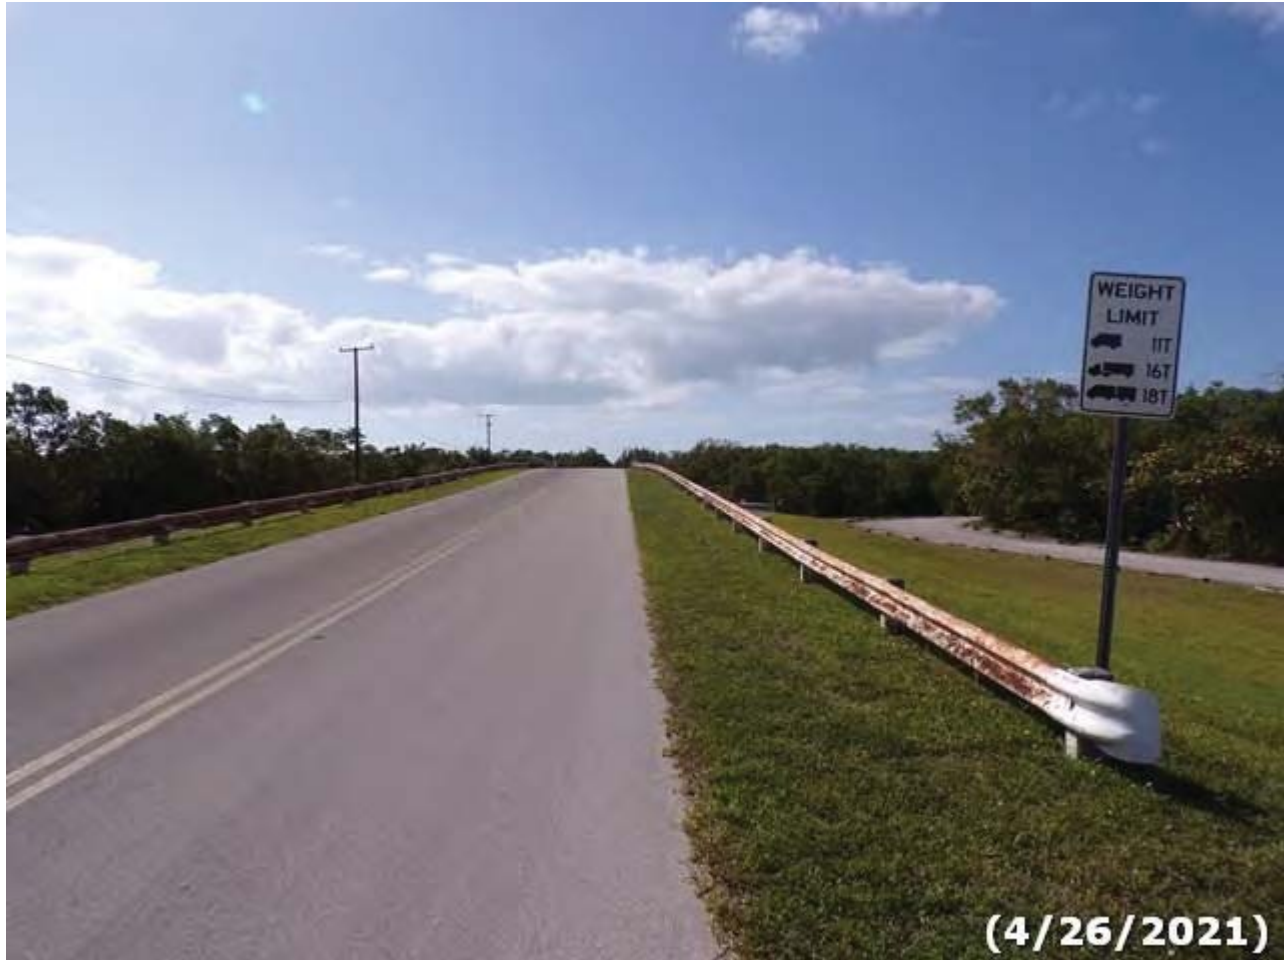
Photo 19: STRUCTURE NOTES

Based on the current load rating analysis dated 1/13/2020, the bridge is posted for the SU, C and ST5 type vehicles as follows:
 SU = 11 tons, C = 16 tons, ST5 = 18 tons. Refer to posting signs Photos 19 and 20.

North Approach Posting Sign

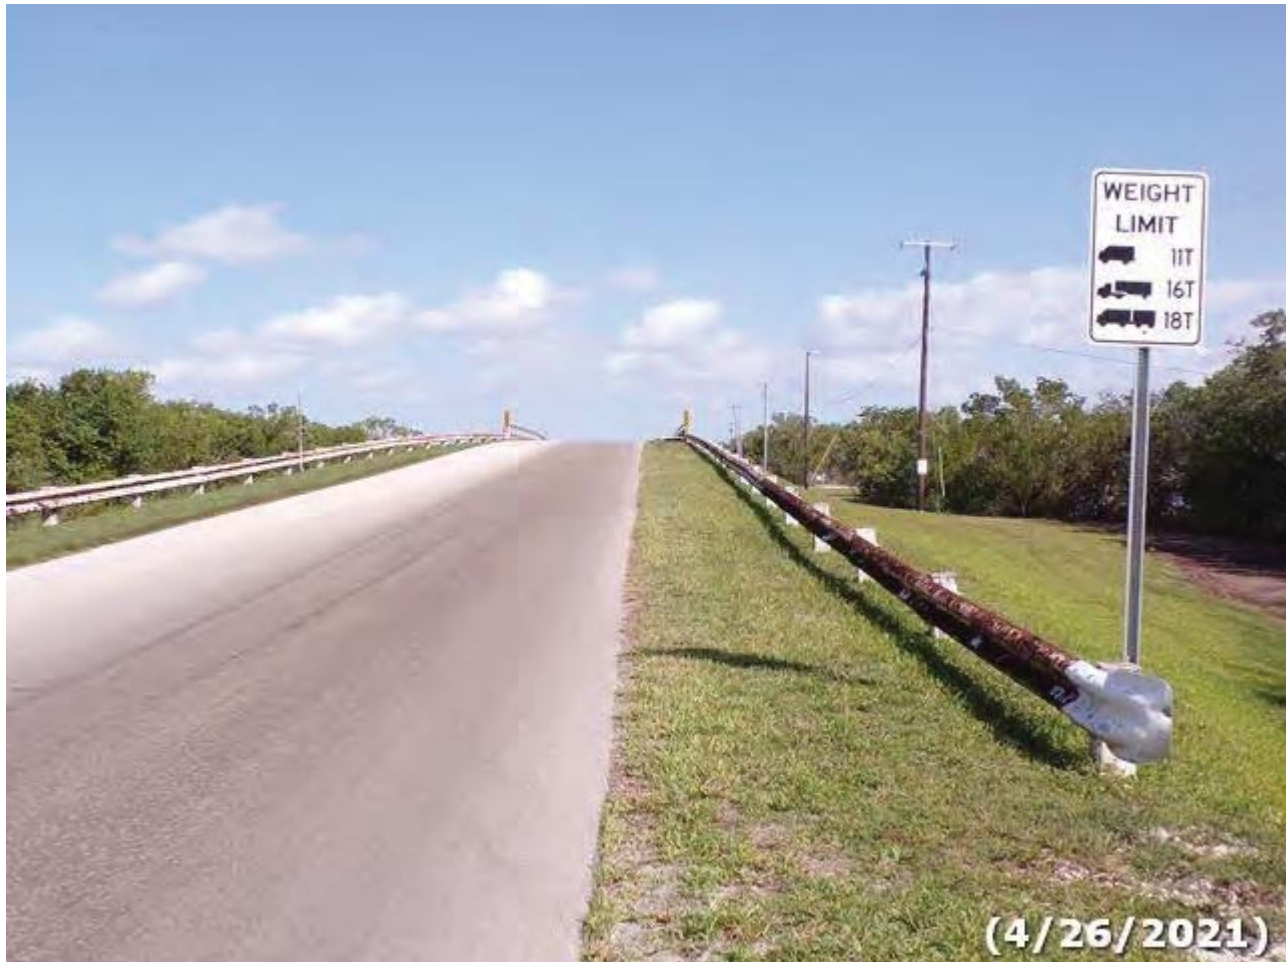
Photo 20: STRUCTURE NOTES

South Approach Posting Sign
