Miami Dade County  
Resources Recovery Facility  
COVANTA

**Summary of Lab Results - Water Quality Analysis**

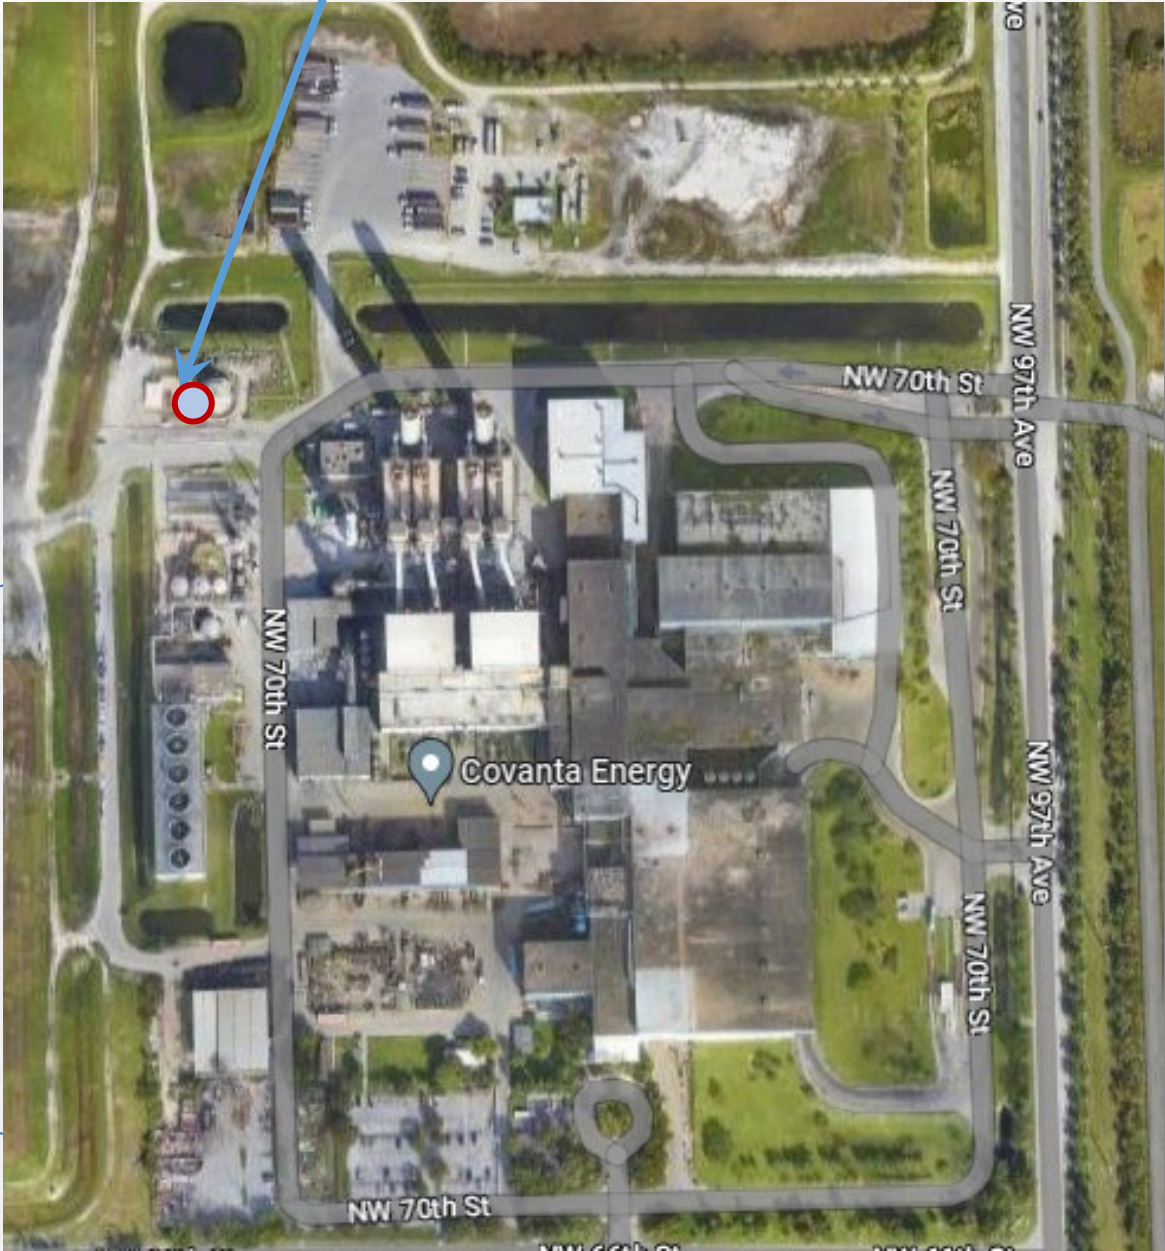
# SAMPLING LOCATION

Sample on 02/17

Sample Location #3  
WASD Pump Station #9938
