RESOLUTION NO. R-745-07

RESOLUTION APPOINTING BOARD OF COUNTY  
COMMISSIONERS AS COMMUNITY  
REDEVELOPMENT AGENCY FOR THE WEST  
PERRINE COMMUNITY REDEVELOPMENT  
DISTRICT; RESERVING RIGHT TO RETAIN  
CERTAIN POWERS AND DELEGATE ONLY LIMITED  
POWERS TO ANY BOARD APPOINTED OTHER  
THAN PURSUANT TO SECTION 163.357, FLORIDA  
STATUTES

This Finding of Necessity (FON) report seeks to establish slum and blight determinants in the West Perrine area in order to support the formation of a Community Redevelopment Area (CRA) and its Community Redevelopment Agency. The FON is an assessment of the area that provides the evidence of blight and the need for redevelopment due to the area's deficiencies in attracting market-based investment of the same rate and quality as surrounding areas and the County as a whole. The area was found to exhibit sufficient blight to recommend the formation of a CRA.

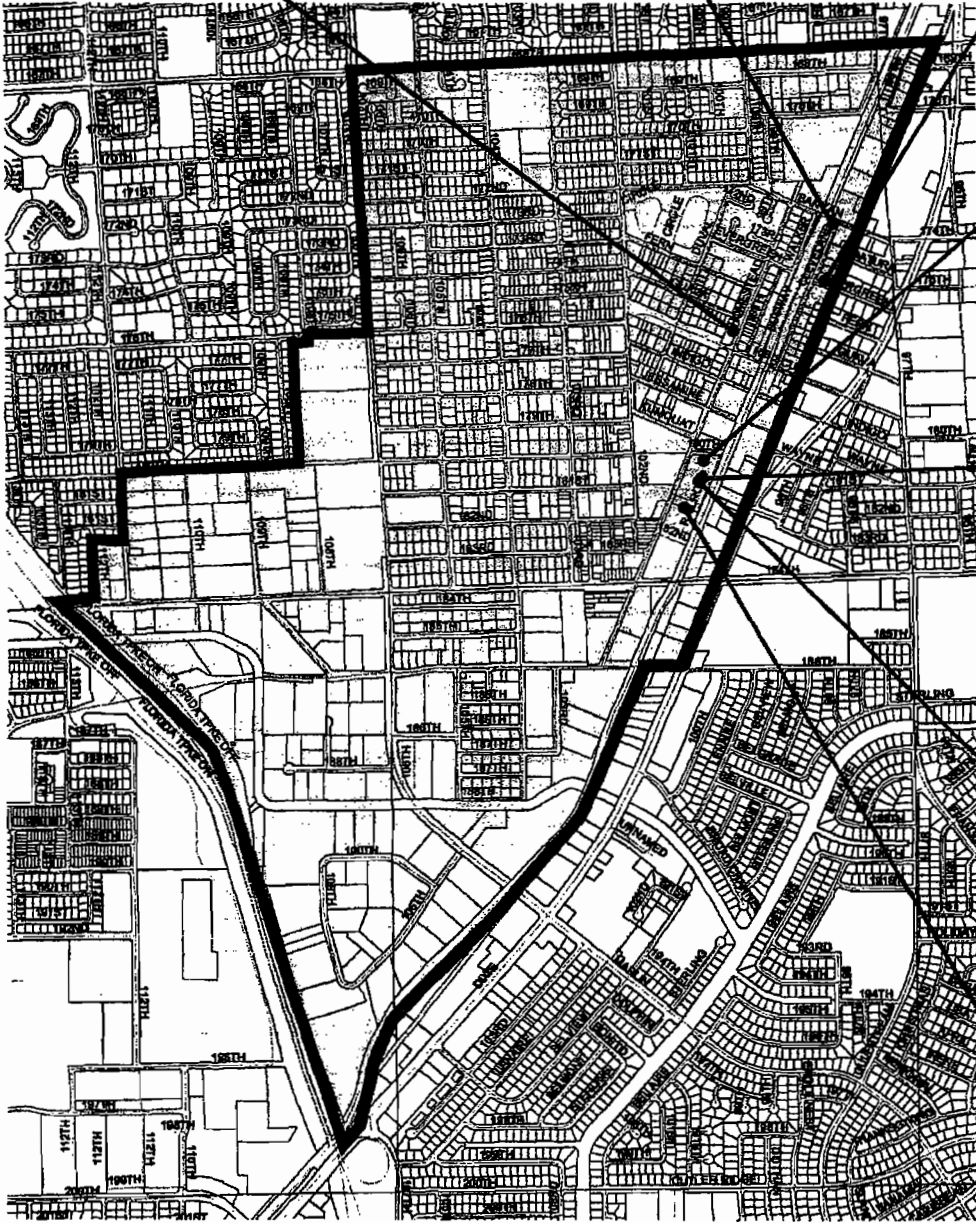
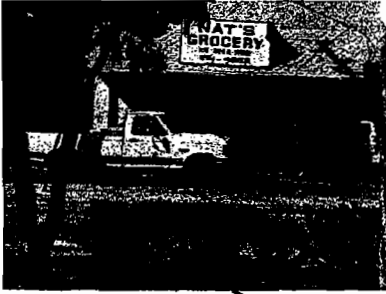
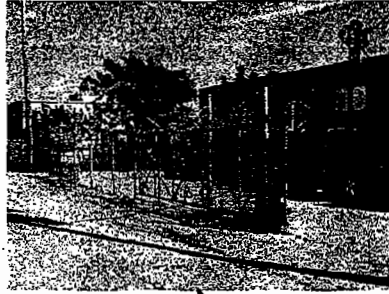
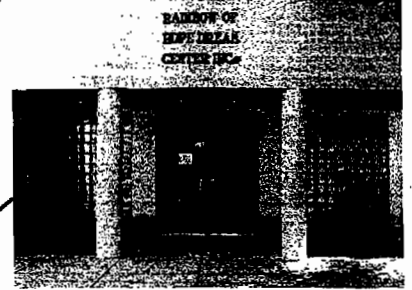
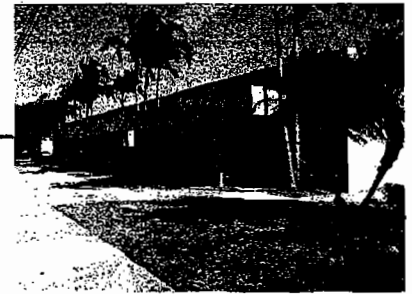
Commercial Areas are surveyed according to the same criteria; however, some consideration is given to the type of use. The industrial areas are not subject to the same criteria. Industrial buildings, structures, and land are often found in conditions that may be viewed as deteriorating; however, it is often related to the "messiness" of the business in its daily operation, to some extent the competitive position of the industry, and often to the business priorities of the management. Industrial area physical conditions as they relate to devaluing adjacent residential or commercial areas are more properly considered as use conflicts and defective land use controls. Examples of the types of commercial uses existing on the site and their physical conditions are shown on the photographs on **Figure 4, Commercial and Institutional Site Photographs.**

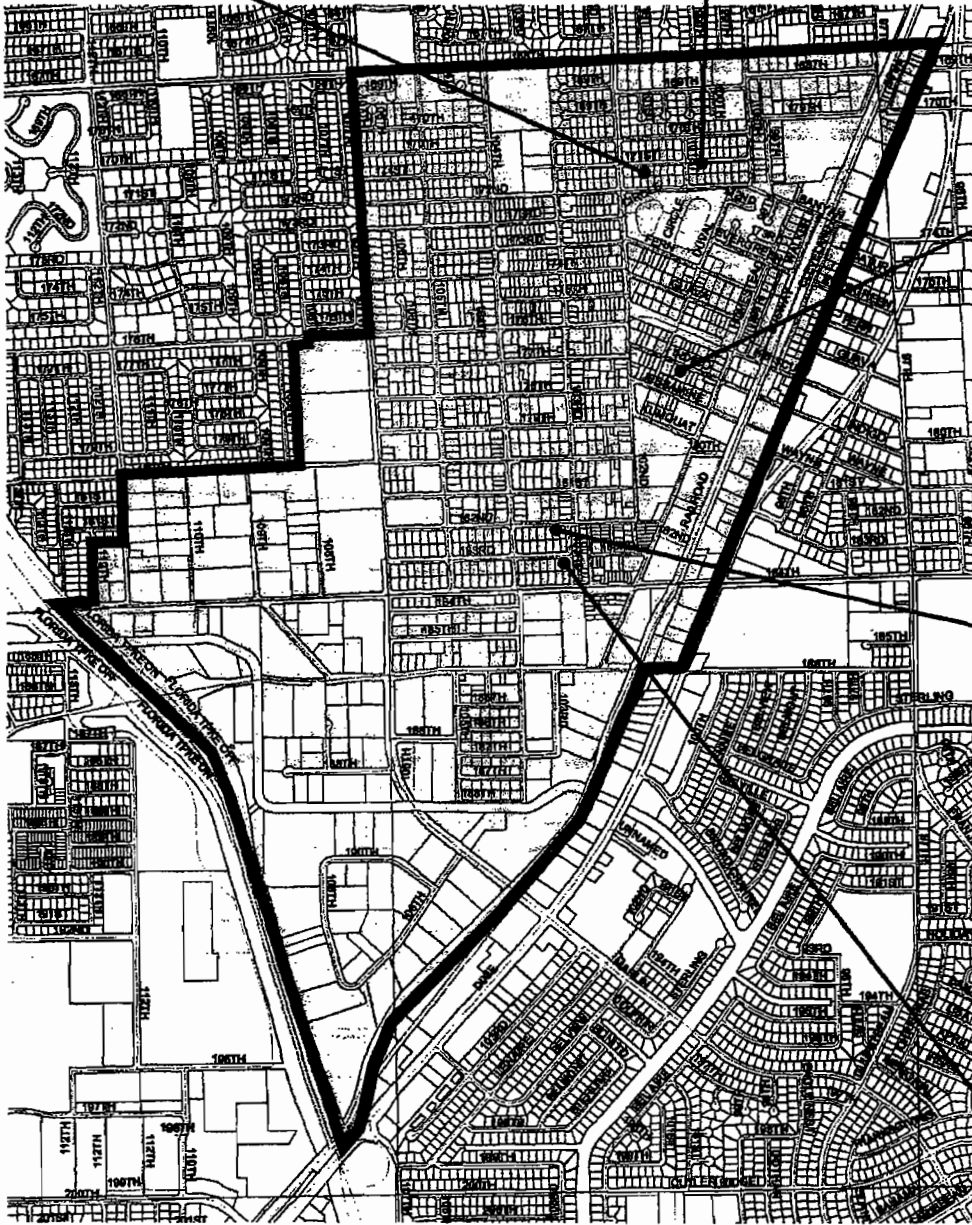
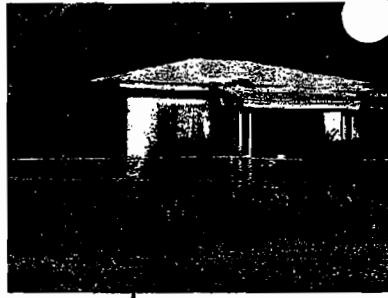
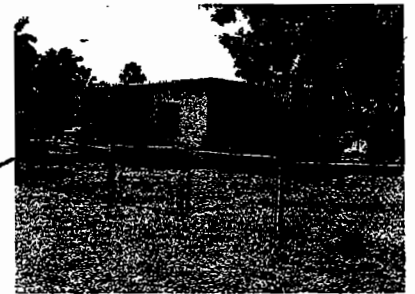
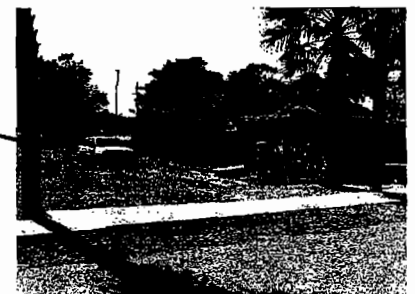
**Figure 5A**  
**Housing Characteristics Photographs**  
**West Perrine CRA**

In summary, 91 of the 899 residential buildings are showing signs of deterioration, and 11 are dilapidated. Together, the deteriorating and dilapidated buildings are 11% of the stock of residential structures in this area. On a typical block of 16 to 20 lots, this would mean that two buildings are deteriorated or dilapidated. Examples of the quality and condition of the residential properties in the area are shown in **Figures 5A and 5B, Residential Site Photographs**.

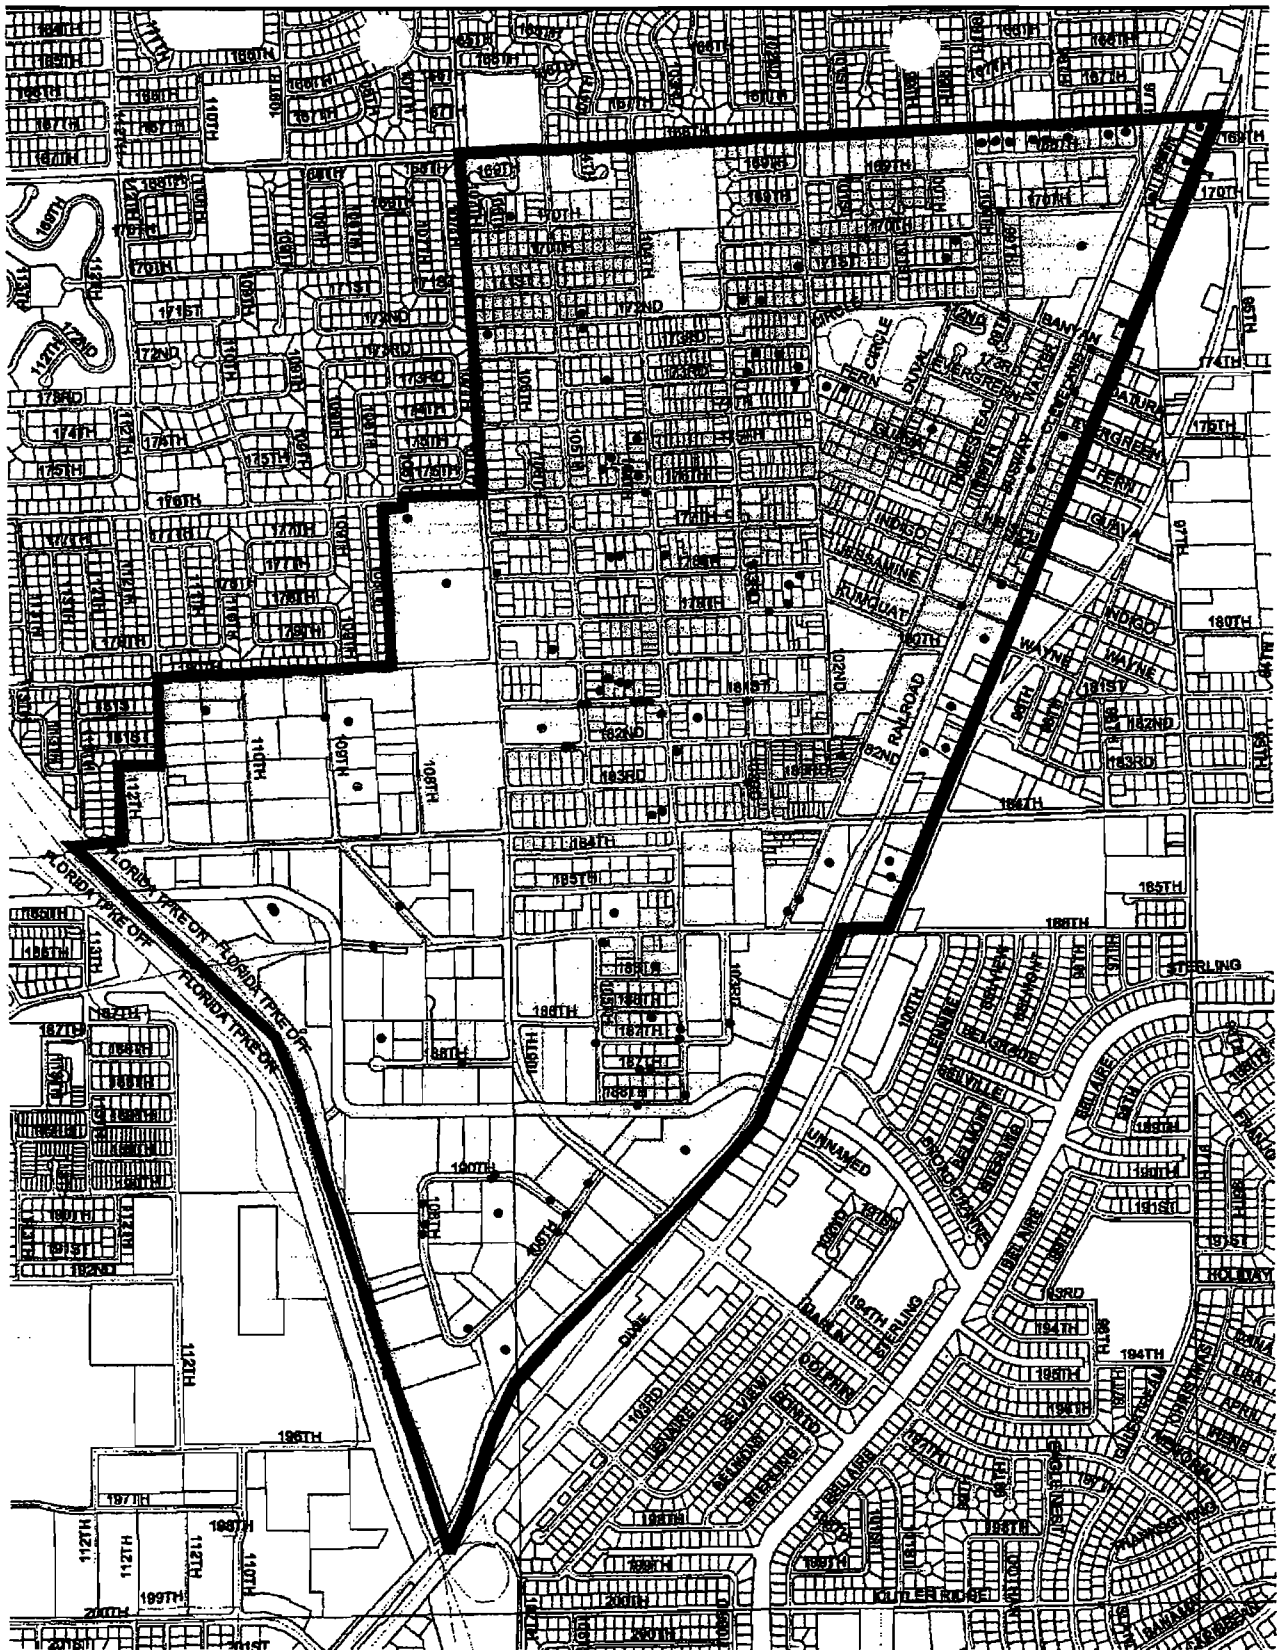
**Figure 6**  
Code Violations  
West Perrine CRA

To further support the visual survey, data was gathered from Miami-Dade County with respect to code violations. **Table 4, Open Code Violations**, lists the open code violation cases and **Figure 6, Open Code Violations** shows the extent of the code violations throughout the study area. Details of the open code violations are contained in **Appendix A**.

Code violation data can contain evidence of: additional defects not evidenced in exterior surveys, health and safety issues that create unsafe conditions and may contribute to risk of loss and injury from electrical hazards, fire, and unsafe structures. In addition, evidence of unsanitary conditions, and health issues related to structure materials, hazardous material contamination, presence of vermin, and poor light and ventilation may be obtained. The area suffers from a trash in the right-of-way and abandoned vehicle problem that contributes to the blighting of the area.

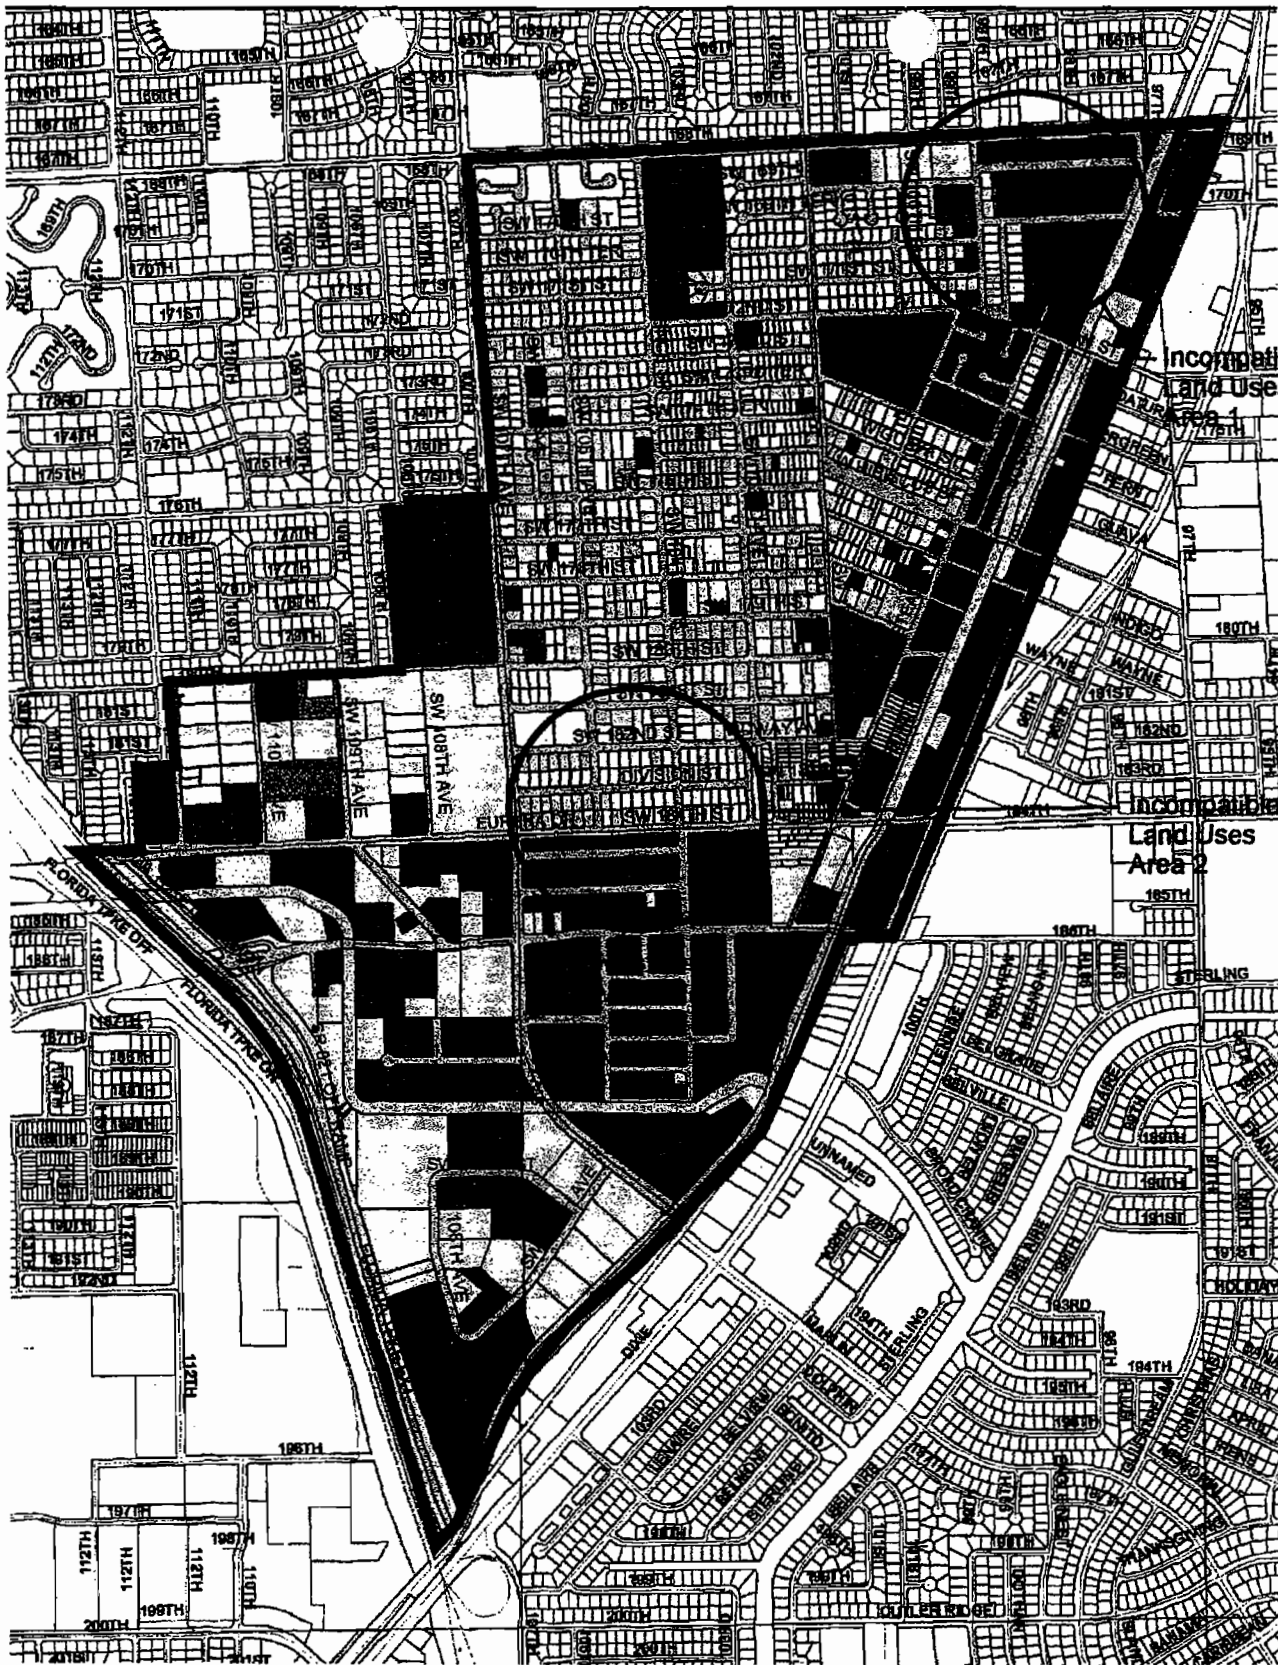
1. The northeast corner of the area has single-family residential uses in close proximity and adjacent to industrial uses. This industrial area mixed with commercial uses, are located just north of SW 172<sup>nd</sup> Street and east of SW 97<sup>th</sup> Avenue, up to SW 168<sup>th</sup> Street on the north, and the South Dade Busway Extension on the east. In this area are located a significant number of facilities for long-term, open auto storage, auto dismantling and salvage operations, and boat building. These types of uses, are visually blighting, cause significant noise, and are associated with the use of noxious and potential hazardous materials in open areas. These uses, even if walled, should not be in close proximity to places where people live. The location of these uses at this location seriously devalues the area and may even cause health associated risks. These incompatible uses are a significant contributing factor to blight in the area.

In summary, there are two areas of serious, incompatible use conflicts that are contributing factors to causing blight in this area.

There are two instances of defective land regulation, and they are both related to the incompatibilities discussed above. These areas are also zoned for "Industrial – Light Manufacturing" (zone # 7100). This zoning lay, with such close proximity of these industrial uses to residences, is defective. In both cases, it is a significant contributing factor to blight in this area.

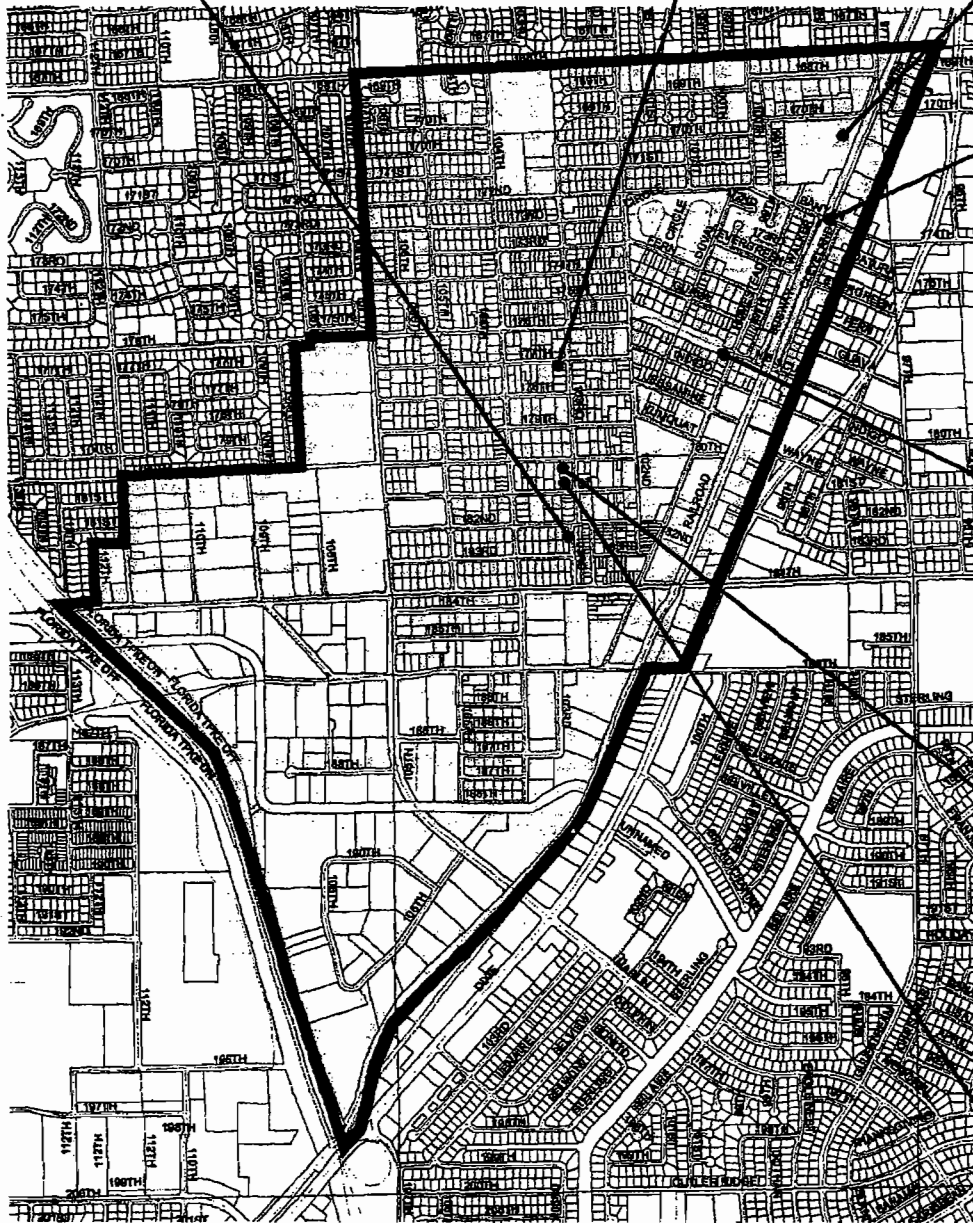
**Figure 9A**  
**Trash Site Photographs**  
**West Perrine CR.**

Vacant lots diminish a community's value because they attract dumping, and are usually overgrown. The dumping and trash, in combination with overgrown tall grasses can easily create a higher risk of fire hazard, as well as attracting vermin that create other health risks. Finally, vacancies under these conditions may contribute to higher crime due to their provision of large spaces that are hidden from view and not easily patrolled by police. Examples of the trash and dumping that vacant lots attract are illustrated in **Figures 9A and 9B, Trash Site Photographs.**

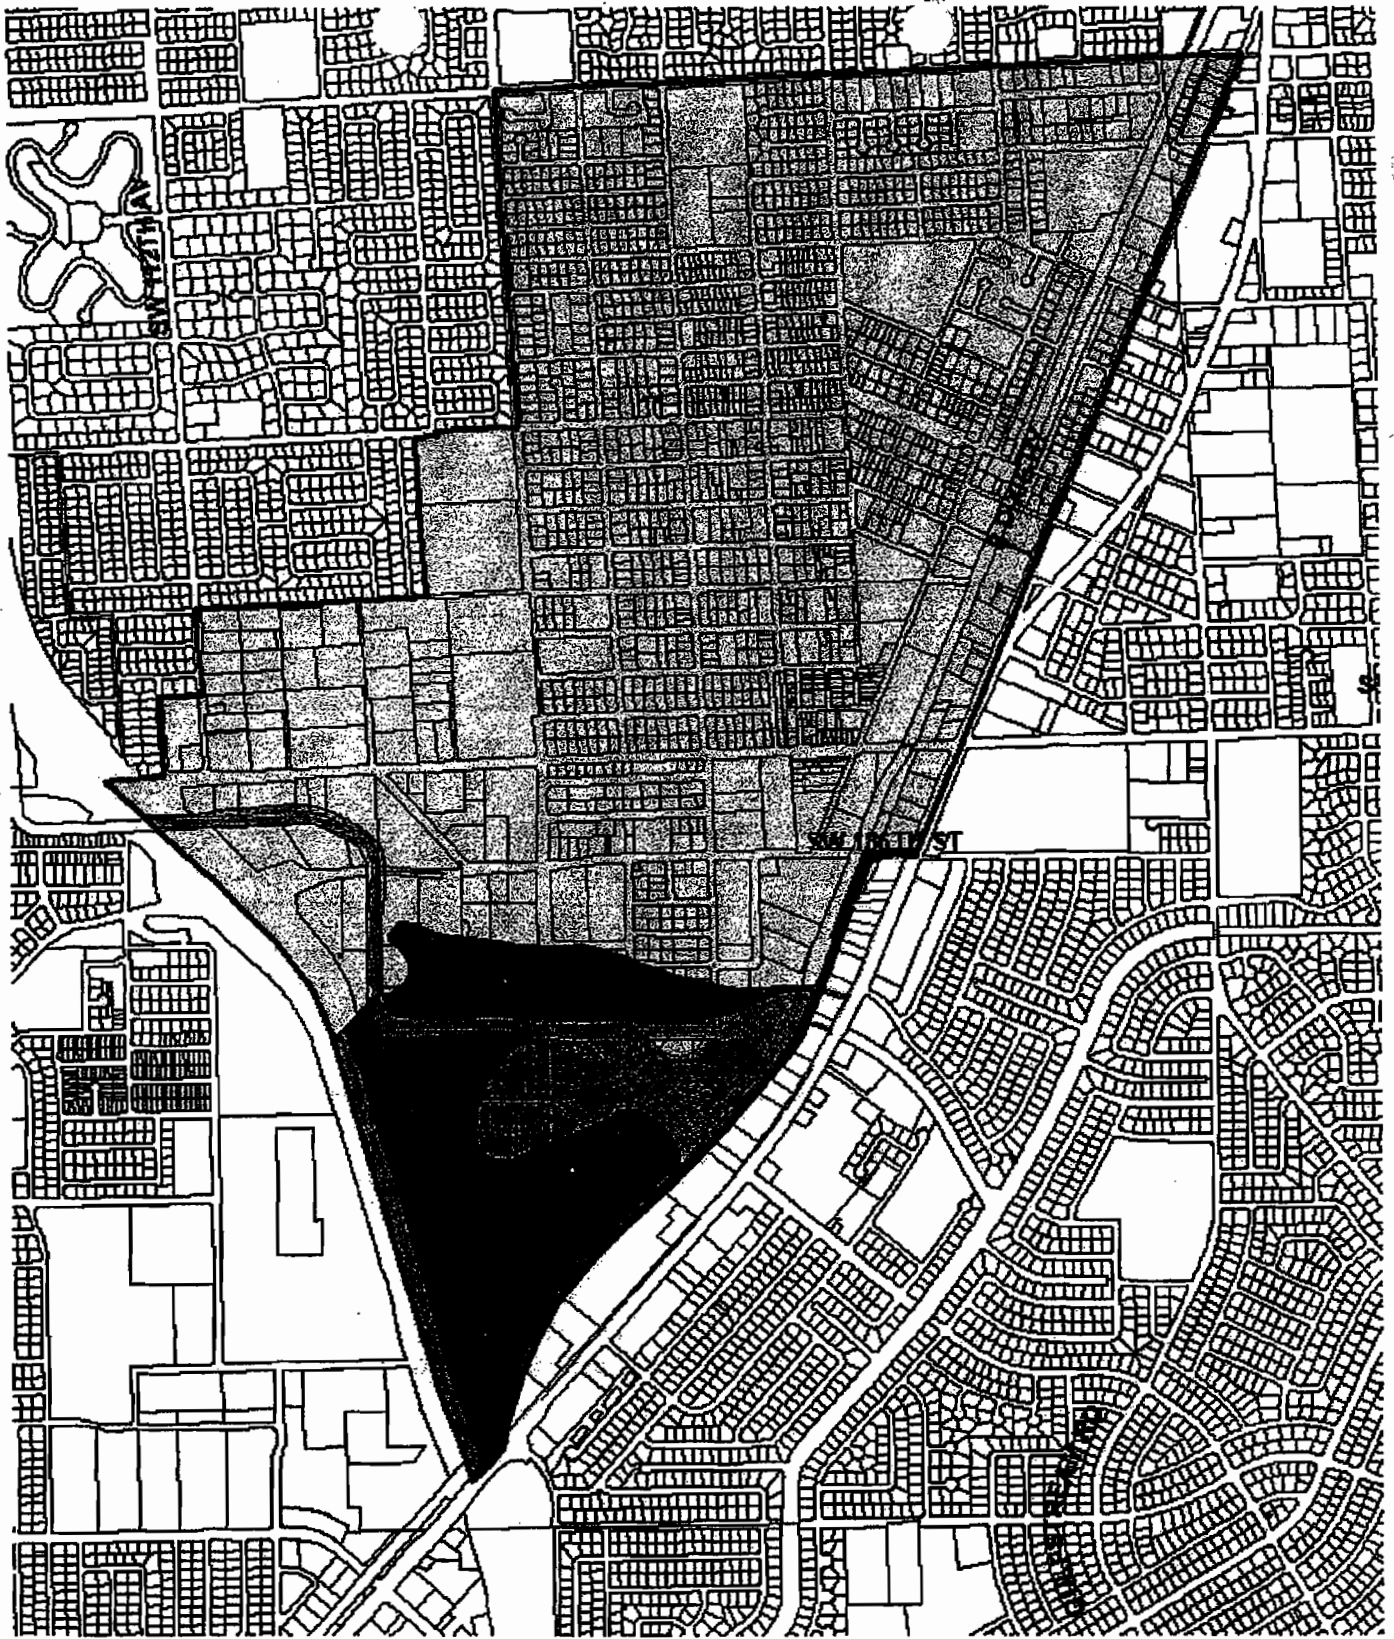
The majority of the West Perrine area is in flood zone X, or flood zone X-500. These areas are not considered flood zones and structures within them are not generally at risk. However, at the southern end of the area, there are two pockets where the flood zones are AE or AH, both of which are considered flood zones. Structures in these areas may be at risk for flooding. Development may be more expensive in those areas as well and as a result, those areas may receive less development. The general area of each flood zone is shown in **Figure 10, Flood Zones.**

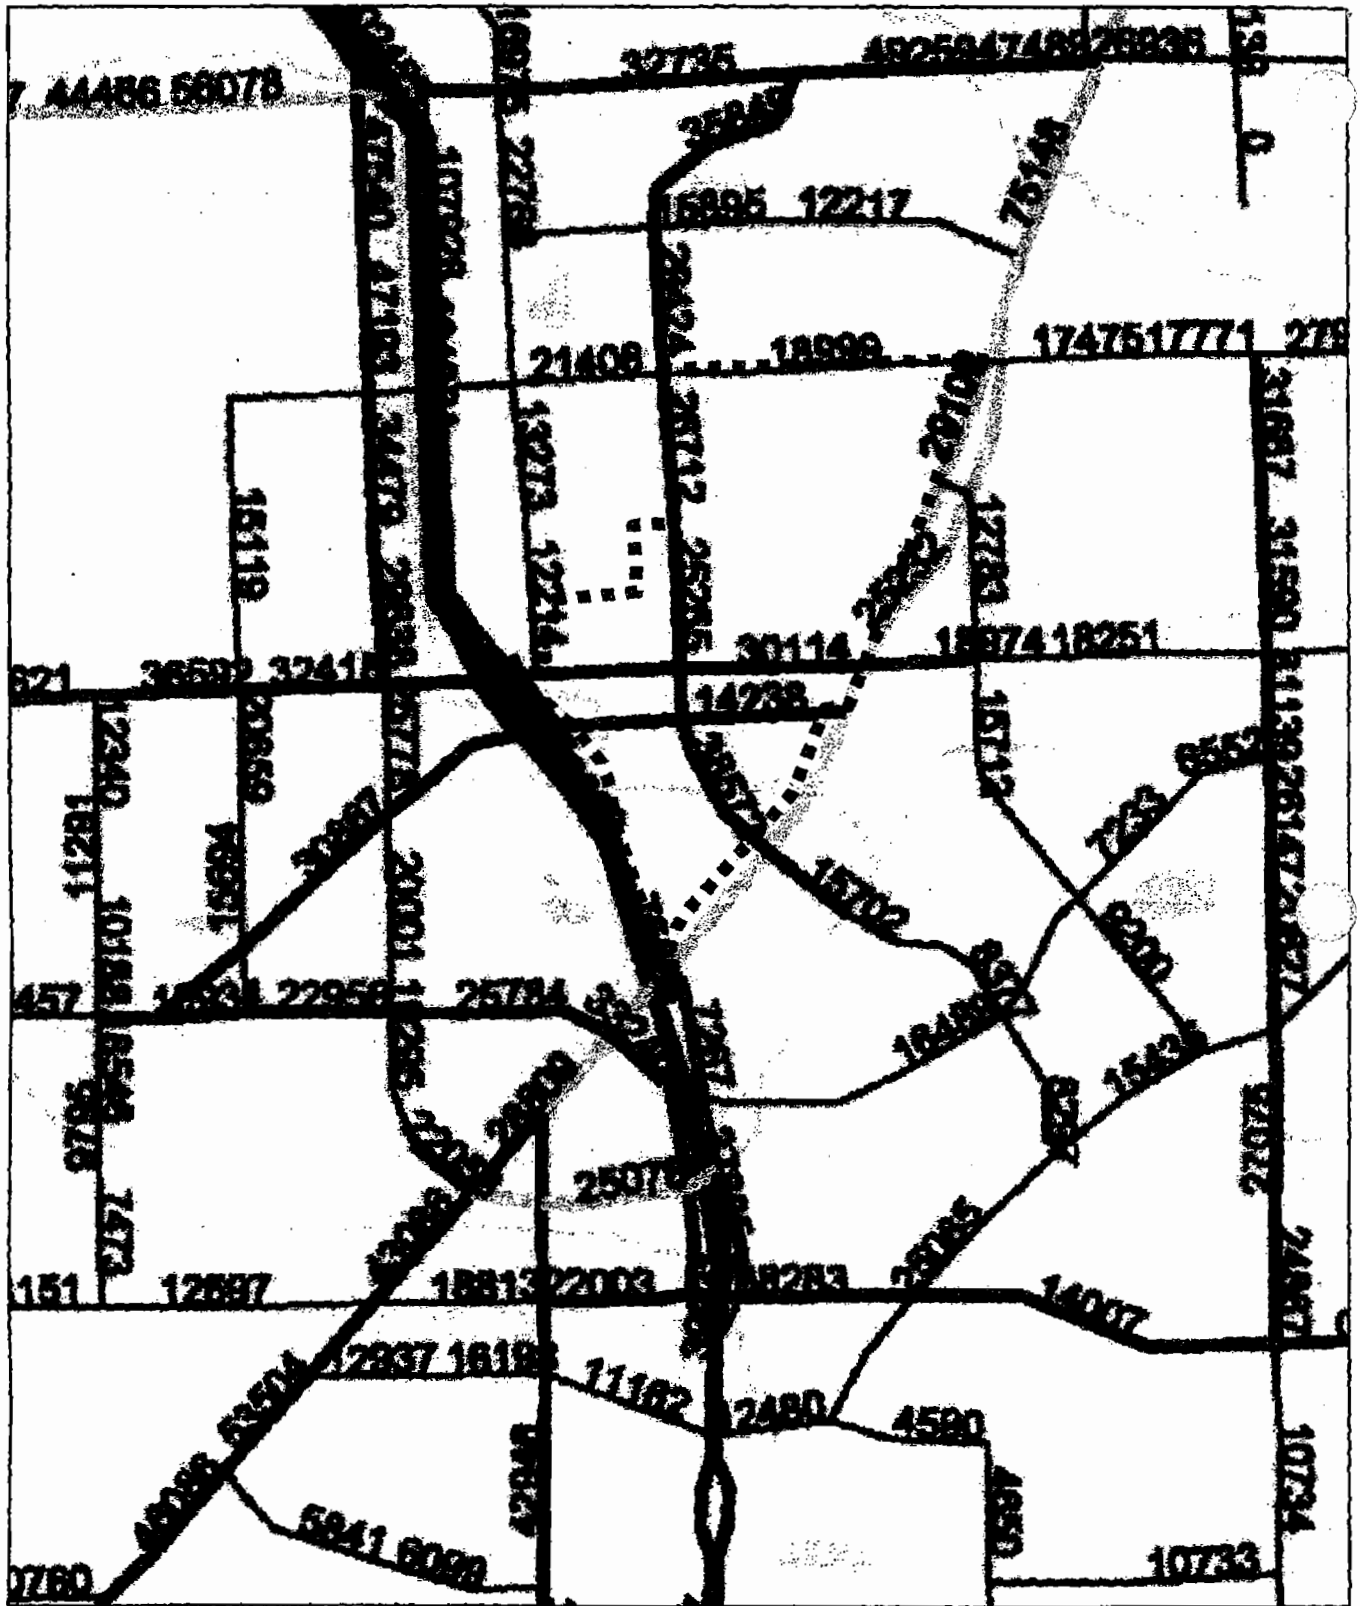
XXXXX Year 2025 Projected Traffic Volumes
